Oatlands Gaol Remedial Works Report 2004

Barry and Eleanor Bjorksten 2004.

Remedial Works Report 2004

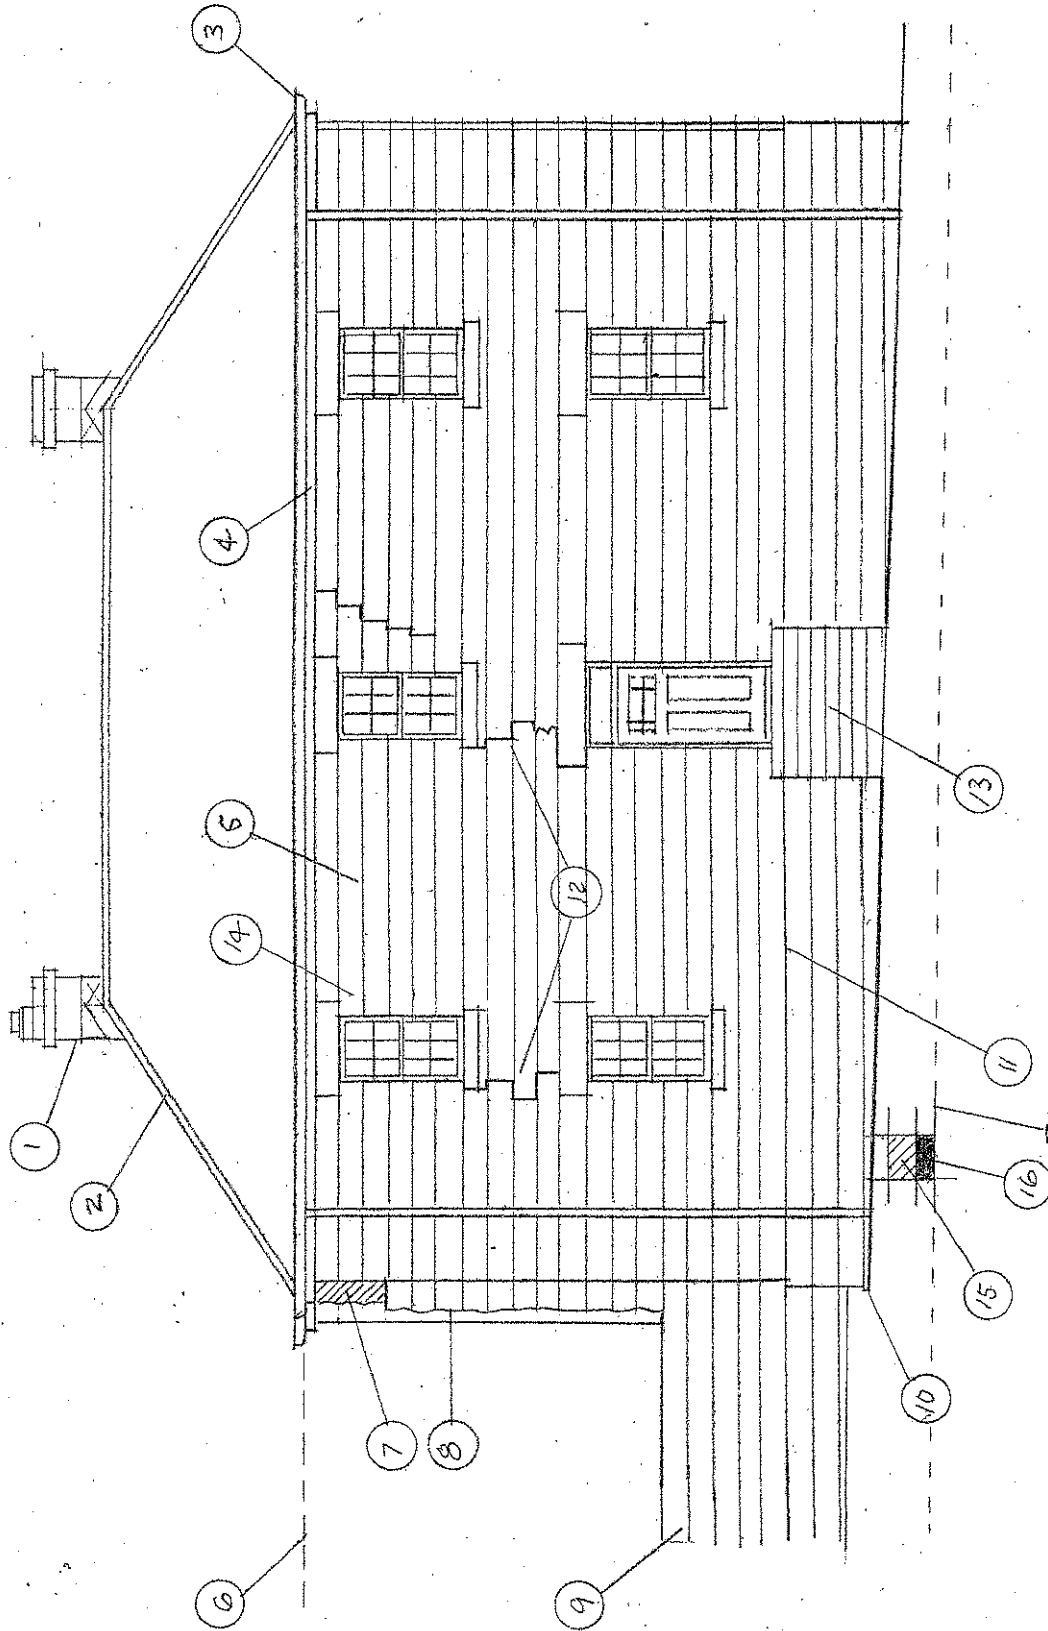
NORTH ELEVATION and remedial work

Crack following joints } Crack across stone block. Scale 1:100 =

- Install recycled blocks and wire bed joint ties at the NW corner in accordance with Detail 22 (P 78) Make good corresponding internal cracks..
- Install a pit at a point 1600mm back from the NE corner and drain to the street storm water pit to remove water from under the building. Confirm location by flow of water through the footing.

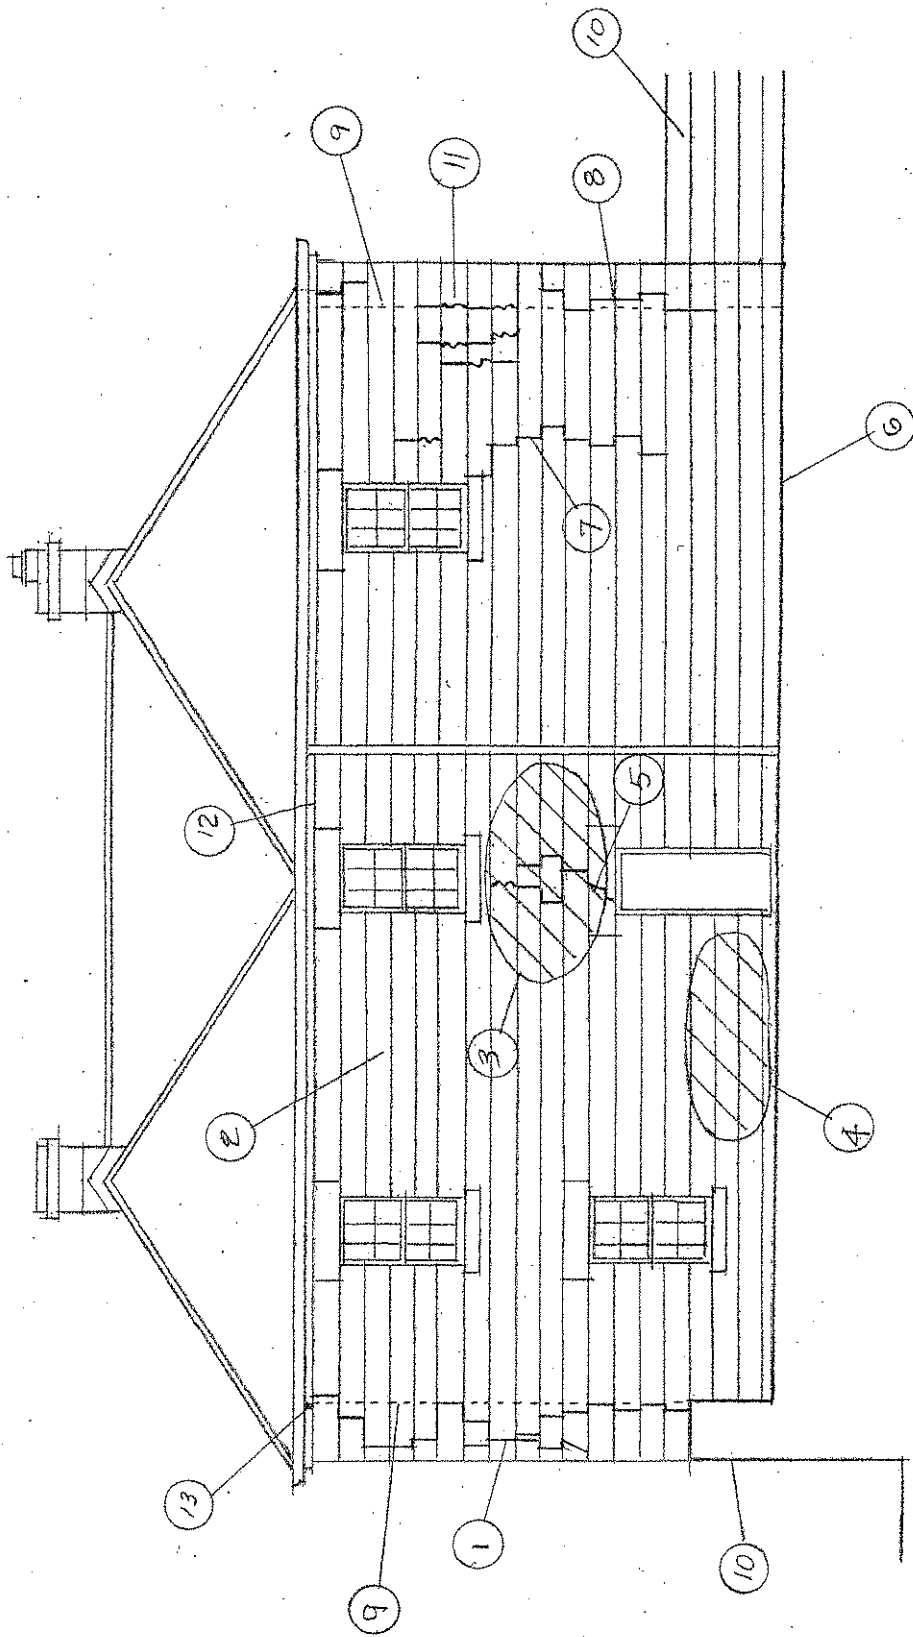
SOUTH ELEVATION and remedial work

Cracks following joints 3 Crack across stone block Scale 1:100

- Install recycled blocks and wire bed joint ties as shown in Detail 24 (P 82).
- Make good cracks following joints.
- Make good pointing loss including removing loose pointing.
- Prop and insert new lintels to doorway and window. Refer Detail 21. Build in a steel angle below the lower window lintel. (P 77)
- Rebuild sandstock brick window sill.
- Do whatever other improvements are found upon investigation to be necessary to adequately stabilize and make safe the lower part of the SW corner.
- Re-build portion of gaol wall as per Detail 24 (P 82).
- Make good internal cracks corresponding to external work.
- Make good remnant east wall and entrance wing wall. Refer Detail 32 (P 90).

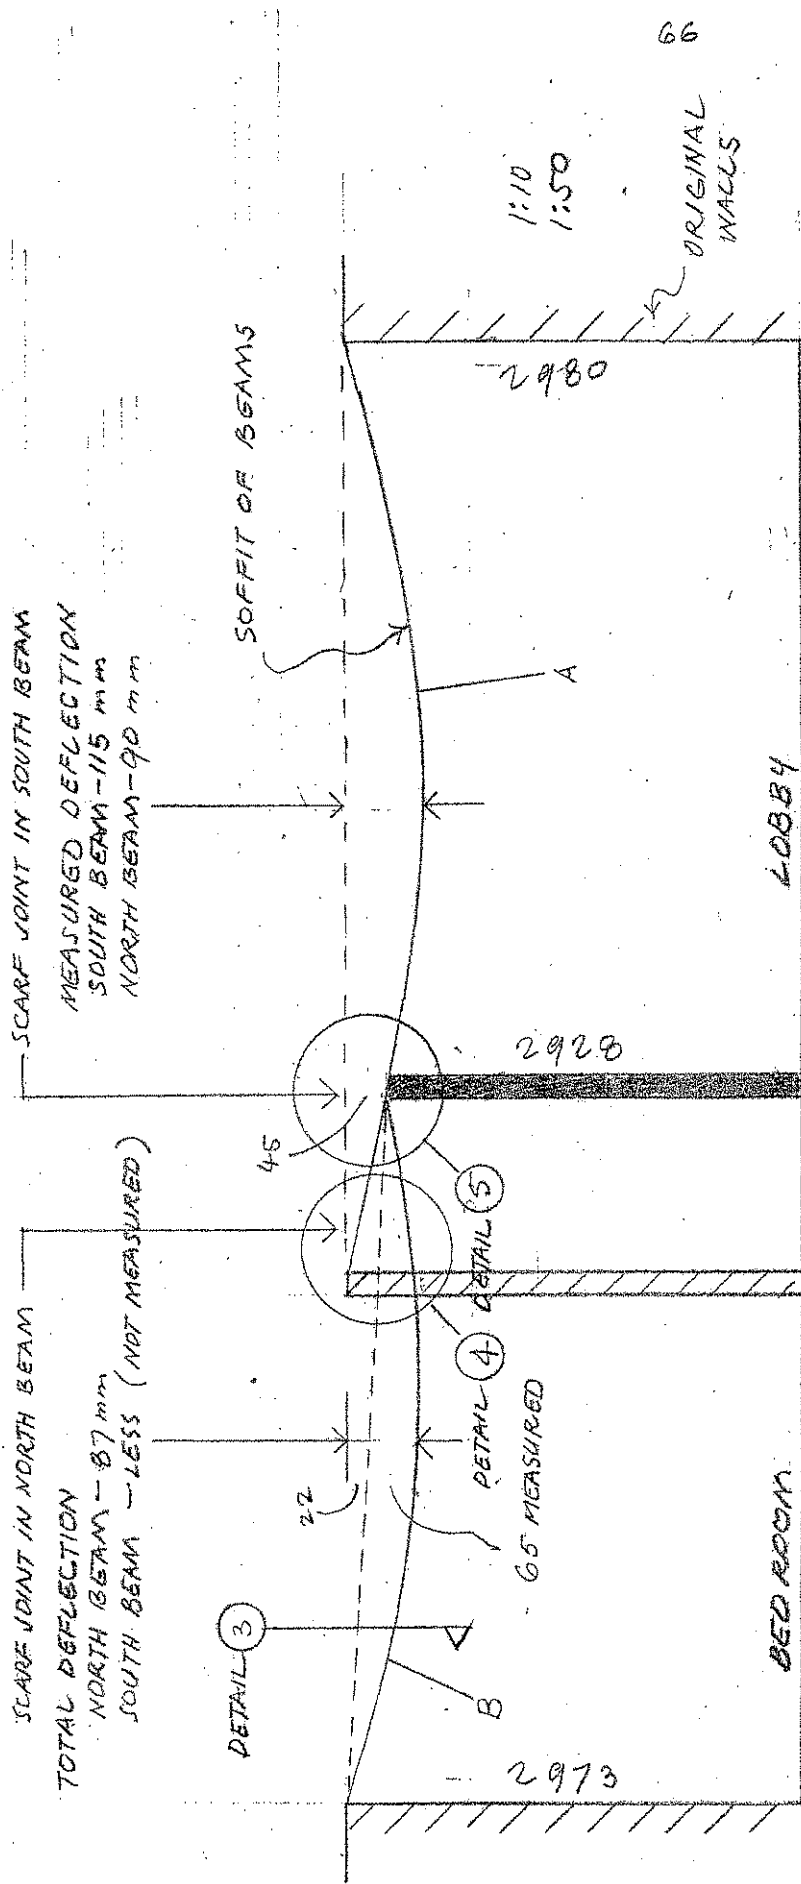
DETAIL 1 DIAGRAM OF CENTRAL PAIR OF BEAMS

It is likely that the size of the central pair of beams was determined on the basis of a 4700mm span east of the central N-S masonry wall. Lee Archer's plans show a passage on the first floor formed on the west side of the masonry wall by a timber stud partition. The masonry wall at this passage was not built thereby increasing the span by 29%, most likely causing the beams to deflect under their own weight and some alarm to the carpenters as the beam which shows the greater deflection has an iron collar around its scarf joint, presumably to close the crack along the centre line. These beams were most likely installed green and the collar positioned at the same time as there is a gap of some 12mm, probably representing timber shrinkage, between the timber and the top of the collar. Refer Detail 5. (P 69) At a later date, possibly in the 1940's when the gaol was used as an army base, the masonry cross-walls to the west of the central N-S masonry wall and the timber partition were removed to make one big room. The ceilings were re-supported by providing hangers from the roof and a new stud wall was built in line with the central N-S wall to support the pair of central beams. With increased span and additional load the western half of the beams deflected (as did the top member of the stud wall) allowing the valley rafters to drop. As the hip apexes were held up by the long diagonal struts, one valley rafter fell right out of the apex and the other broke its back. In addition long term leakage from the box gutter has caused extensive rotting of the beams, spacers, joists, etc, seriously impairing a scarf joint and reducing beam size to an effective 170 x 70mm, or even less. Refer Details 1 and 3. (P 66, 68)

The diagram shows the early deflection 'A' due to self weight and roof load and later deflection 'B' due to the shift in support and extra ceiling load.

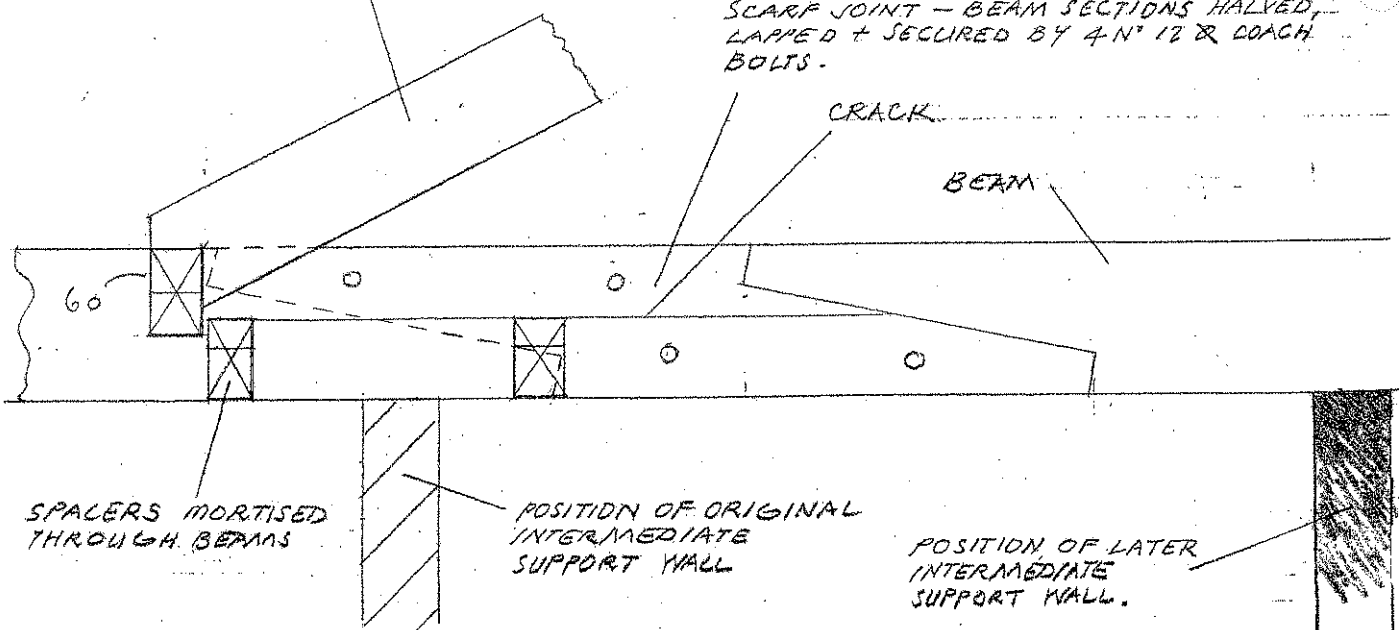
DETAIL (4) NORTH BEAM SCARF JOINT Scale 1:10

- The northern beam of the pair is weakened at the scarf joint by the housing and mortising of other timbers, rot and a long crack.
- A long crack in the southern beam scarf joint.
- Many rafters have deflected.
- The long ridge has developed a slight lateral sine curve.
- The lower half of the northern valley rafter has deflected.
- The southern valley rafter has a considerable bow to the SW.
- Creeper rafters are parting company with the valley rafters.
- A hip rafter in the SW hip end is dropping out of the apex.
- A short ridge board at the NE hip apex has split.
- Ceiling joists show considerable deflection.

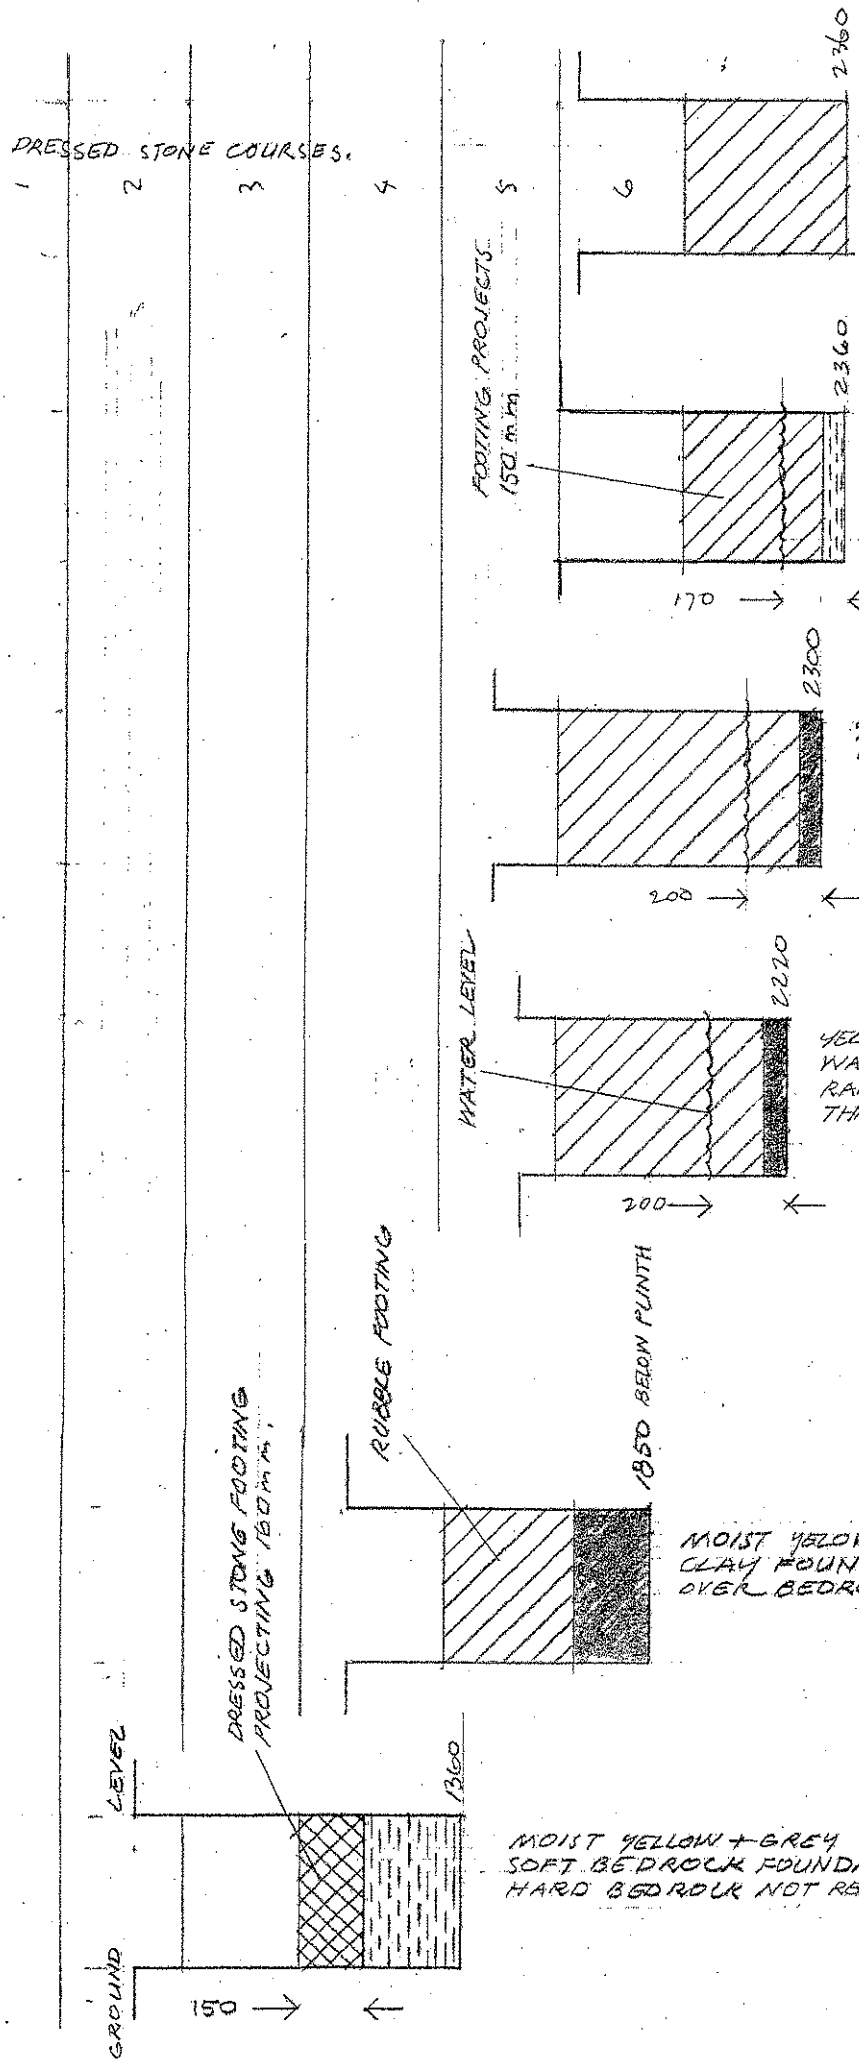
DETAIL 31 HOLES SUNK TO
BEDROCK AGAINST WALLS.

Some six inspection holes were dug against the walls of the gaol and the gaoler's residence. Refer Detail 31 (P 89). In three of the lower holes, but not the lowest, water ran in from the gaol and residence and stopped at a fairly consistent height above the bedrock at roughly the same level as water sitting in the street drainage swale four metres to the north. Since the holes in the upper part of the site remained dry the water in the lower holes will most likely be from within the gaol enclosure or from the street to the south flowing within fault planes and trapped by the wall and saturation of the ground in Mason Street (it having been a wet winter).
