Oatlands Gaol Structural Report

***Oatlands Gaoler's Residence
Structural Report***

***Oatlands Gaol
Structural Report***

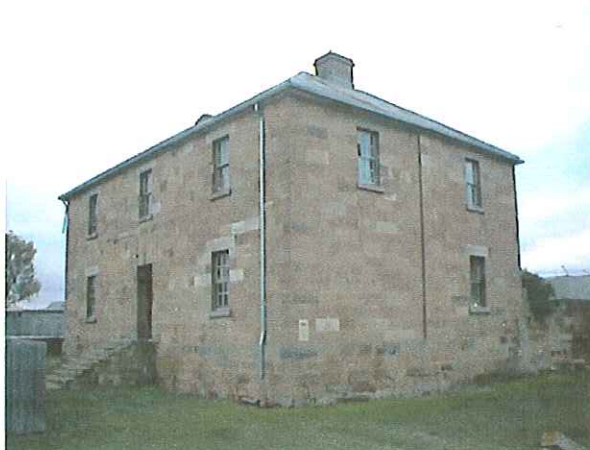
Photo 1. East front and north side walls.

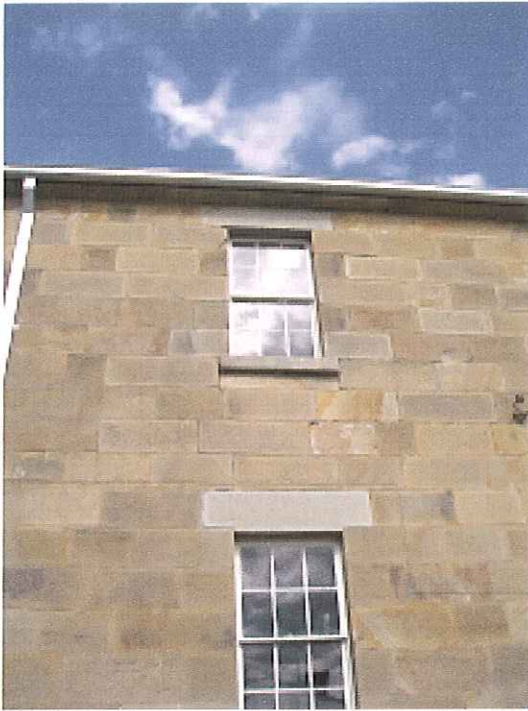
- The ashlar stones are of variable thickness and it is indicated that some stones provide little vertical support area to the stones above.
- The roof load is on the ashlar facing and any roof vibration or movement is transferred into the ashlar.

- The combination of roof ridge drop, member buckling, poor ashlar bonding of roof loads on the ashlar, likely bedding washout and rot of critical roof timbers has led to extensive ashlar delamination and cracking of the ashlar and cracking of bonding internal cross walls at their junction with the external walls.

Photo 2. Note lack of headers and vertical stone cracking between windows indicating ashlar movement and delamination

The ashlar delamination is simply and effectively corrected by grouting and spiking the delaminated sections to solid.

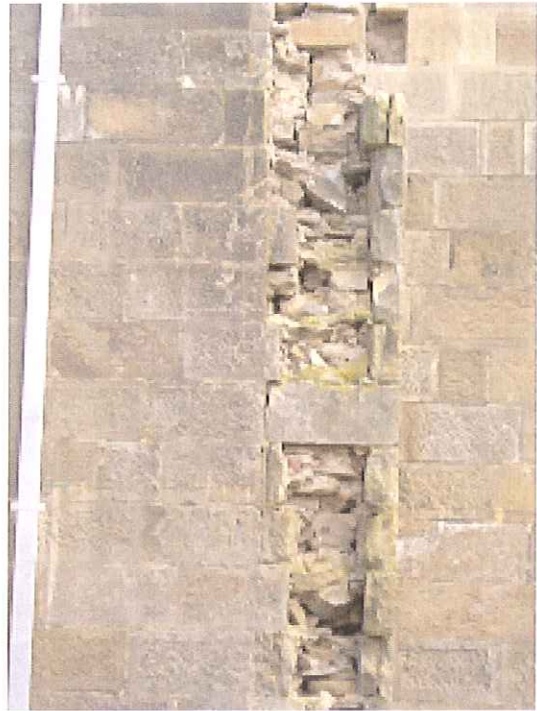
- The building is ashlar faced with few headers bonding the facing to the main wall behind.
- The stones are bedded in site soil with little or no quicklime with the result that the bedding has little bond strength and is readily washed out with water entry.

Photo 3. Site soil bedding and variable thickness.

2. Water entry into site soil bonded ashlar stonework with an inadequate number of headers and with a variable ashlar stone thickness where thin section or sharp edged ashlar gives little vertical support to stones above.

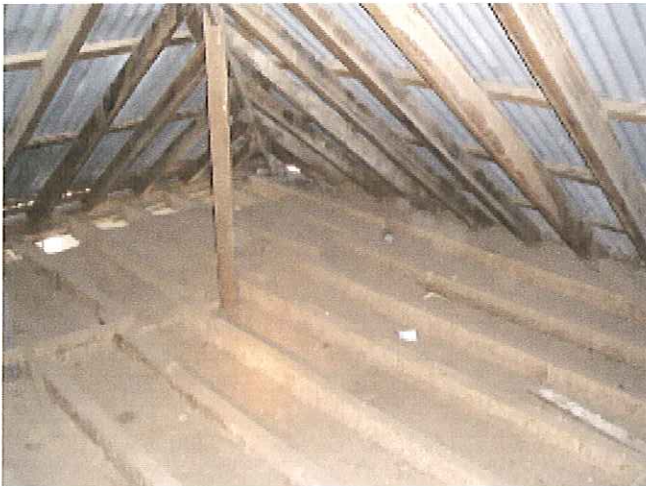
- The roof ridges are not adequately supported and the ceiling joists do not tie the roof rafter landing plates in either direction between the outside walls. As a consequence the roofs have spread as the roof ridges have dropped.

Photo 4.
The roof lands on the outside ashlar.
Note the joists on the right are parallel to the wall plate and there is no connection between the roof and the joists.

3. The specific construction details of lack of ties across the building between the roof rafter landing wall plates.
4. The specific construction details of inadequately supported roof ridges and the use of undersized roof framing members which readily buckle under wind load.

The roof is best practice stiffened by constructing timber trusses along the roof ridge lines and as truss underpurlin support to the roof rafter centres with truss bottom chords simultaneously stiffening the ceiling joists under. The trusses will additionally tie the roof structure to all the building walls.

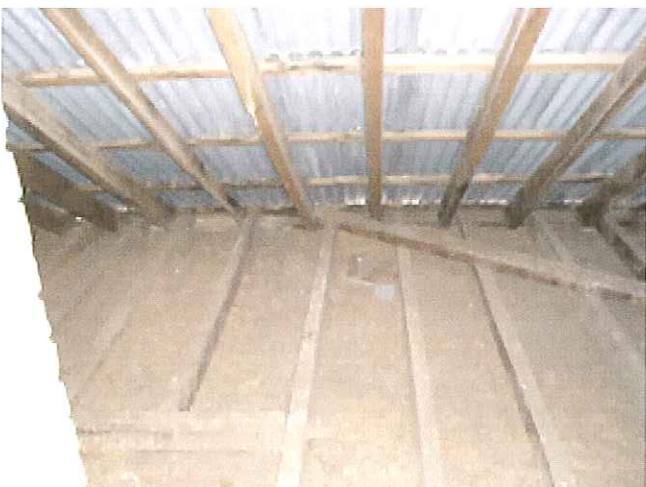
- The roof framing timbers have excessive slenderness ratios and readily buckle under compressive wind forces.
- There is major water entry into the walls from faulty gutters, downpipes and flashings.

Photo 5.
Note the very slender roof members which readily deflect or buckle in compression.
Compression member span divided by member minimum thickness should not exceed 50.

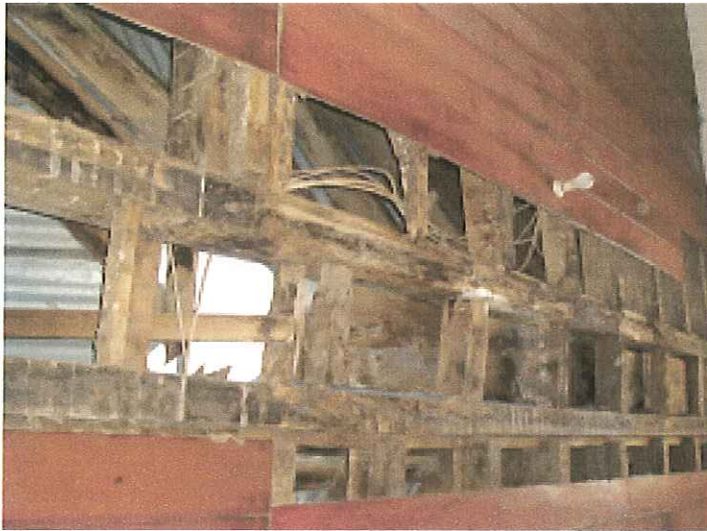
- The water entry has caused major rot of critical supporting timbers in the roof.
- Structural alteration with the removal of essential load bearing walls on the first floor west side has resulted in overload and adverse deflection of members tying the roof structure together and imposing additional laminating stress on the ashlar at the wall plates on the east and west sides.

Photo 6.
Rot of ceiling tie beams with water entry.
A supporting wall has been removed increasing beam span and deflection.

5. The specific later removal of critical supporting walls exacerbating the effects of the problems.
6. Water entry from gutters and flashings particularly from the central east to west defective valley gutter causing rot of critical support beams to the roof and the first floor under.

First works are to rebuild the removed walls and to make good the rotted roof timbers and floor timbers caused by the defective valley gutter.

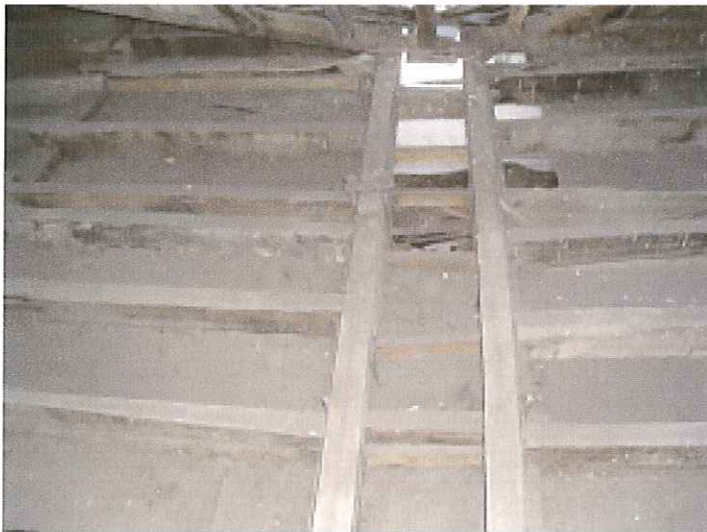
Photo 7.
As photo 6 from above.
The beam deflections have dropped the ends of the joists which the beams support.

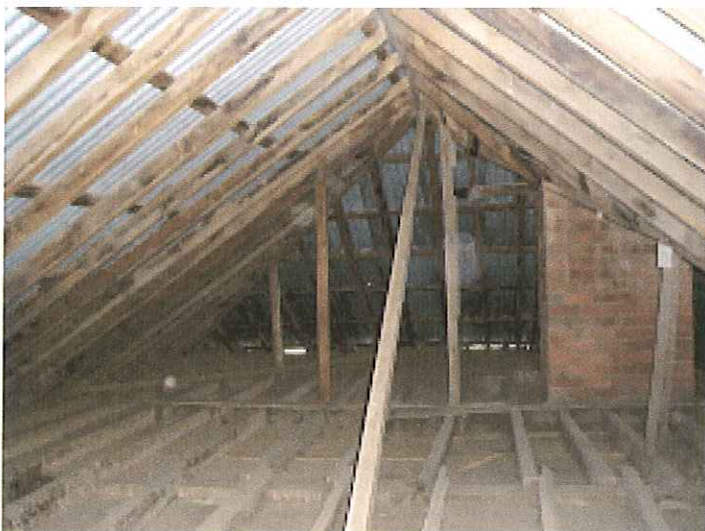
Photo 8.
Typical roof construction with inadequate ridge support, readily buckled struts and braces and with all roof timbers undersized.
