Analysis of the effect of excessive damp and chlorides on the sandstone walls of the Oatlands Gaol (1837)

Brad Williams
Heritage Project Officer

May 2007

**SOUTHERN
MIDLANDS
COUNCIL**

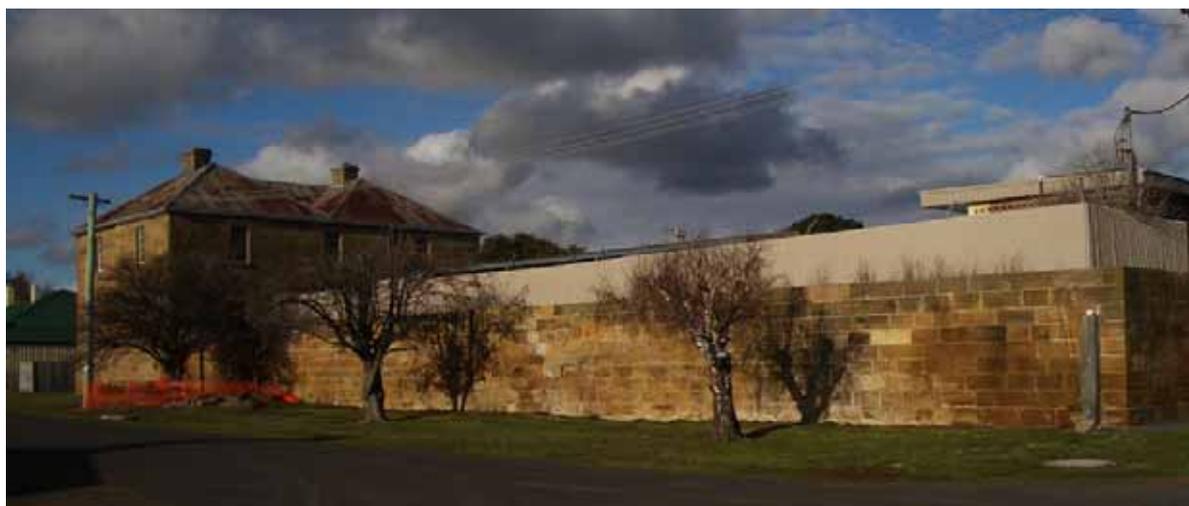
The only drainage from the site is from showers/toilets and stormwater from the roof of the change rooms. All other water must find its way from the site via natural seepage. Bedrock appears to be less than a metre below natural ground level (evident by an outcrop 3 metres from the western wall), and it is assumed that the foundations of the buildings and perimeter wall are built directly on bedrock (supported by the apparent lack of foundation movement – Spratt 2005). All seepage will either run through the 700mm thick sandstone perimeter walls, or well-up behind the walls. As the site is on a gentle slope (natural ground level on the western side is approximately 1000mm less than on the eastern side (a gentle 1 in 40 grade), seepage naturally flows westward – as apparent by the excessive damp on the western wall.

Figure 5 – The western wall of the gaol (the Gaoler's residence at left). The perimeter wall shows signs of damp (dark patches) and efflorescence of salt (white patches) even at this distance.

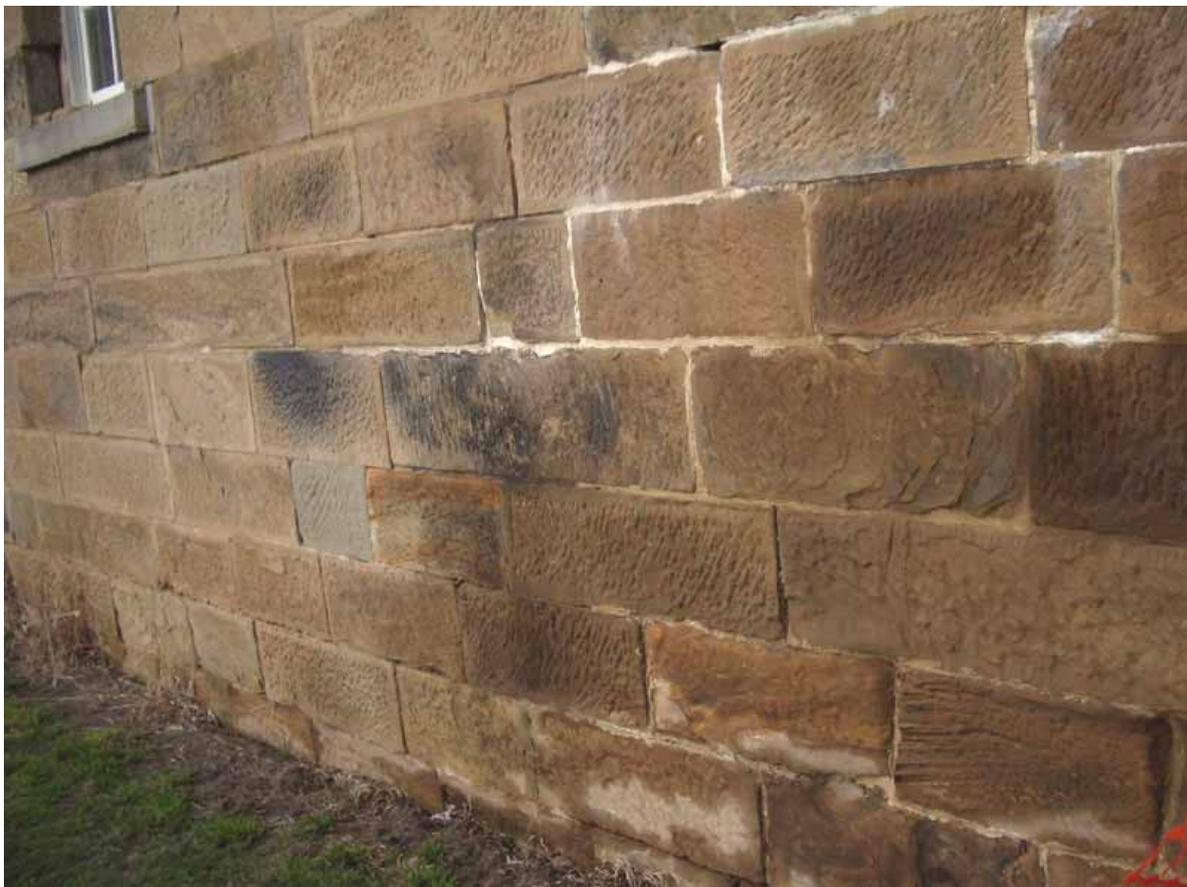
Figure 6 – The dark areas on the gaol walls are distinct patches of moisture. The ground level inside the walls is at the fourth course shown here.

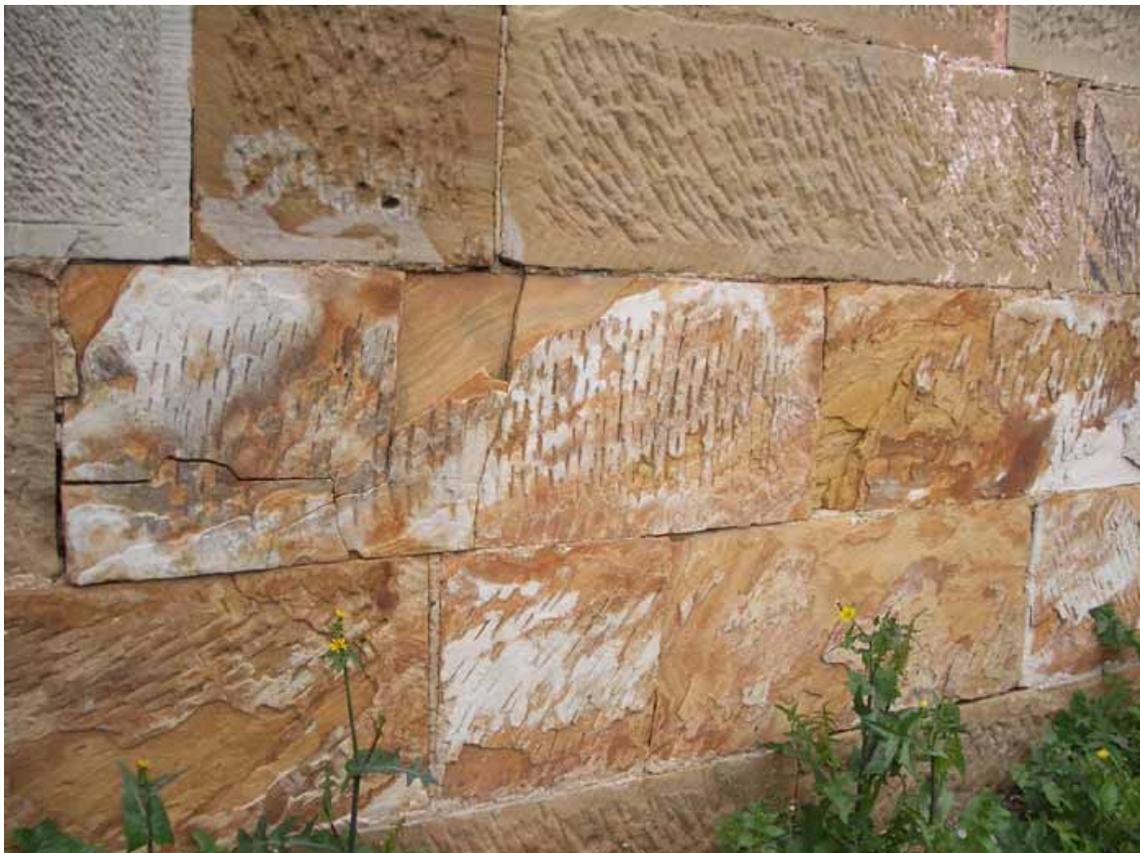
Figure 7 – Efflorescence of salt on the face of stone. Whilst the exfoliation is probably a result of face bedding, continued salt attack will accelerate this (note also pointing loss).

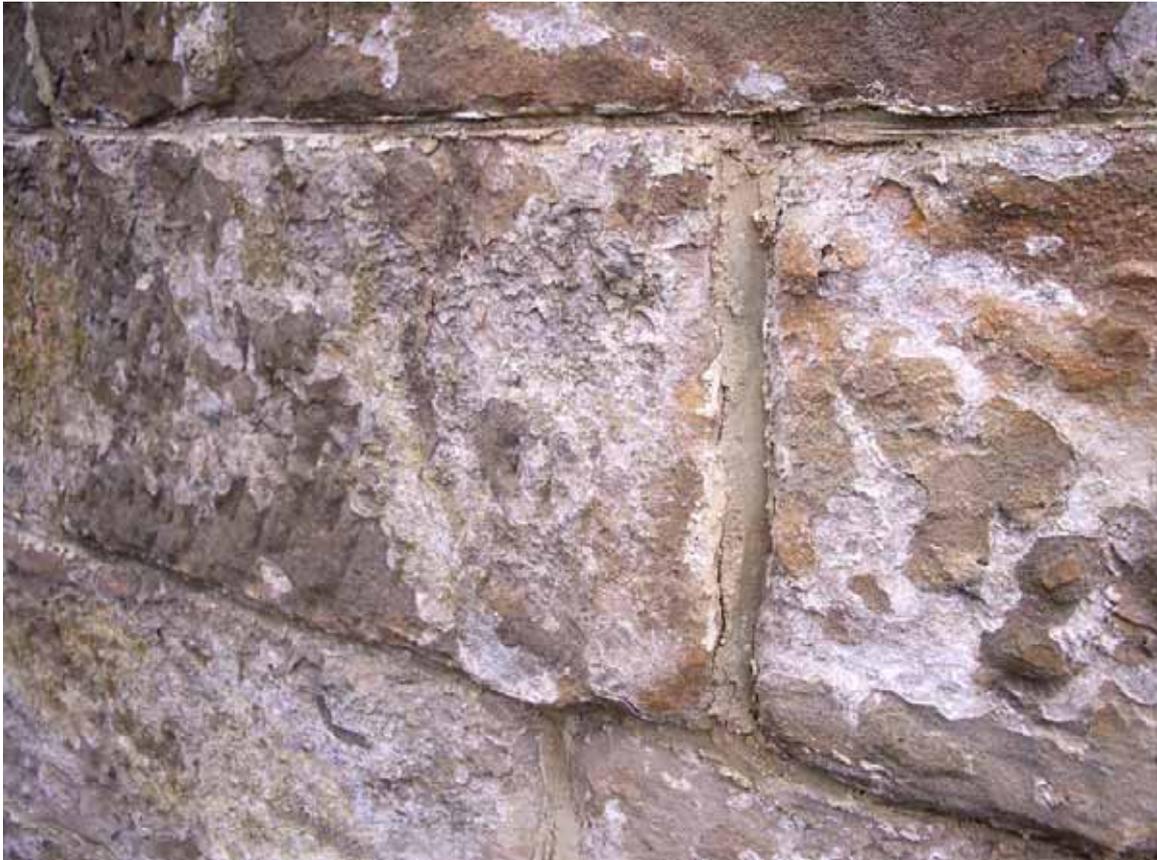
Figure 8 – Efflorescence of salt forming on the face of the stone of the gaol walls, with some flaking beginning to occur. Note that the pointing was replaced in 2003.

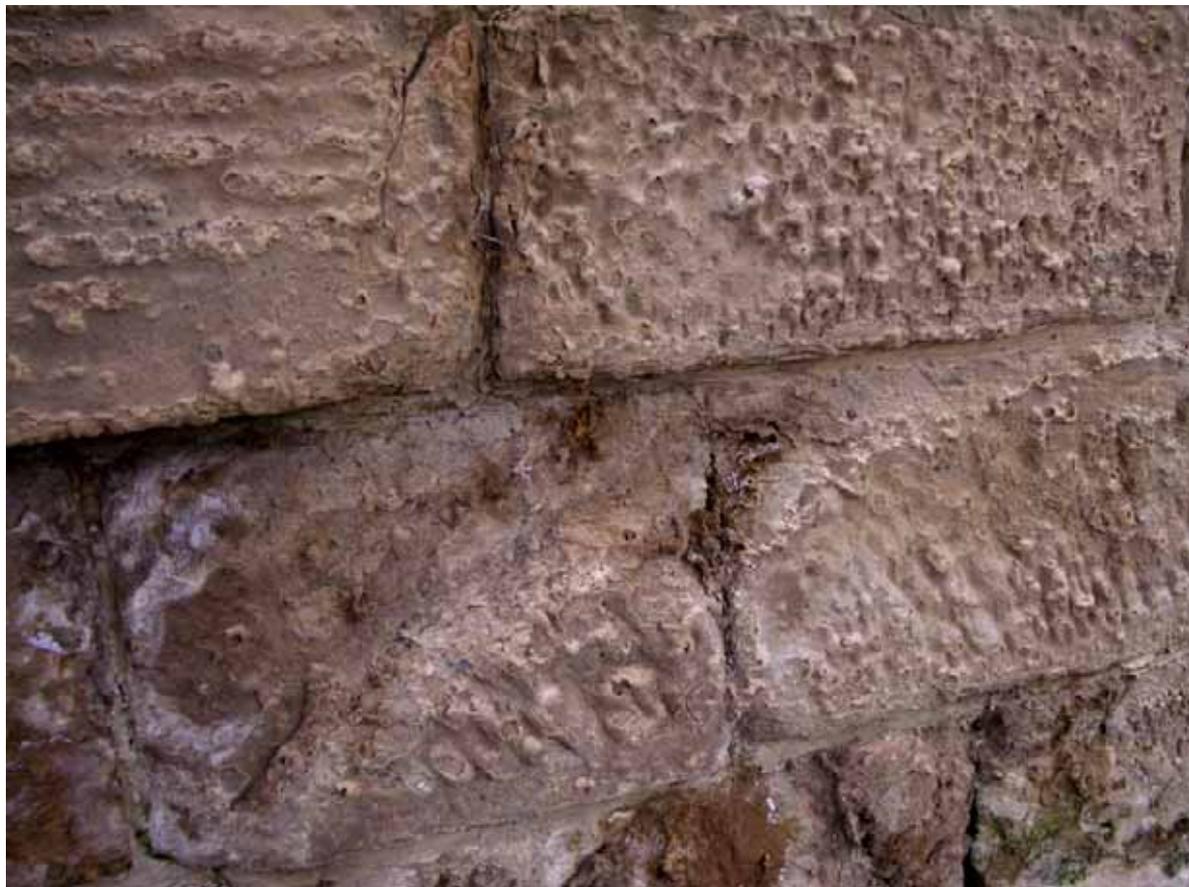
Figure 9 – Severe flaking and blistering of the face of ashlar blocks.

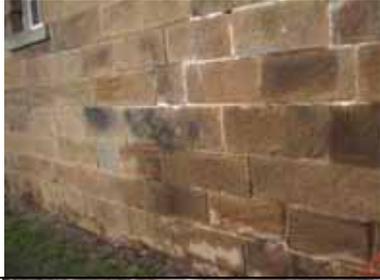
Symptom	Example	Number of blocks observed	% of wall (n=420)	Note
Visually damp (i.e. dark colour of wet feel in full sunlight at 15 degrees ambient temp.)

64	15	Levels have been observed to fluctuate according to weather, temperature, pool use etc.
Flaking, erosion or salt accumulation (i.e. some visual evidence of active salt accumulation)

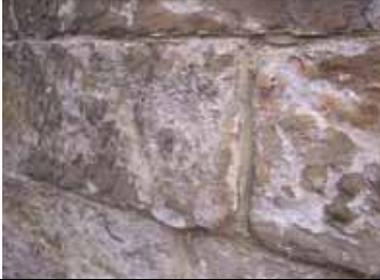
270	64	Mostly limited to the lower 5 courses of stone, where incidence is practically 100% (consistent with the mechanism of rising damp described here).
Efflorescence (i.e. distinct minor build-up of salts on face – number included in above)

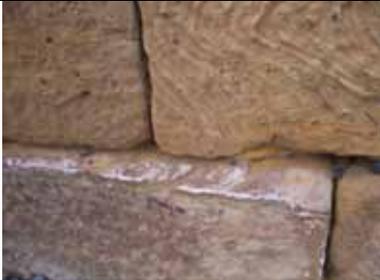
101	24	
Severe blistering (i.e. indicating severe active salt attack)

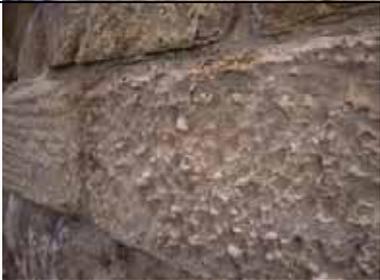
20	5	
Deep erosion which may result in structural failure (i.e. severe loss of all the stone face – number included in above)

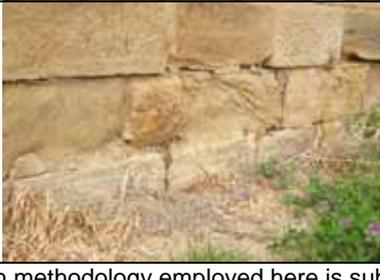
20	5	
Note that the observation methodology employed here is subjective. More accurate measurements could be made by empirical testing for salt and moisture. These observations are therefore indicative only.
