**Southern Midlands Council  
18 Church St. Oatlands – SMC Works Depot**

Site History Report  
For  
Bzowy Architecture

June 2013

Project No: 4193.001

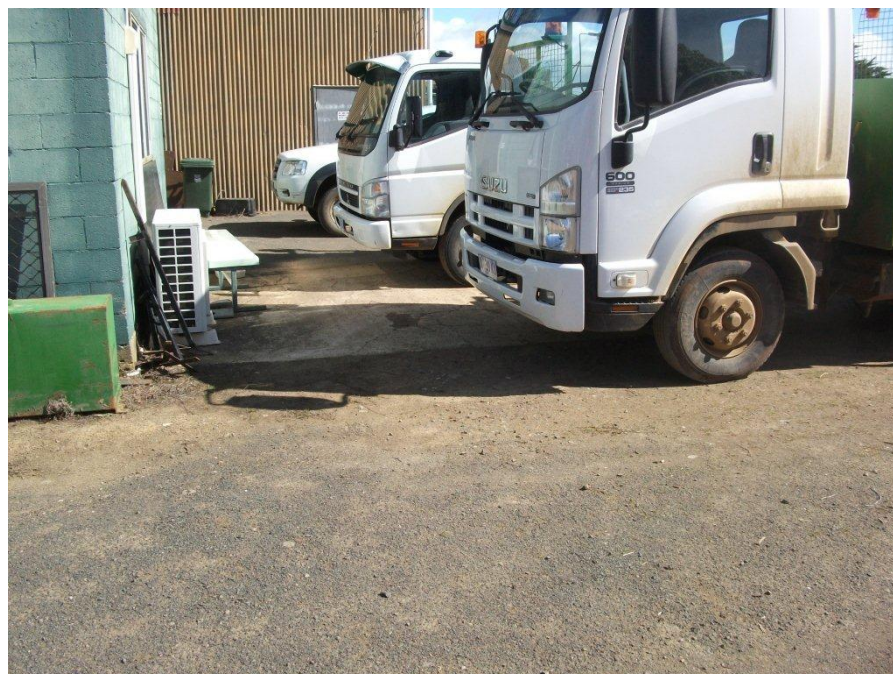
**Plate 4: Site of AST 1 (removed)**

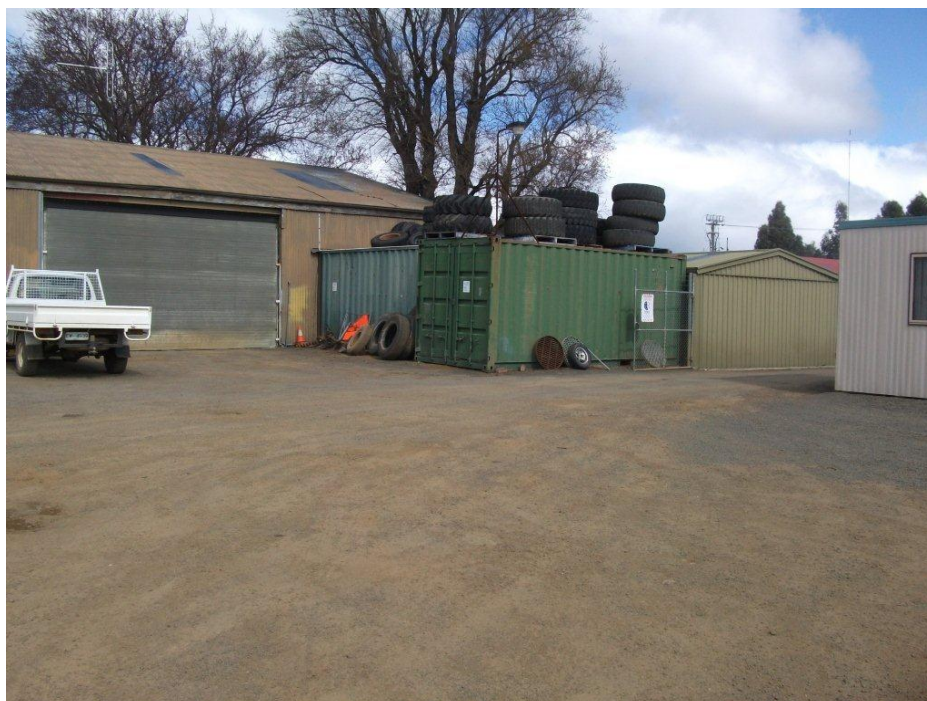
**Plate 5: Site of UST 1 (decommissioned)**

It is noted from anecdotal evidence UST 1 may already have been removed. If so, given the lack of records to this effect, Location 2 will still need to be validated which may require the removal of remnant contamination. Management of excavated soil and requirements for validation sampling of excavations are as for Location 1.

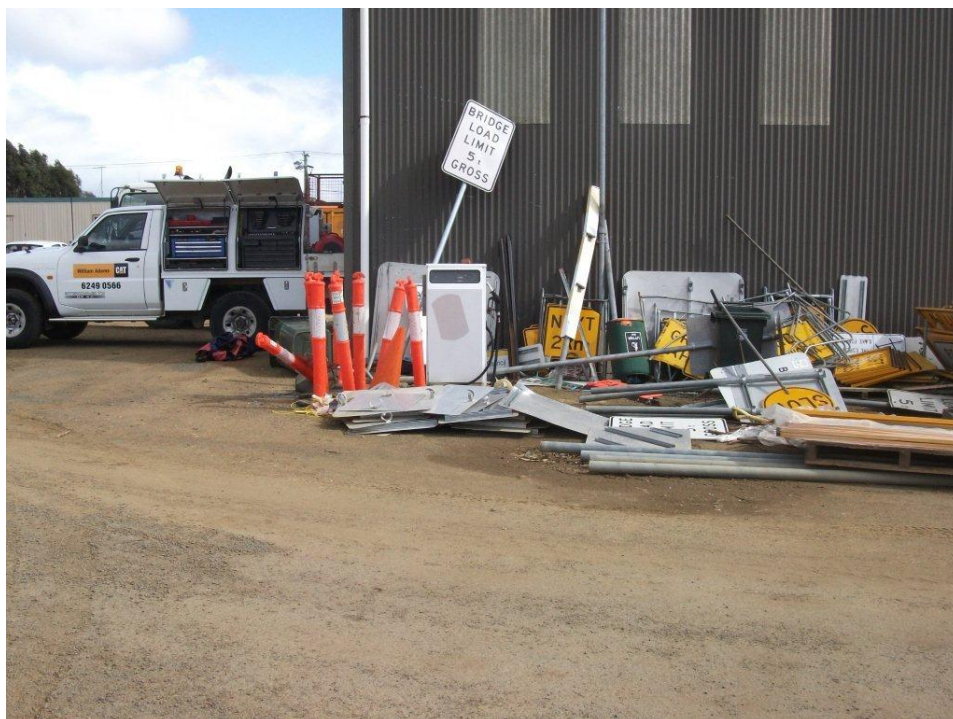
**Plate 6: Site of UST 2 and Bowser (operational)**

Prior to any soil remediation, USTs which have been used for the storage of flammable or combustible liquids must be decommissioned in an appropriate manner when they are no longer required, or are no longer suitable, for such use. Adherence to strict decommissioning procedures is necessary to avoid the potential health, safety and environmental hazards associated with the closure of a UST system.

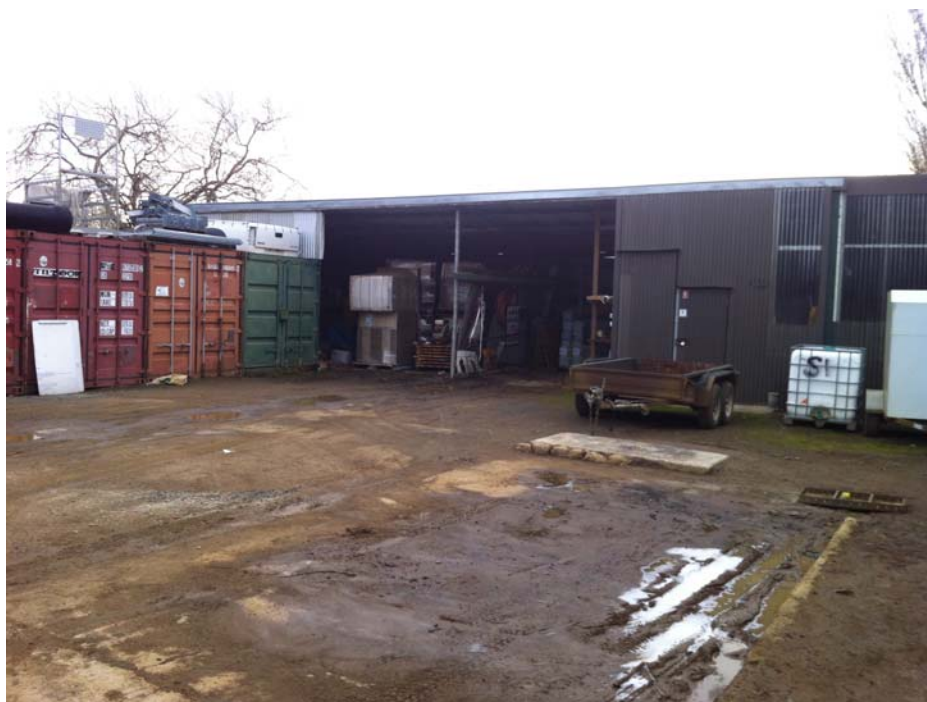
**Plate 7: Vehicle Wash Bay**

Due to the lack of a bund, the gravel floor and poor drainage; potential exists for soil contamination down to 1.0 mbgs, extending to say 1.0 m beyond the wash bay boundary. Management of excavated soil and requirements for validation sampling of excavations are as for Location 1.

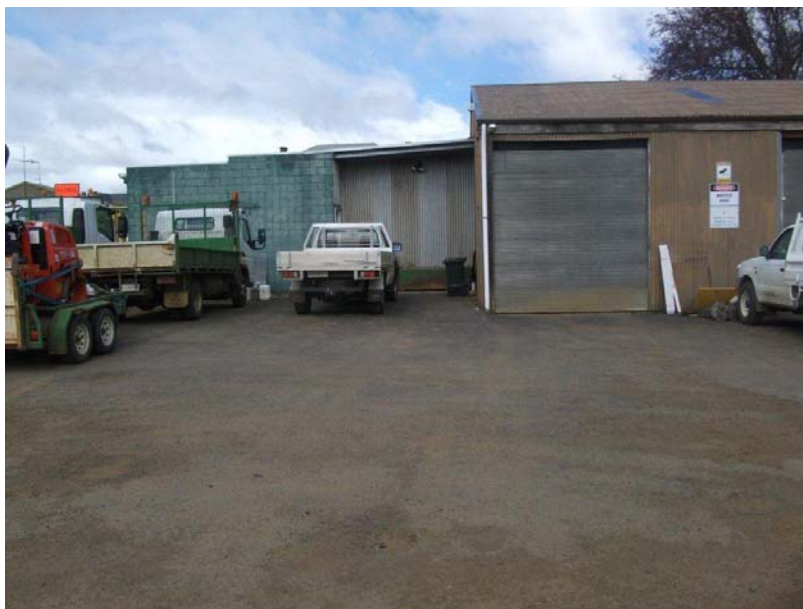
**Plate 8: Location of Original Oil Store**

The potential exists for soil contamination to be present at the entrance to the workshop containing the current oil store (Location 5) and in the vicinity of the original oil store (Location 6). Contaminated soil may need to be removed down to 0.5 mbgs. Management of excavated soil and requirements for validation sampling of excavations are as for Location 1.

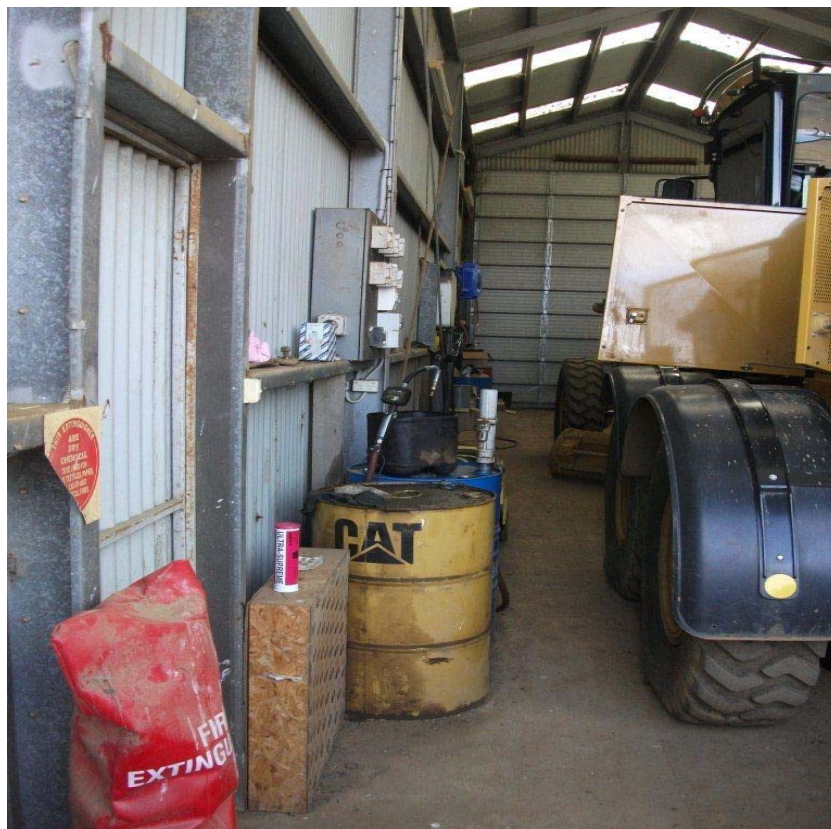
- Location 5 – Current oil store. Undercover storage of oils, greases, fuel and solvents in drums and other sealed containers on concrete floor (un-bunded) is likely to result in localised contamination within the workshop and hydrocarbon-contaminated soil down to say 0.5 mbgs at the workshop entrances (caused by careless disposal).

**Plate 9: Current Oil Store**
