Appendix E – Oatlands Gaol Wallpaper Analysis
Alan Townsend 2006.

Oatlands Gaol Wallpaper Analysis

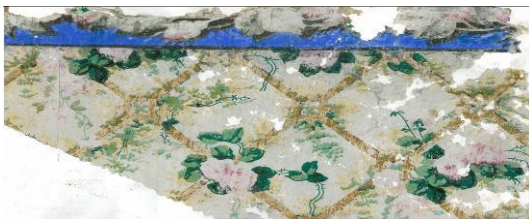
The individual layers are as follows: (see appendix for full scans)

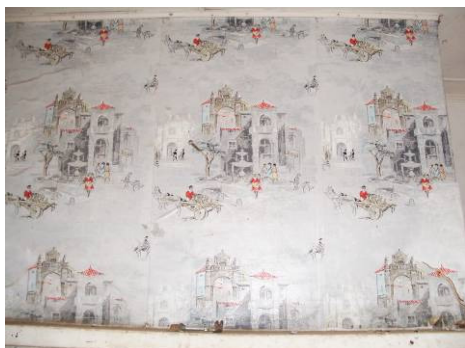
The top layer is the only example of wallpaper in the gaolers house that has not been covered over by later decoration. The paper is a pictorial design, probably ca.1950's, a rather fanciful depiction of a mediterranean village square with figures in the foreground walking, driving carts, etc. The pattern is printed in 6 colors on a pale blue ground, in the pastel tones that were popular in the 1950's.

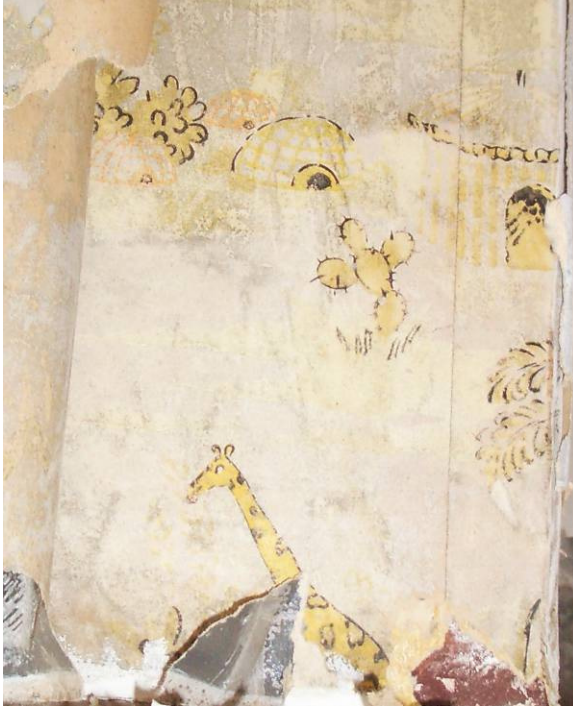
Underneath this paper, as can be seen by folding back a loose corner, is a gem of 1940's children's wallpaper. The pattern is a melange of giraffes, cactuses, and exotic foliage in very bright yellow and black. As the top layer of wallpaper is in good condition, it is not possible to get a larger sample of this lower layer without the risk of damaging the top layer.

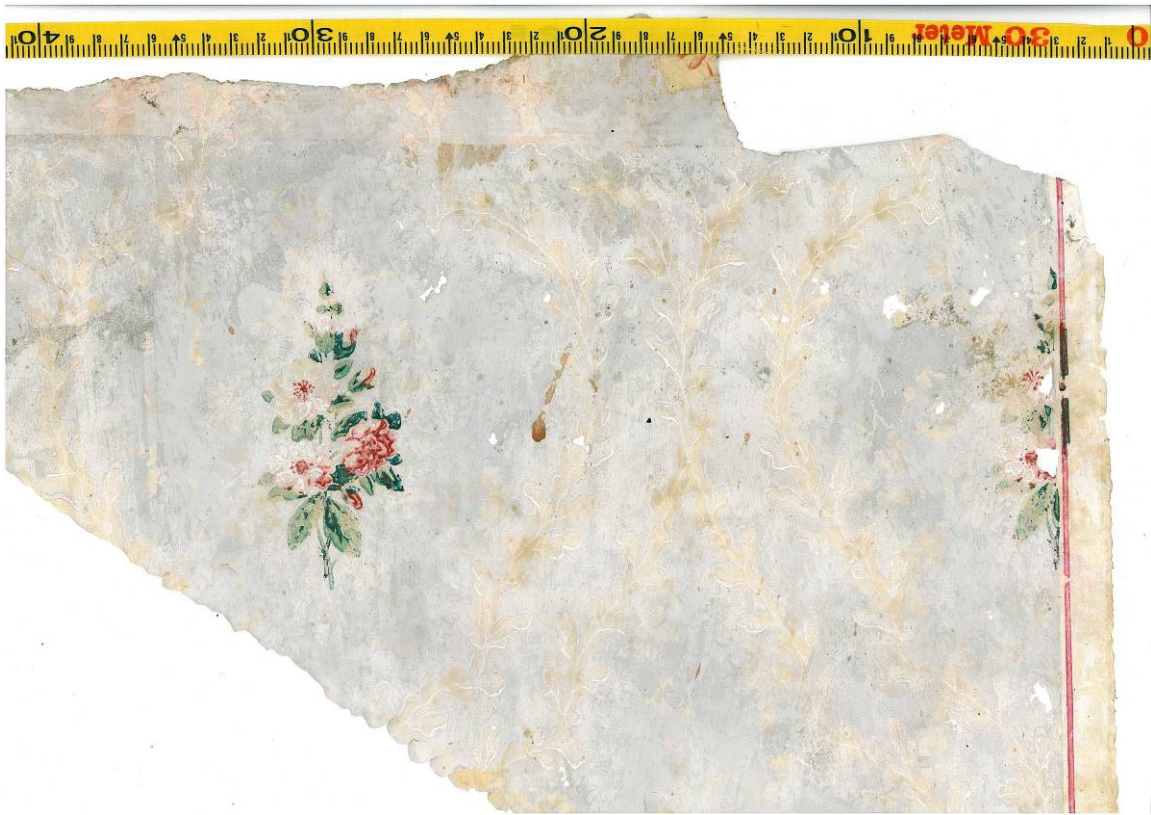
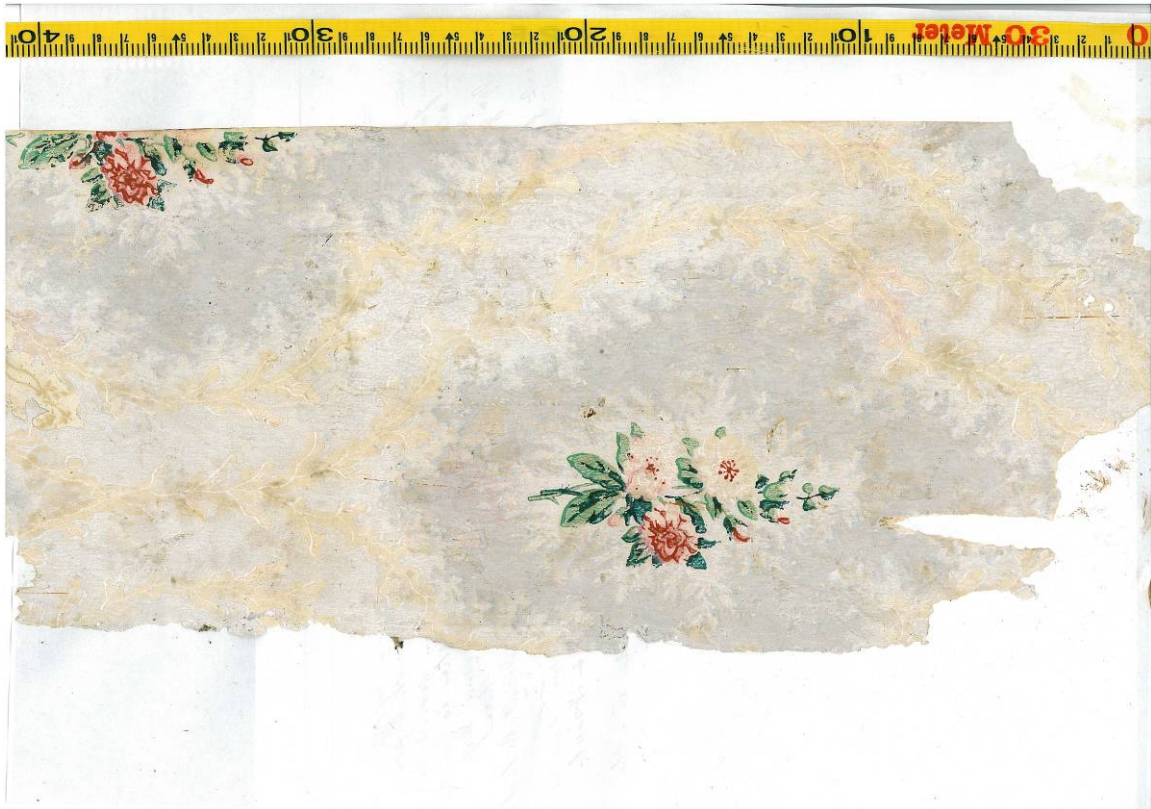
6.2 Bedroom, second layer

Second layer: Although this layer has lost some of its definition and intensity of colour, we are fortunate in having a very large sample - one of those taken from the floor - and a section of the selvedge (see section 2 for definitions of terms). There is a degree of similarity with the first layer in that the design consists of bunched roses in a roughly diamond pattern, however the design as a whole is much less formal or geometric.

Unlike the first layer, this paper appears to have been wood block printed. The selvedge shows register marks for the principal colours, and there are various places where the ink has the distinctive raised edges produced by block printing. The ink itself appears to be distemper.

The ground colour is a pale cream, quite probably the natural colour of the paper. The foreground colour is a pale blue-grey, but would most likely have been darker when new, thus giving a greater contrast between the ground, the foreground, and the connecting pattern of foliage in white. Assuming this to be the case, the original paper would have appeared as bunches of roses on a clearly defined diamond shaped background, an appearance that is largely lost in the sample we have now. Whilst the paper is of average quality, the number of colours – 7 including ground – would have taken considerable labour to block print, thus making this paper a moderately expensive one.

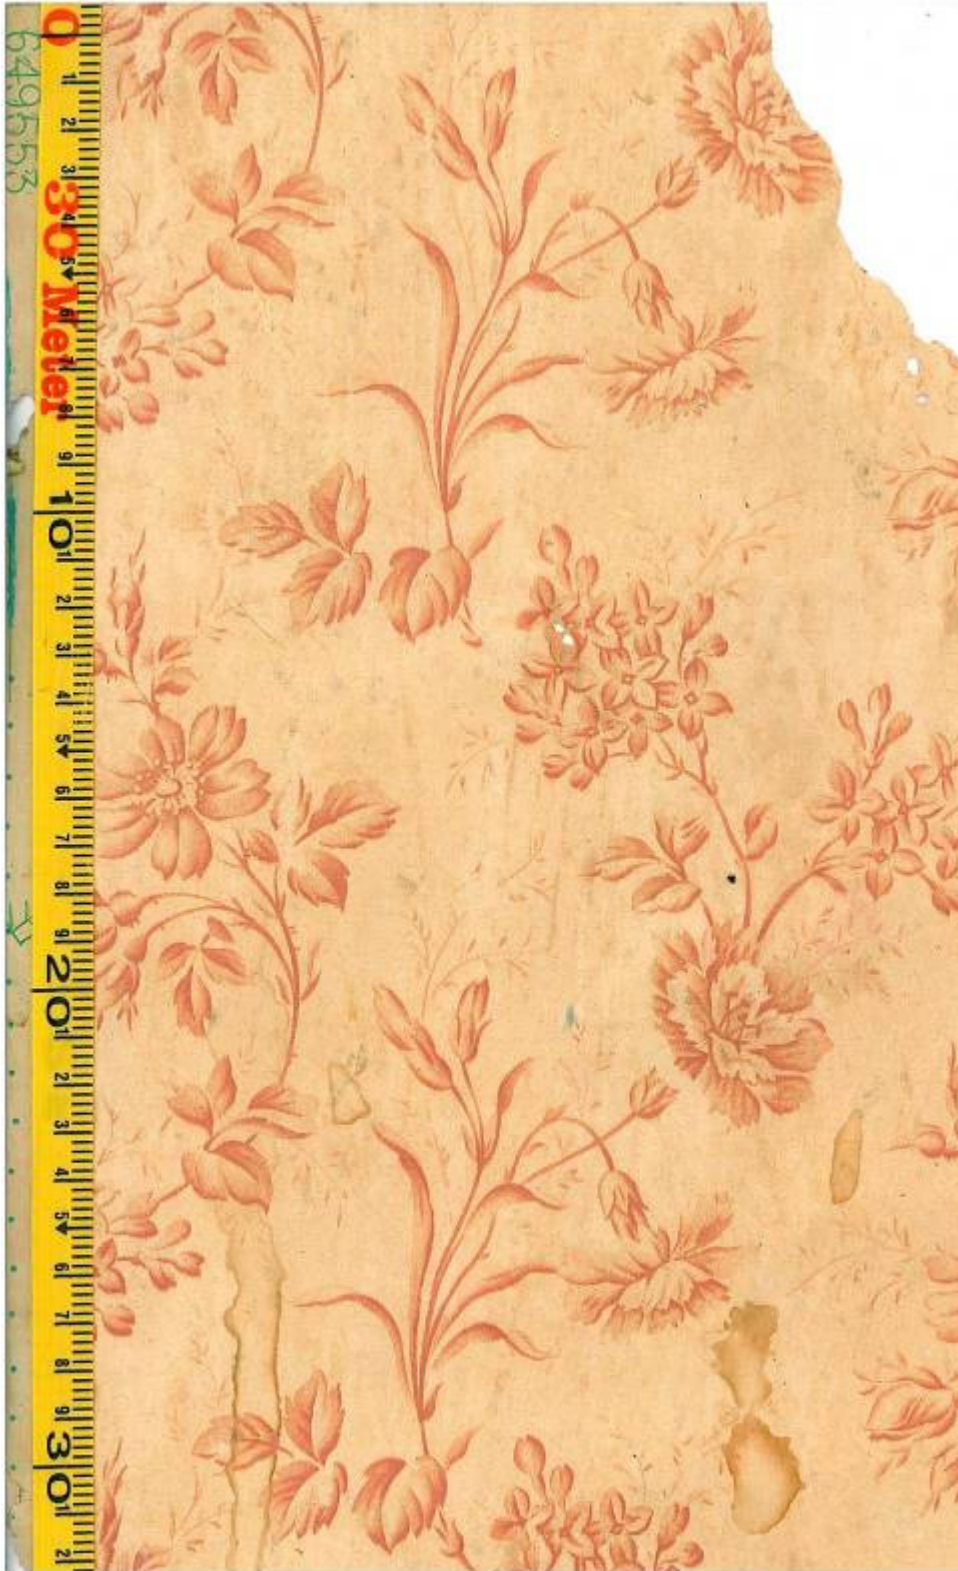
6.3 Bedroom, third layer

Third layer: This paper is quite different, both in colour and pattern, to the first two layers. Rather than a geometric design, it is a much more “naturalistic” design of flowers and foliage. As was common at the time – about 1890 – the pattern includes flowers of various types on the same stem.

As with the other layers, the paper is of average quality, and the ground colour may possibly be the natural colour of the paper. The design is printed in a single colour, and is certainly machine printed, thus producing the variations in shading. Given that it is monotone and machine printed, it would most likely have been a fairly inexpensive paper.

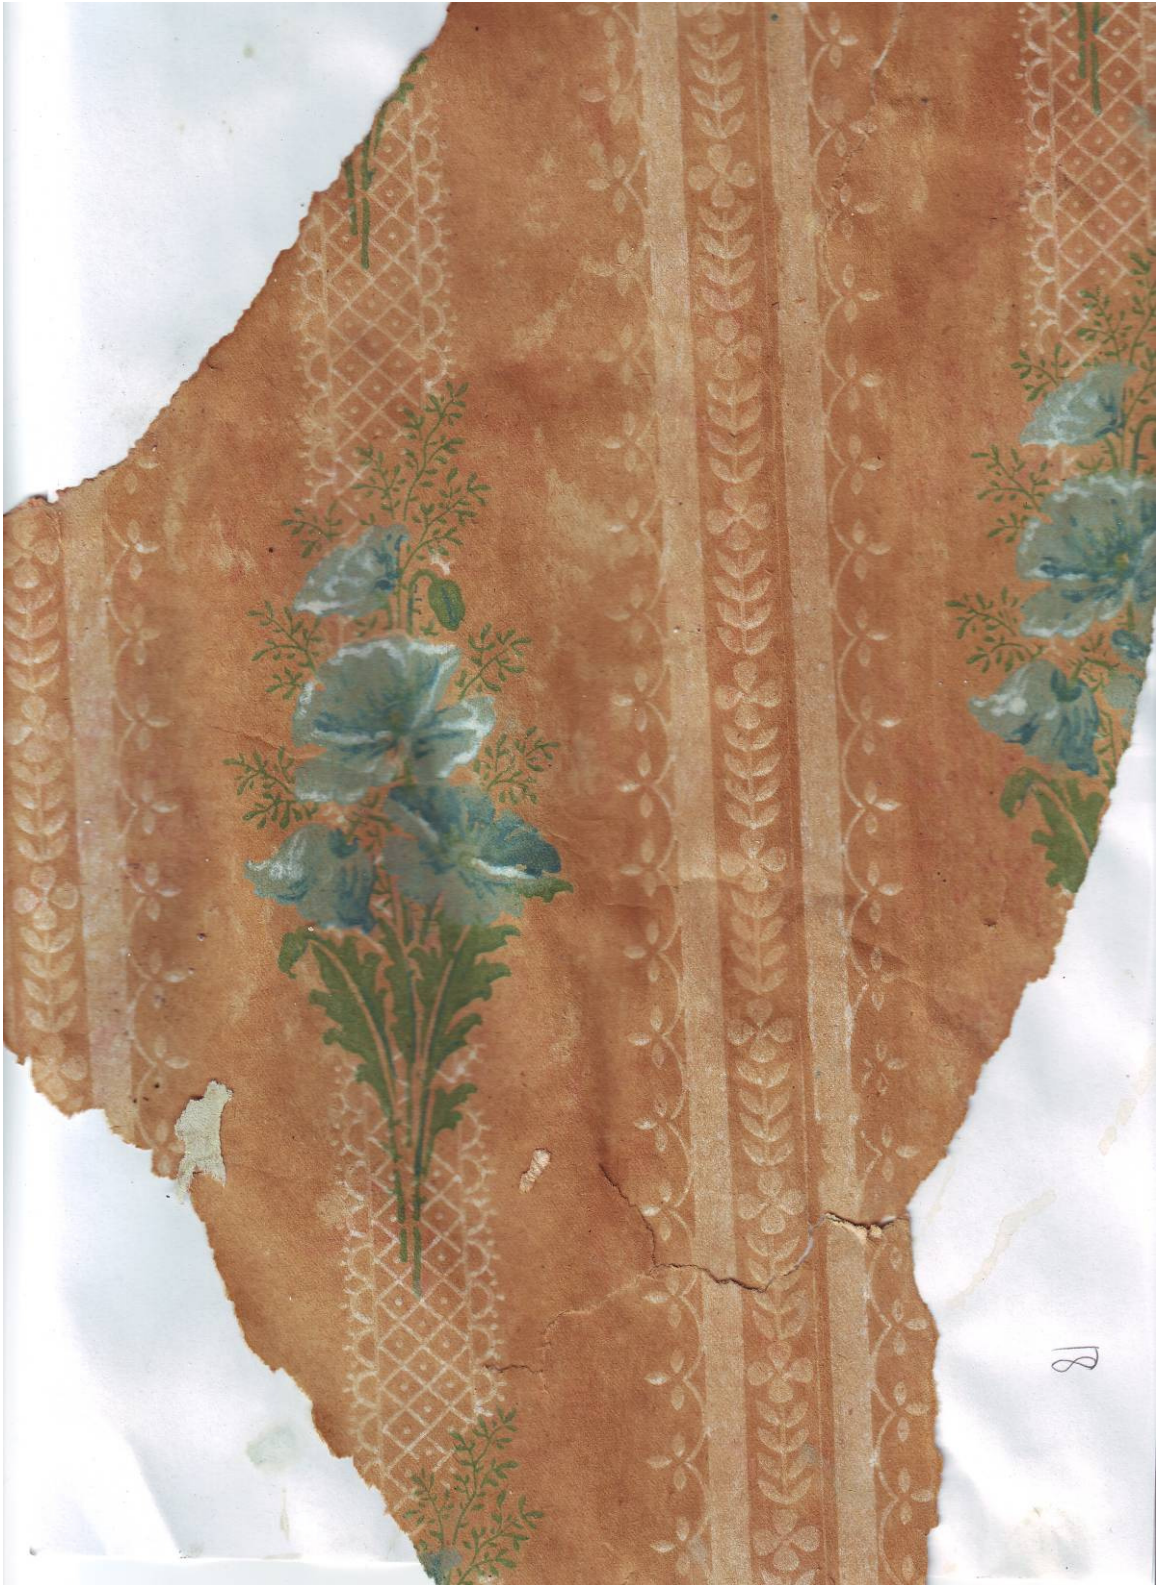
6.4 Bedroom, fourth layer

Fourth layer: This paper is Edwardian both in date and design. Amongst the samples there is a section of selvedge with a full Registered Design number (649553) which dates this paper to circa 1915. The design is a striped pattern of blue flowers and green foliage

on a white trellis with a ground colour of sandy cream. This paper is machine printed with 4 colours and ground on a reasonably dense paper.
