Public Notice Details

Application No	DA2500095

Property Location	570 Huntingdon Tier Road Bagdad

Cheryllyn Heather Thompson & Troy Anthony Thompson COVER PAGE						
570 Huntingdon Tier Road, Bagdad	DATE	SCALE:		SH DRAWN BY:		
NEW FARM SHED		REVISION No.	SHEET SIZE:		A1.0

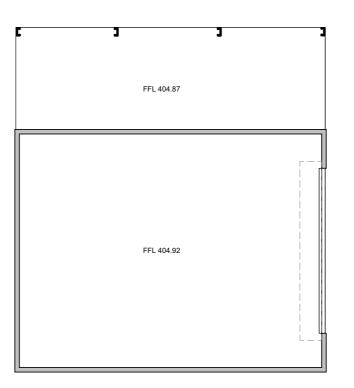
Ground Floorplan 1:100

Cheryllyn Heather Thompson & Troy Anthony Thompson FLOORPLAN						
570 Huntingdon Tier Road, Bagdad		30/07/2025 SEALE 1:100		00	BH	
NEW FARM SHED		REVISION No.	SHEET SIZE:	SNH25-029	A3.0

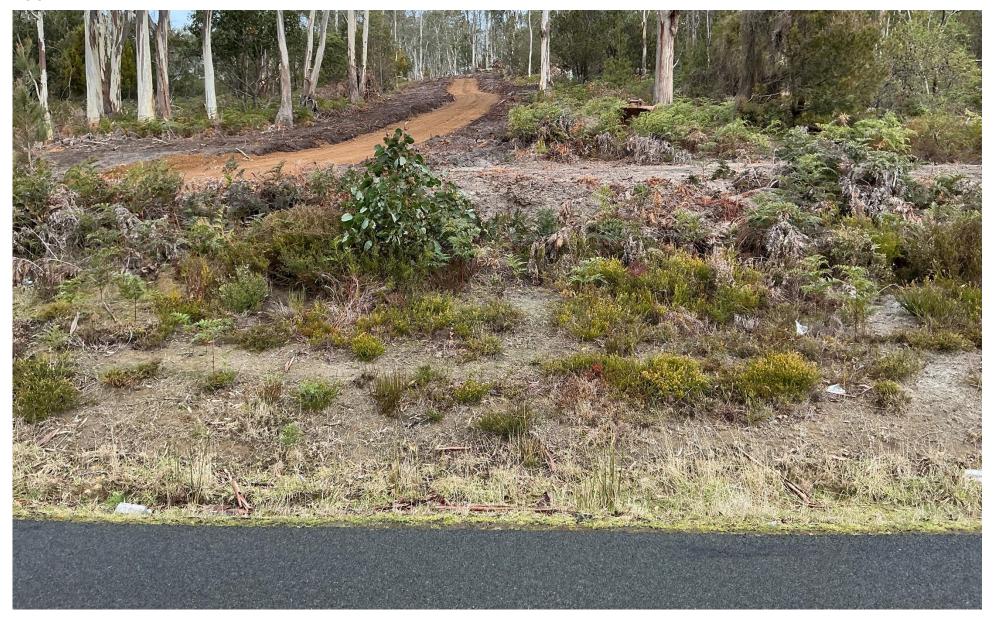
Photo 1 capturing the proposed driveway crossover/cut location which falls within the low landslide hazard overlay

The proposed driveway crossover gradient is at 11° which is at the lower limit of the government landslide trigger code. There is a very low potential for landslip in this setting, however consideration needs to be given to soil dispersion recommendations and general recommendations presented in Appendix H.

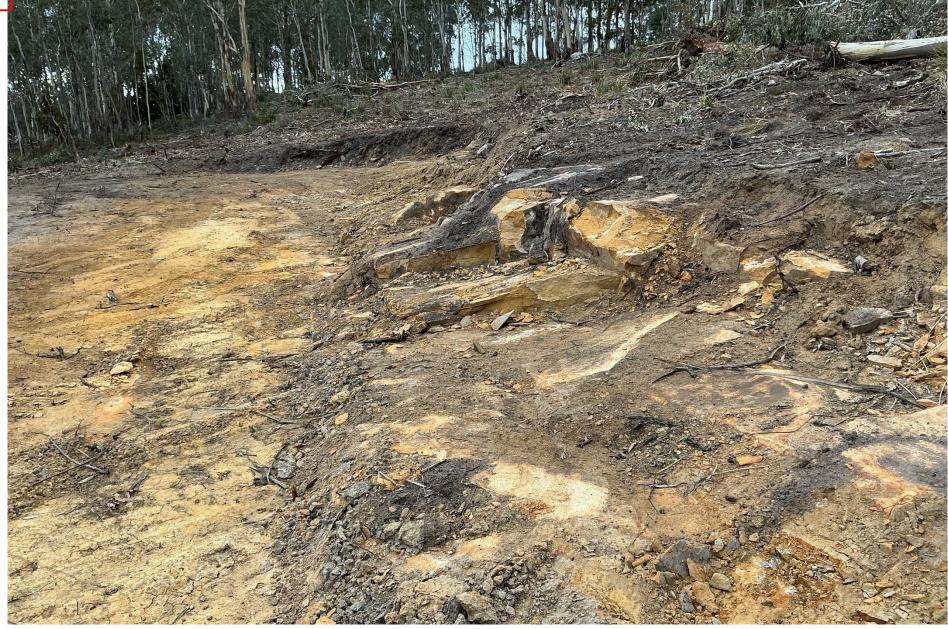
Photo 2 Showing the proposed shed location with exposed sandstone bedrock

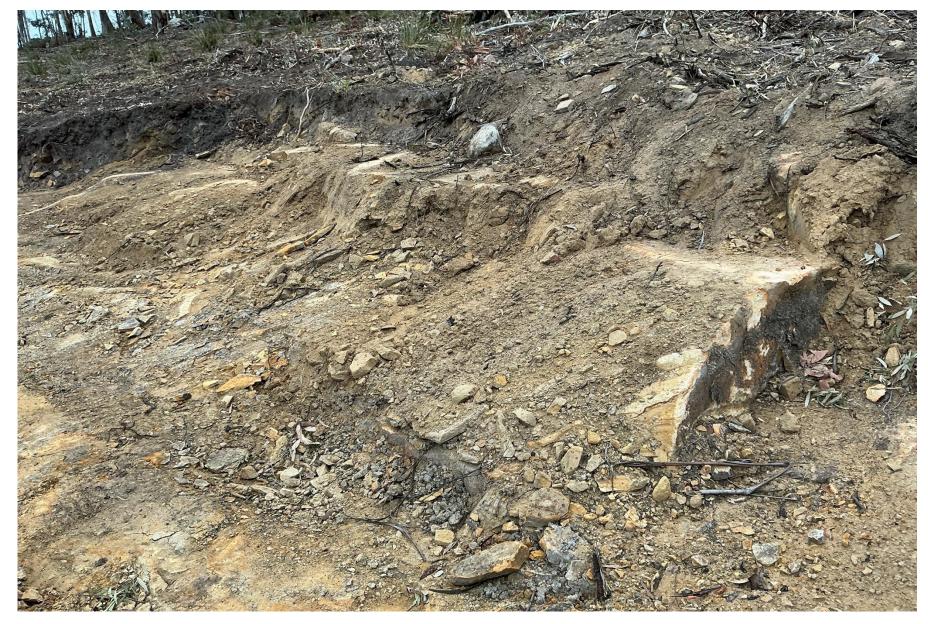
Photo 3 Showing the proposed dwelling location with exposed sandstone bedrock

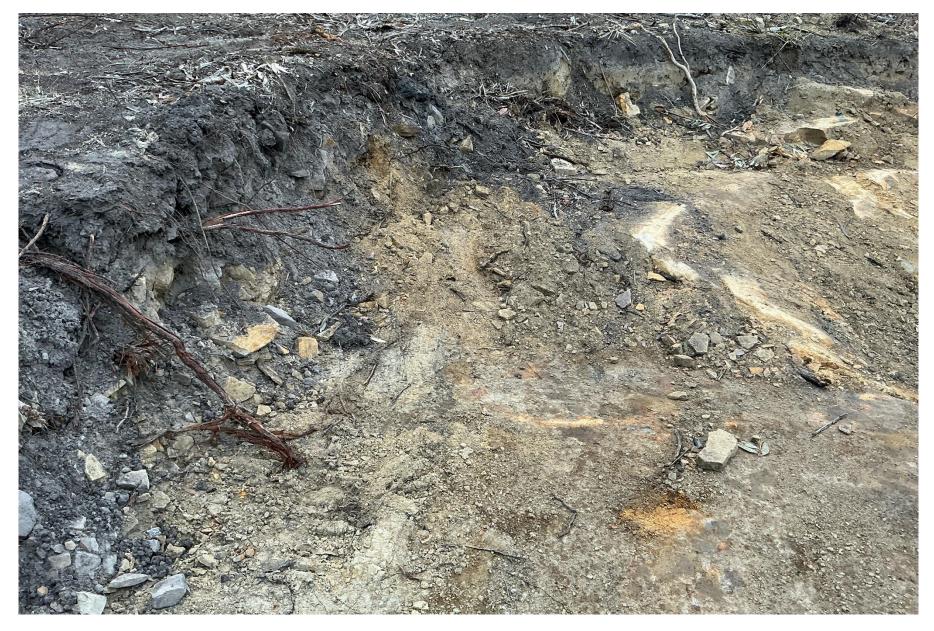
Photo 4 Showing the proposed dwelling location with exposed sandstone bedrock

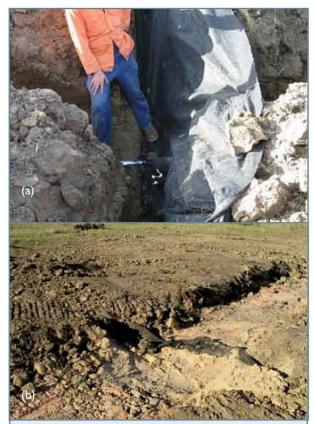
Figure 15. (a) Installation of sandblock perpendicular to a service trench. Note securing of geotextile to the optical fibre cable to prevent water flowing past the sand block. (b) Sandblock before final topsoiling.

Sand filters were first developed to prevent piping in earth dams. Sand filters prevent dam failure by trapping entrained sand and silt, blocking the exit of the tunnel and preventing further tunnel development (Sherard et al. 1977). Following the work of Sherard et al. (1977), Richley (1992 and 2000) developed the use of sand blocks to prevent tunnel erosion during installation of an optical fibre cable in highly dispersive soils near Campania, Tasmania. The sand blocks work slightly differently to the sand filters in that they allow the free water to rise to the surface through the sand. The use of sand blocks has recently been modified by Hardie et al., (2007) to prevent re-initiation of tunnel erosion along an optical fibre cable near Dunalley. Modifications to the original technique developed by Richley (1992 and 2000) include (Figure 14 &15);

- » Upslope curved extremities to prevent the structure from being by-passed.
- » Geotextile on the downslope wall to prevent collapse or removal of sand following settlement or erosion.
- » Application of gypsum (around 5% by weight) to ensure infiltrating water contains sufficiently electrolyte to prevent further dispersion.
- » Earth mound upslope of the structure to prevent runon entering the sand blocks.

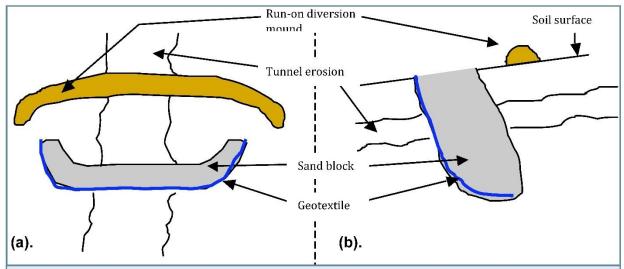
Figure 14. Modified sand block design. (a) plan view, (b) cross section view. The depth of the sand block is determined by the depth of dispersive soils or tunnel erosion. The span length of the structure is determined by the width of the tunnelling.

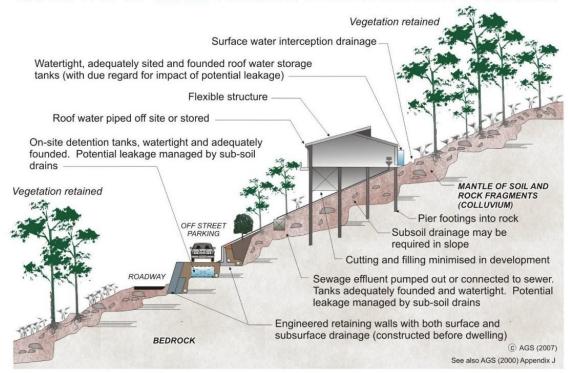
EXAMPLES OF GOOD HILLSIDE CONSTRUCTION PRACTICE

Roadways and parking areas - are paved and incorporate kerbs which prevent water discharging straight into the hillside (GeoGuide LR5).

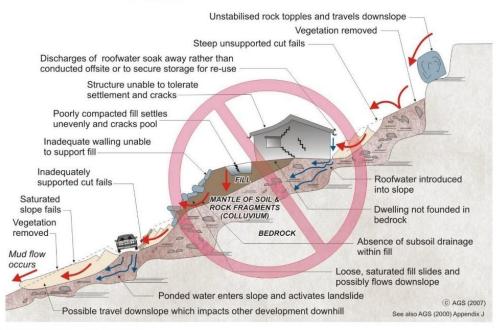
EXAMPLES OF **POOR** HILLSIDE CONSTRUCTION PRACTICE

Roadways and parking areas - are unsurfaced and lack proper table drains (gutters) causing surface water to pond and soak into the ground.

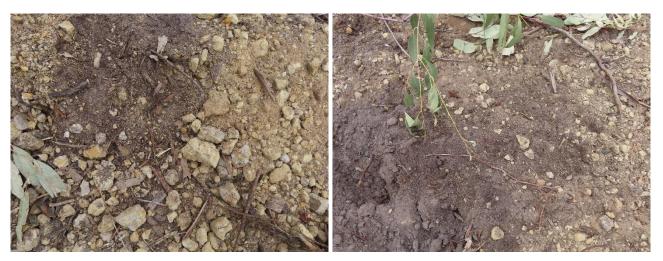
Plates 7 & 8. Examples of sandy quartz-derived soils

The geology of the study area is mapped at a 1:250,000 scale (Figure 8) as Triassic-age "dominantly quartz sandstone" (geocode: Rq) The geology is mentioned because it has a strong influence on the classification of vegetation and the potential occurrence of threatened flora (and to a lesser extent, threatened fauna). The geology was confirmed informally by reference to outcropping rocks and soil types, with the whole site clearly on some form of granitic substrate (Plates 7 & 8).

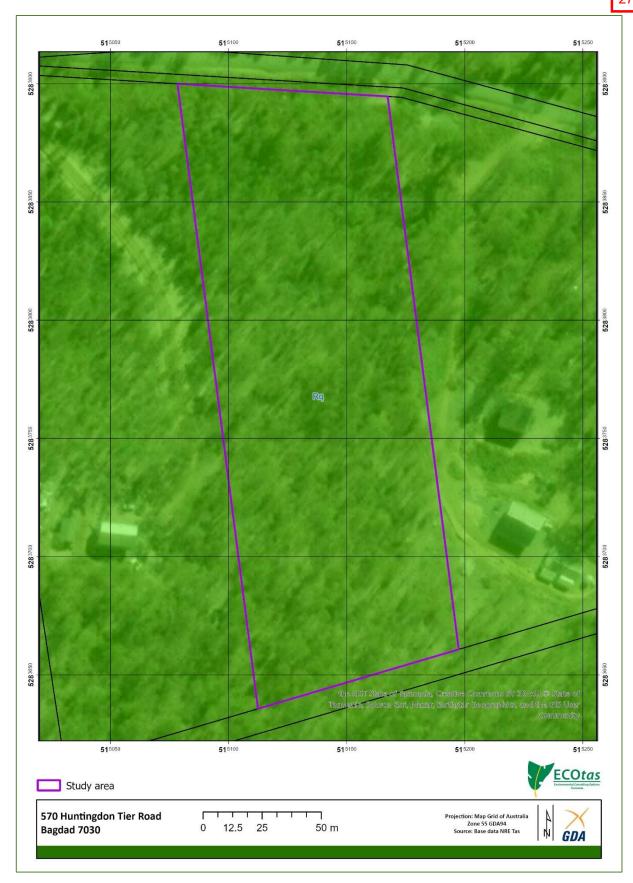
Figure 8. Geology (1:250,000 scale) of study area and surrounds (refer to text for code)

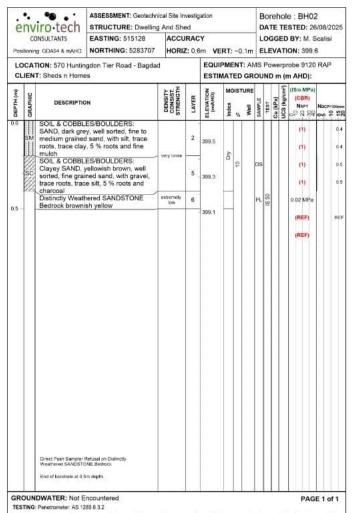
Figure 1, Bore Hole 02 Soil Profile data

and variation in soil materials on site. Test Hole BH02 was drilled within the approximate location where the proposed wastewater irrigation is to be located, in accordance with AS1547.2012 (refer to figure 04)

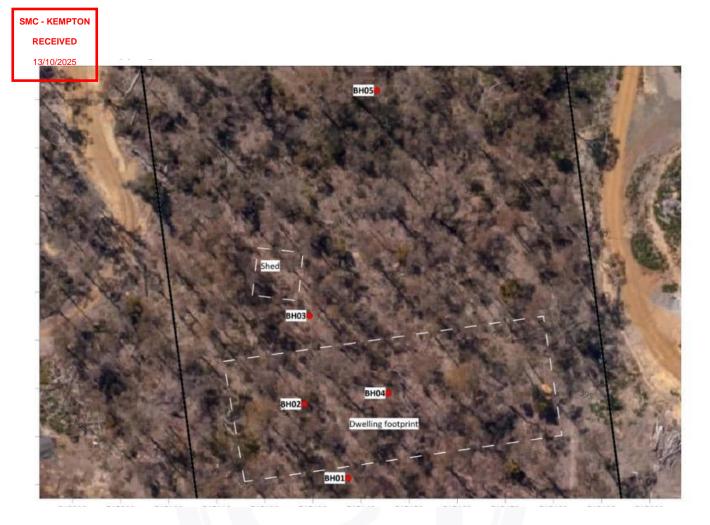
Figure 3 – Bore Hole Test Location

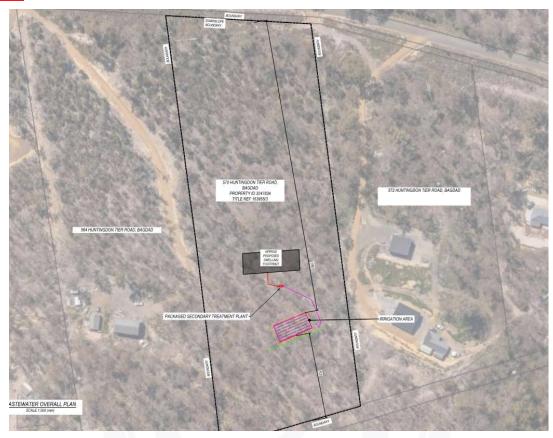
Figure 5: OVERALL SITE LAYOUT

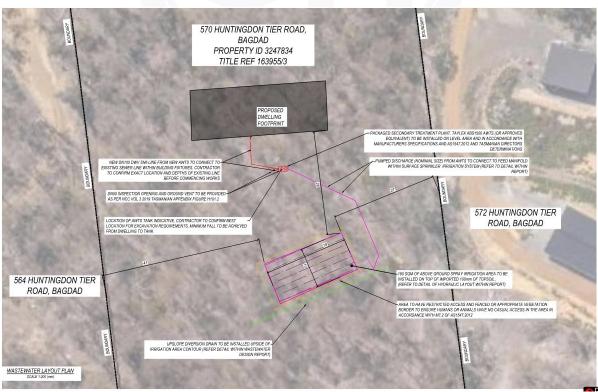
Figure 6: DETAILED WASTEWATER LAYOUT

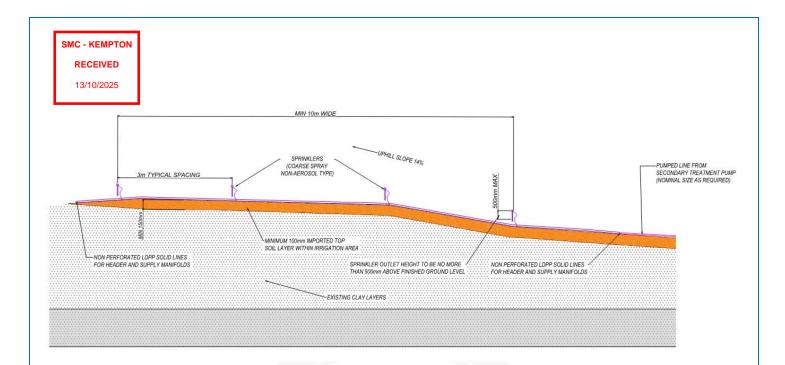
Figure 7: RECOMENDED IRRIGATION CROSS SECTION DETAIL

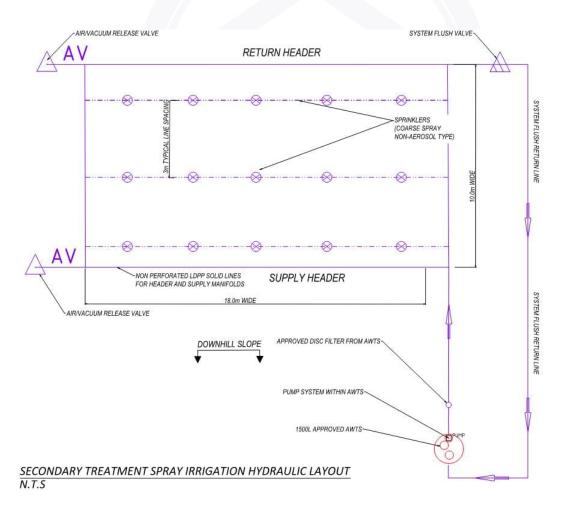
Figure 8: PROPOSED WASTEWATER IRRIGATION LAYOUT

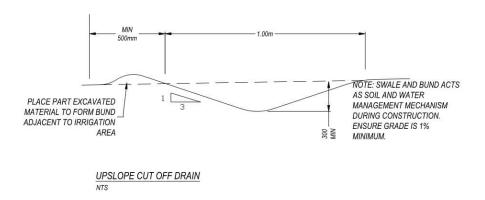
Figure 9: PROPOSED UPSLOPE CUT OFF DRAIN

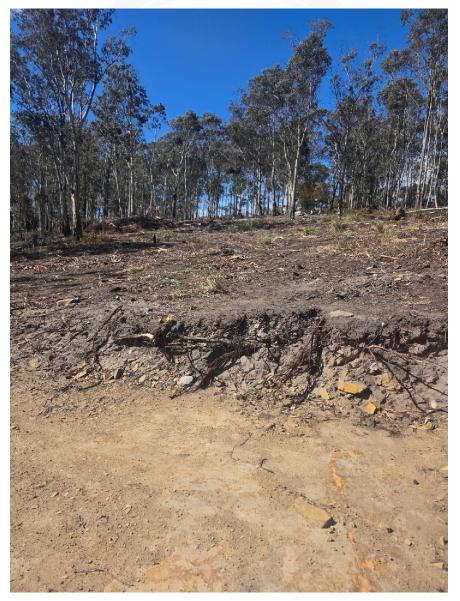
Figure 10: CLEARED AREA PROPOSED FOR IRRIGATION AREA

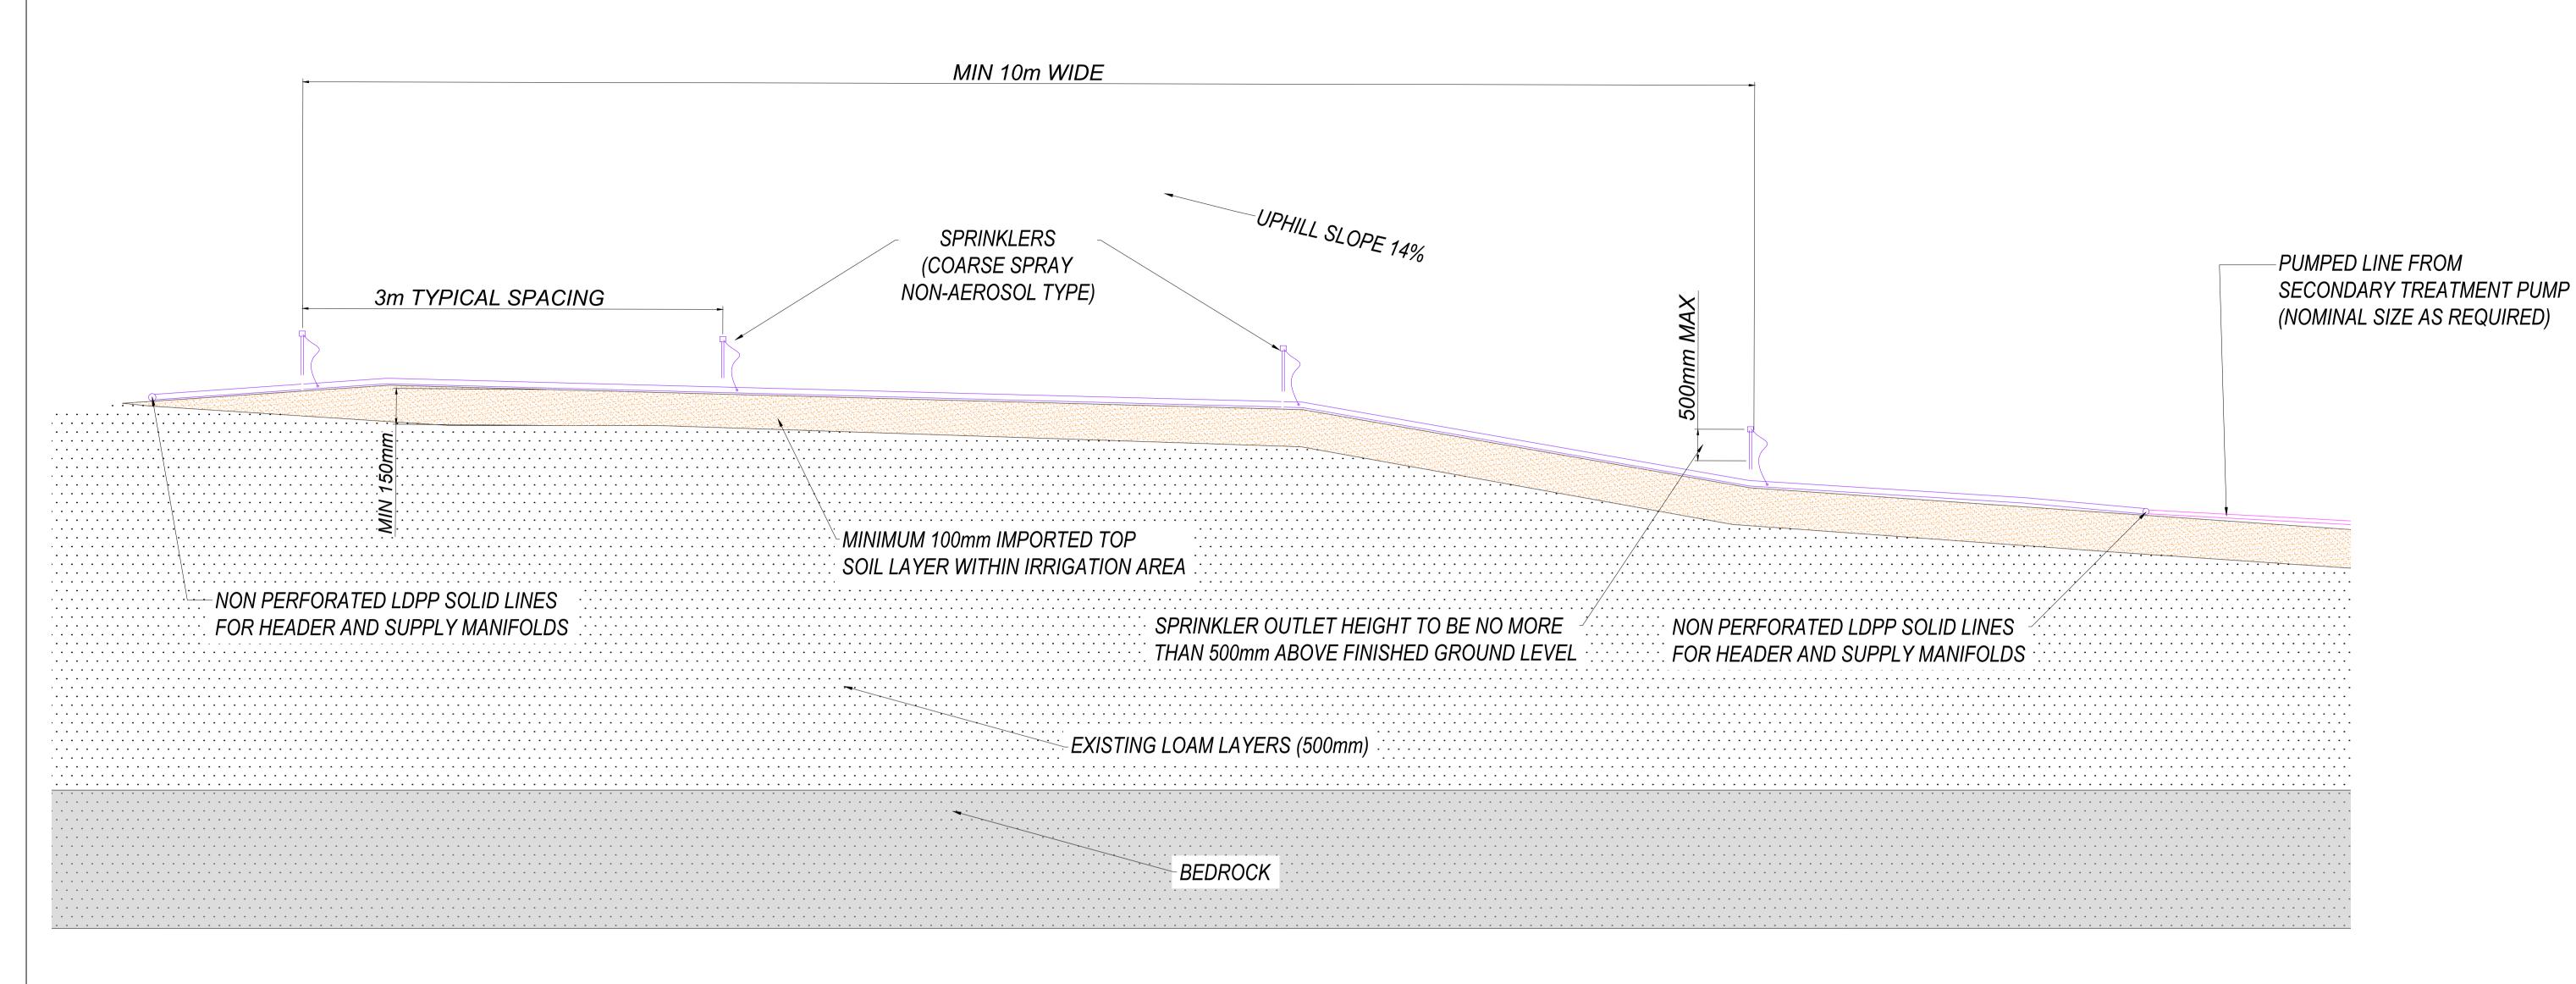
SECONDARY TREATMENT SPRAY IRRIGATION CROSS SECTION DETAIL N.T.S

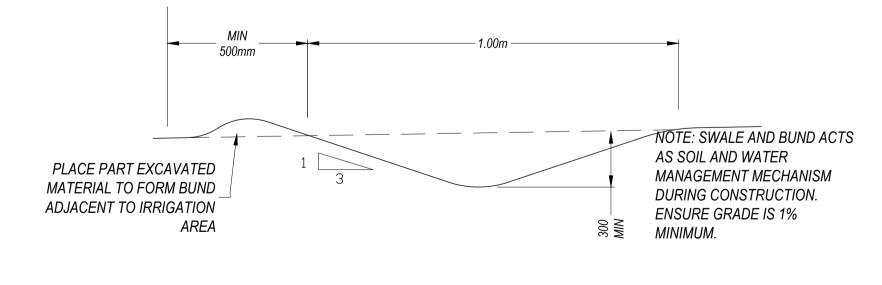
UPSLOPE CUT OFF DRAIN

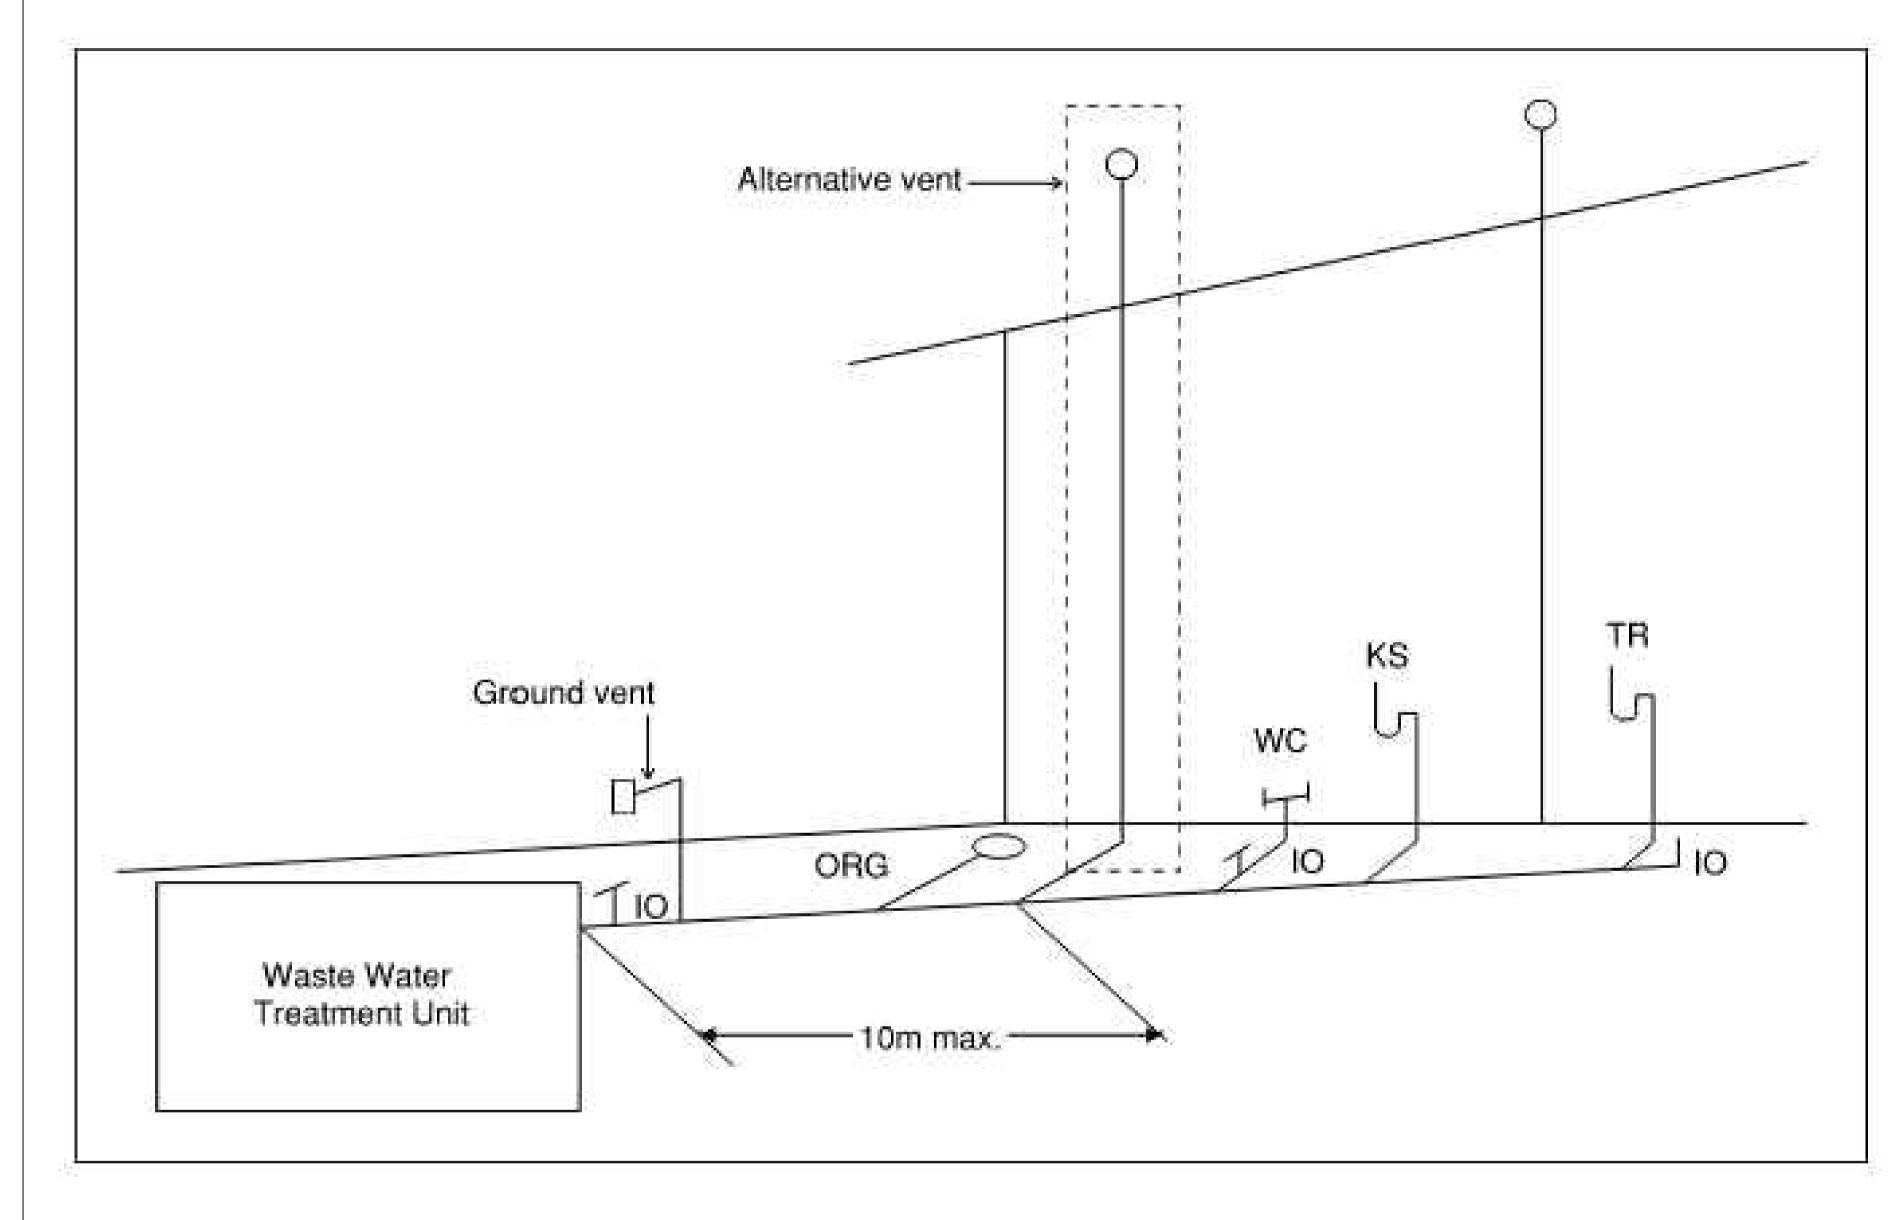
TASMANIAN WASTEWATER VENTING REQUIREMENTS DETAIL

TAS FIGURE H101.2 ALTERNATIVE VENTING ARRANGEMENTS
