**Oatlands Gaol Historical Study  
&  
Archaeological Survey**

**SOUTHERN  
MIDLANDS  
COUNCIL**

Prepared by Brad Williams  
For the  
Southern Midlands Council, Tasmania  
May 2004

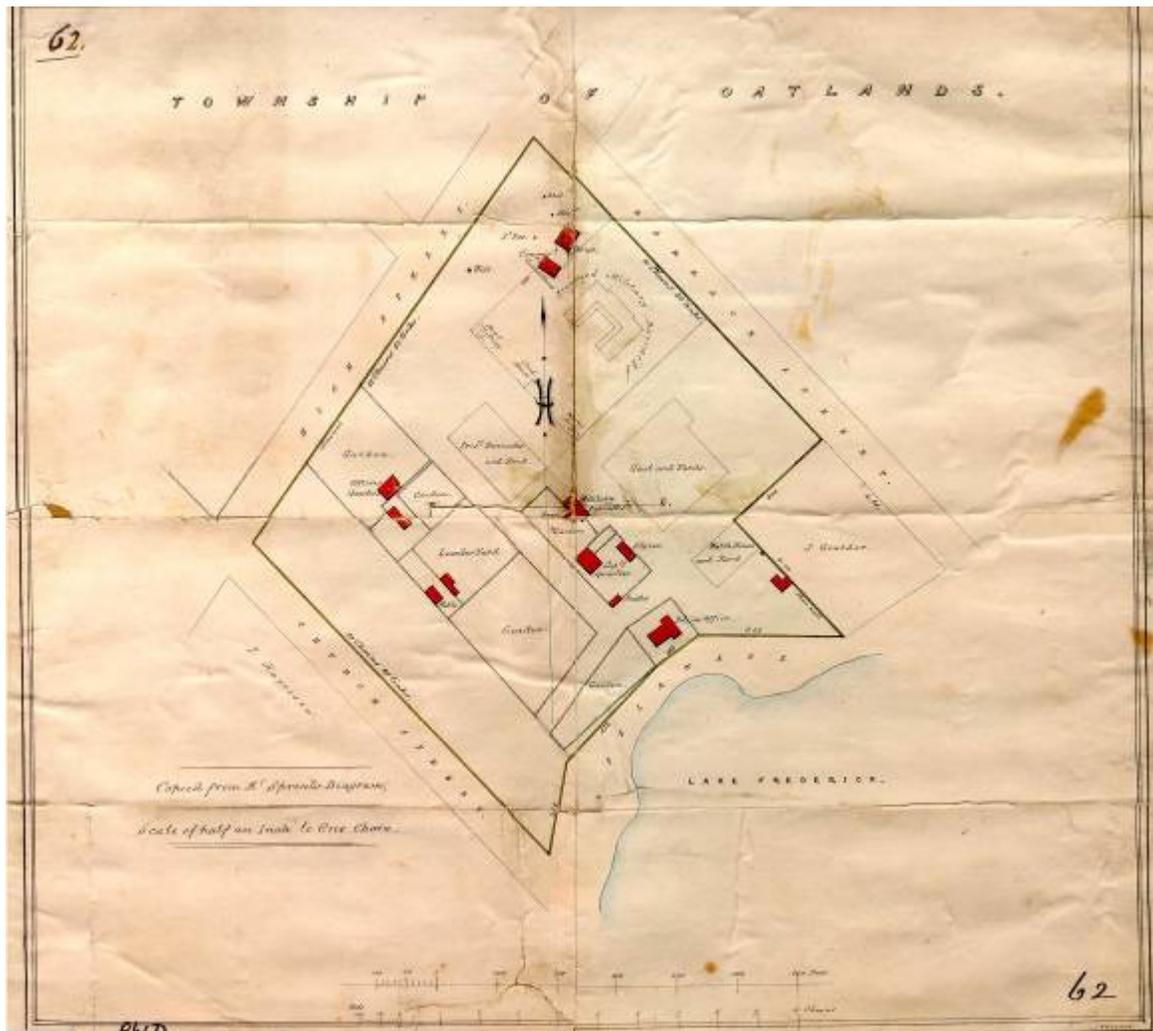
Figure 2.3 – Plan of the Oatlands military precinct c1848 (AOT PWD 266/1531).

The next survey of the military precinct was undertaken by Calder (1845, TLD O/14) and shows the development of the precinct from Sharland's map. This shows the conversion of the first Barracks to a Probation Station (labeled *Prisoner's Barracks*), as well as addition of the Gaol (1837), Watch-House (1836), Superintendents and Roads Offices and Second Barracks (c1835) and a dozen ancillary buildings associated with the Barracks precinct and Officer's quarters. This map shows the final general configuration of the gaol and demonstrates its domination of the precinct (see Figure 2.3).

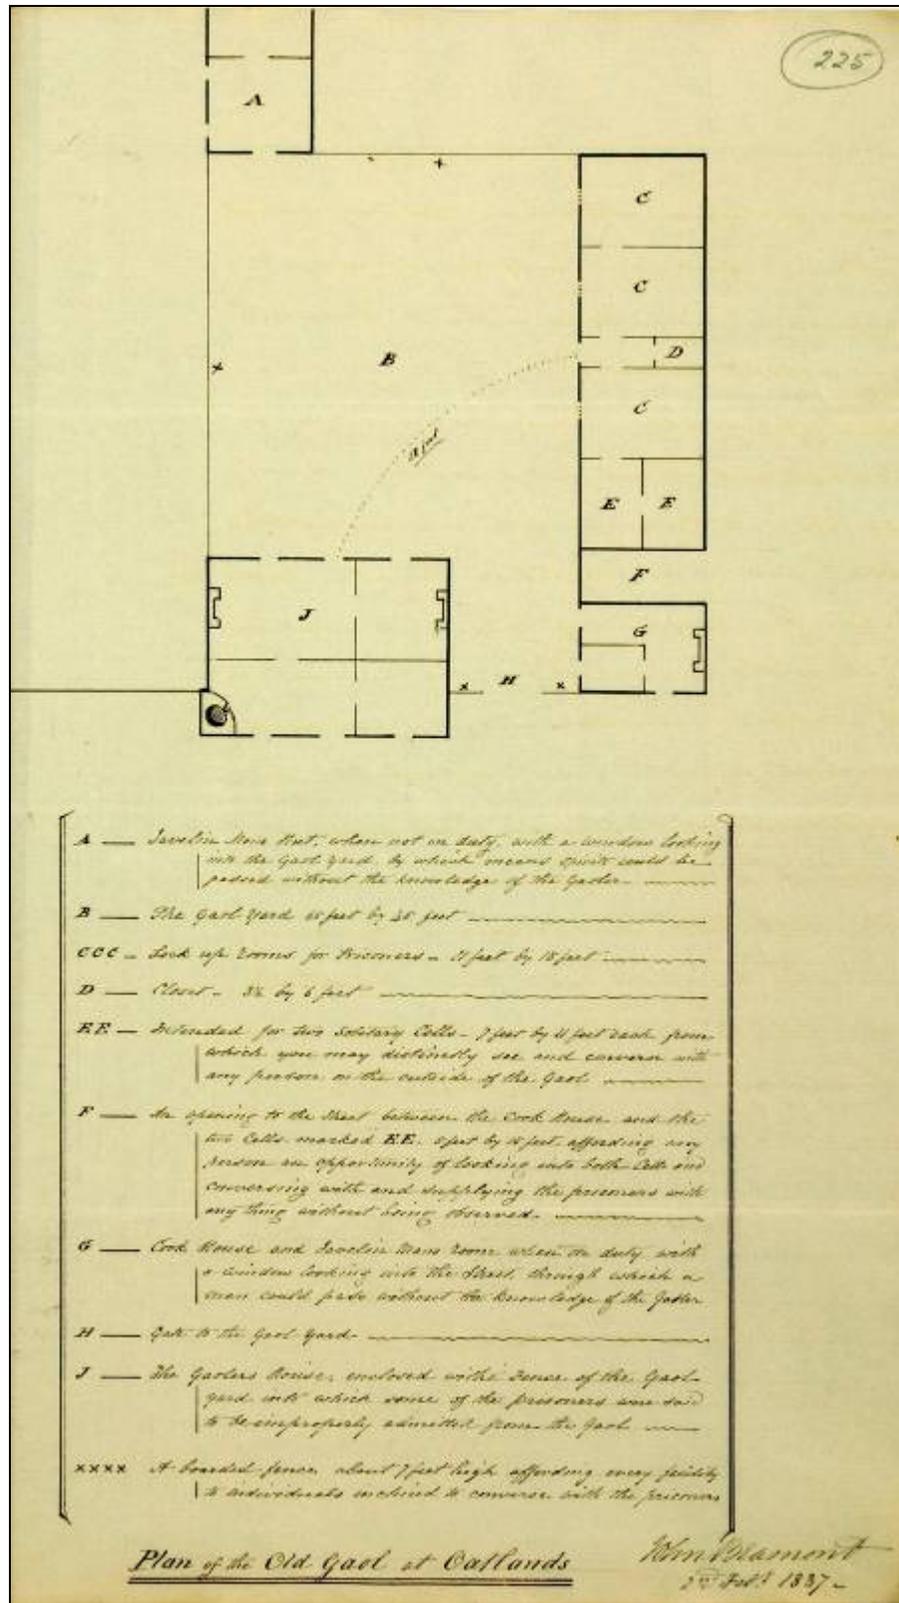
Figure 2.4 – Plan of the original Oatlands Gaol, February 1837 (AOT CSO1/631/14270:225).

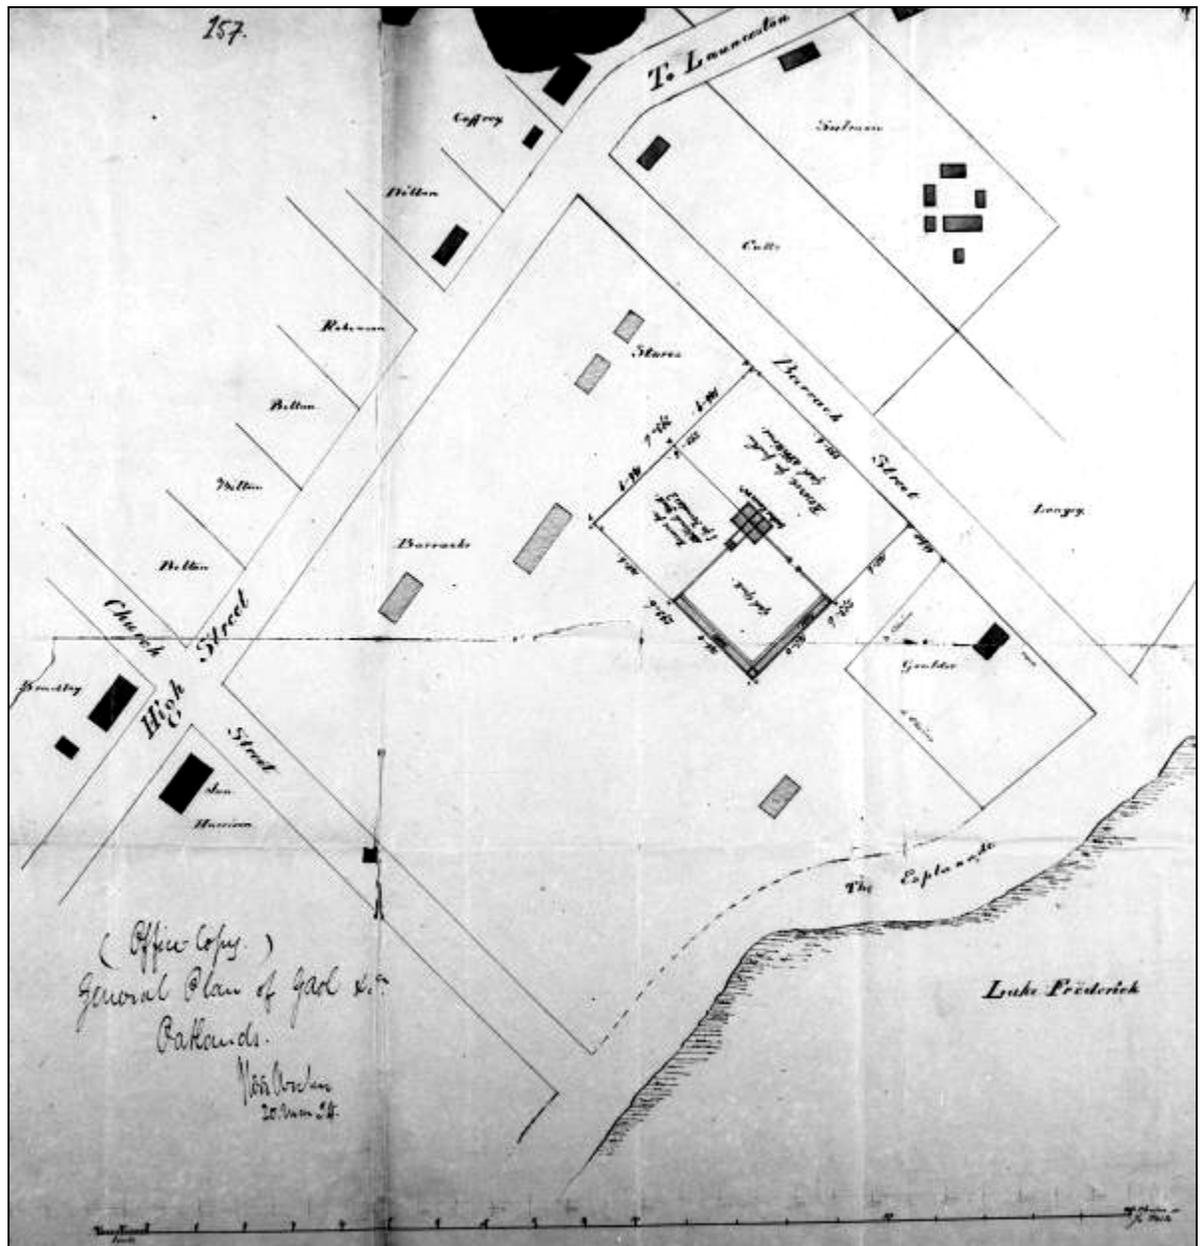
Figure 3.1 – Plan of the Oatlands Military Precinct dated 20/3/1834, showing the location intended for Lee-Archer’s first gaol design (AOT CSO 1/691:15206:157). This plan shows that the complex was intended to eventually be four-times the original size, which is also noted on Lee-Archer’s second plans of April 1835 (Figure 3.3, AOT PWD 266/84, 1546).

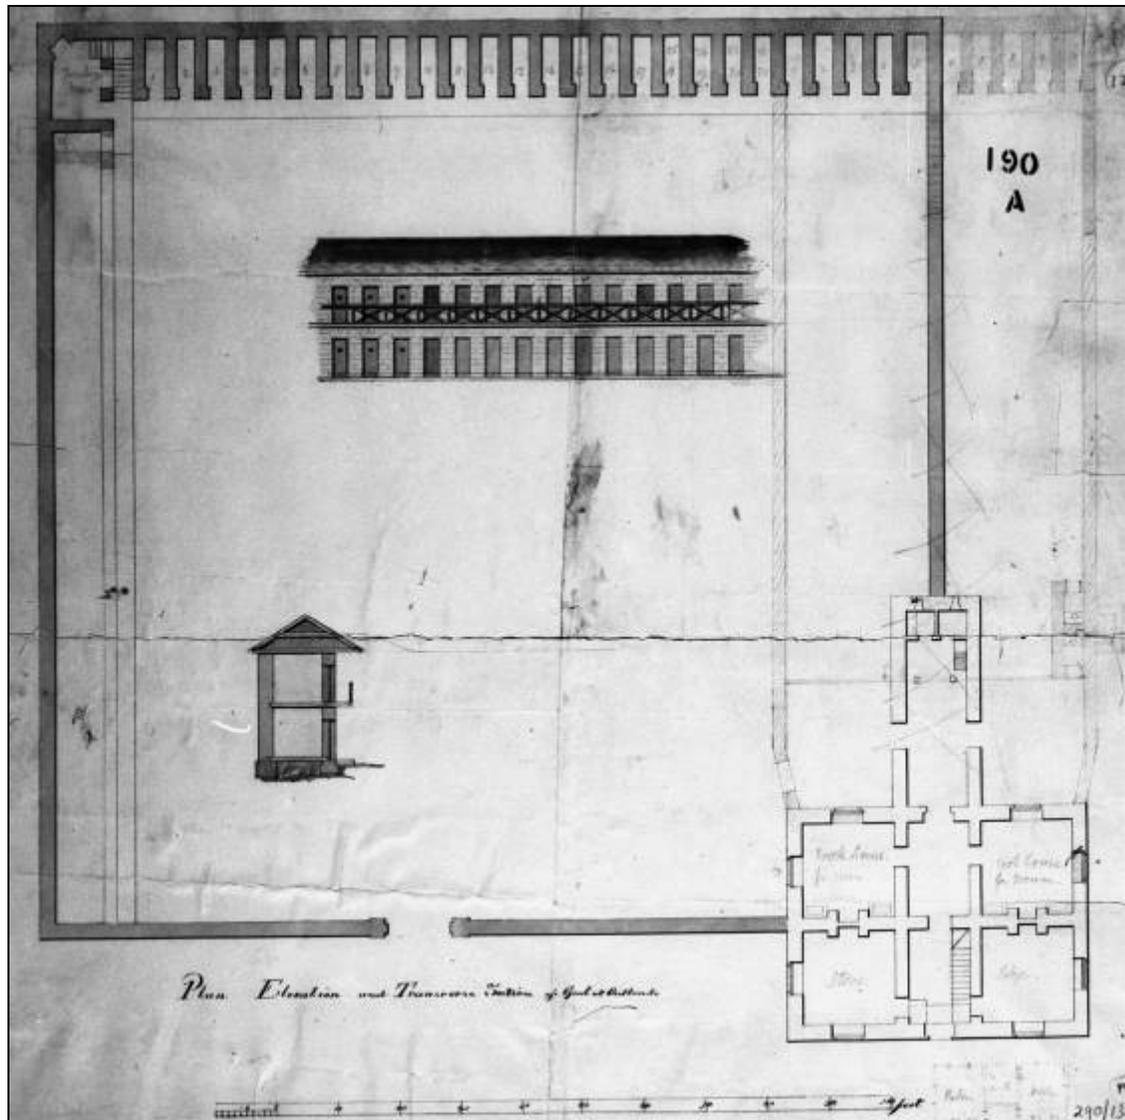
Figure 3.2 – John Lee-Archer's 1834 plans for the Oatlands Gaol (AOT PWD 266/1555).

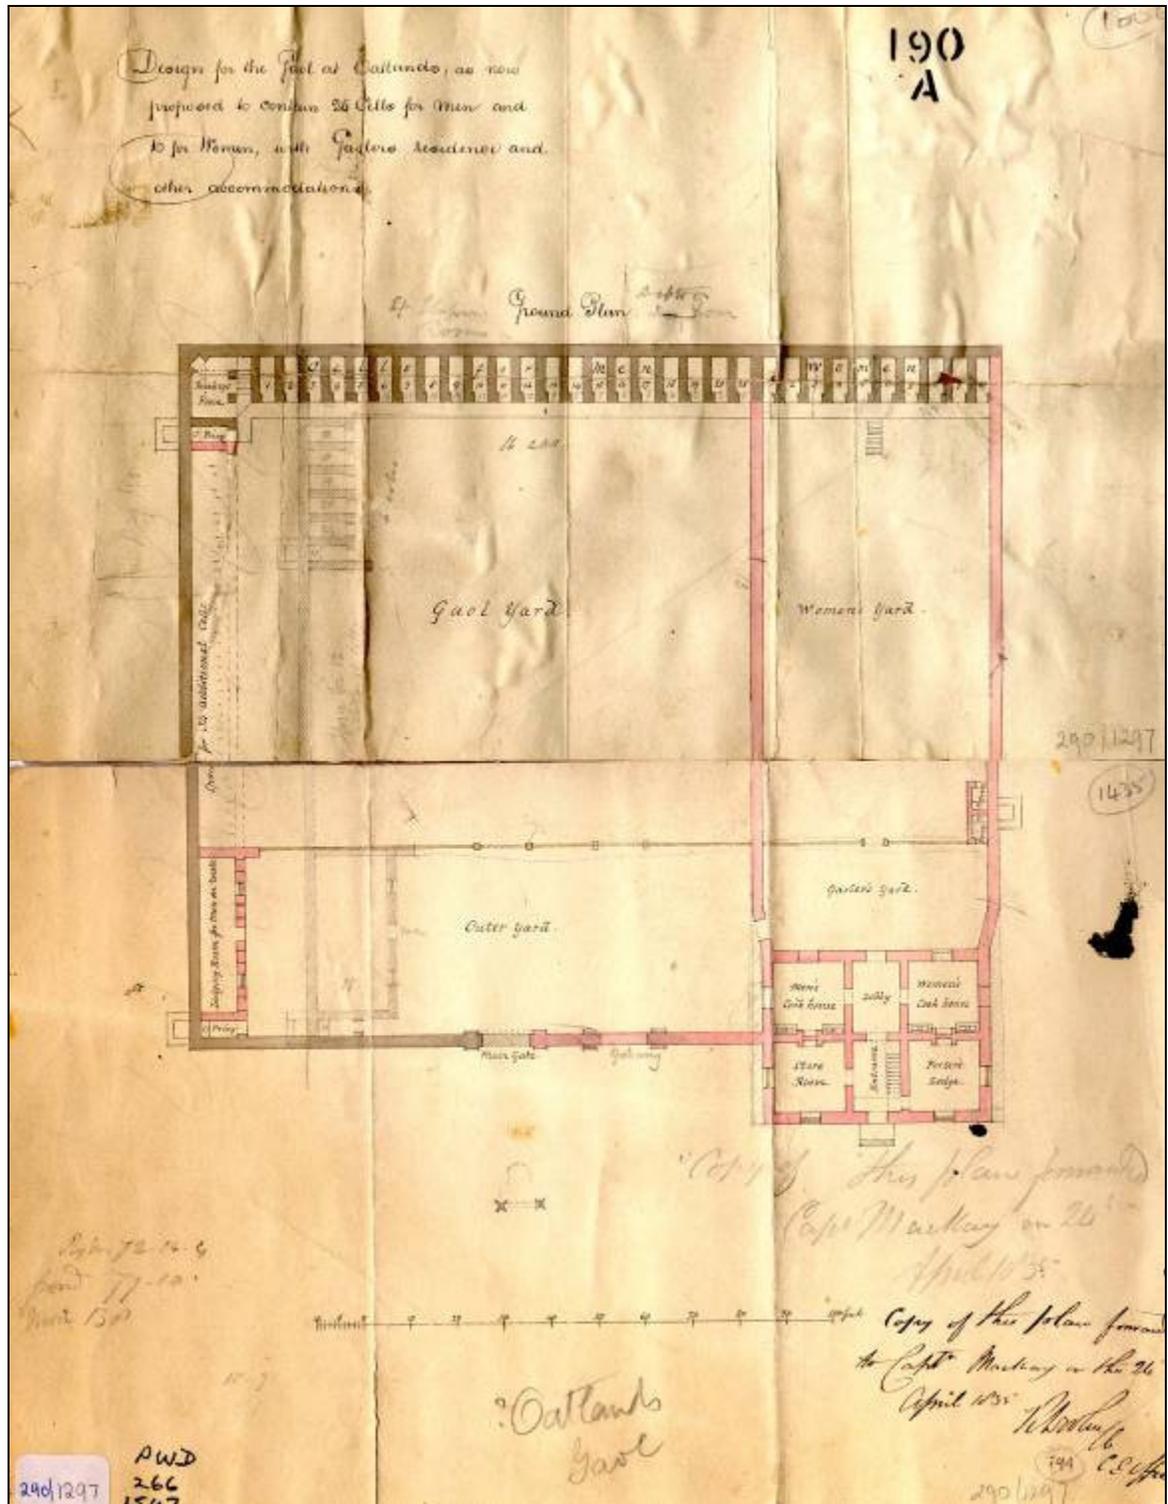
Figure 3.3 – Ground level plan Lee-Archer's second design for the Oatlands Gaol. This plan shows which parts of the gaol had been built (brown ink) by March 1835, and those which had not (pink ink) (AOT PWD 266/1546).

Figures 3.3 & 3.4) show that the original single yard had been separated into four separate yards, the room for men-on-route was moved from behind the Gaoler's residence to the north-eastern corner of the complex and the entire yard widened. The most significant change, however, was the addition of the Women's Division and the replacement of the solitary cells in the upper level of the gaol with lock-up rooms, a debtors ward and hospitals for both men and women. The balcony as depicted on the original plan was enclosed with a timber wall to form a gallery.

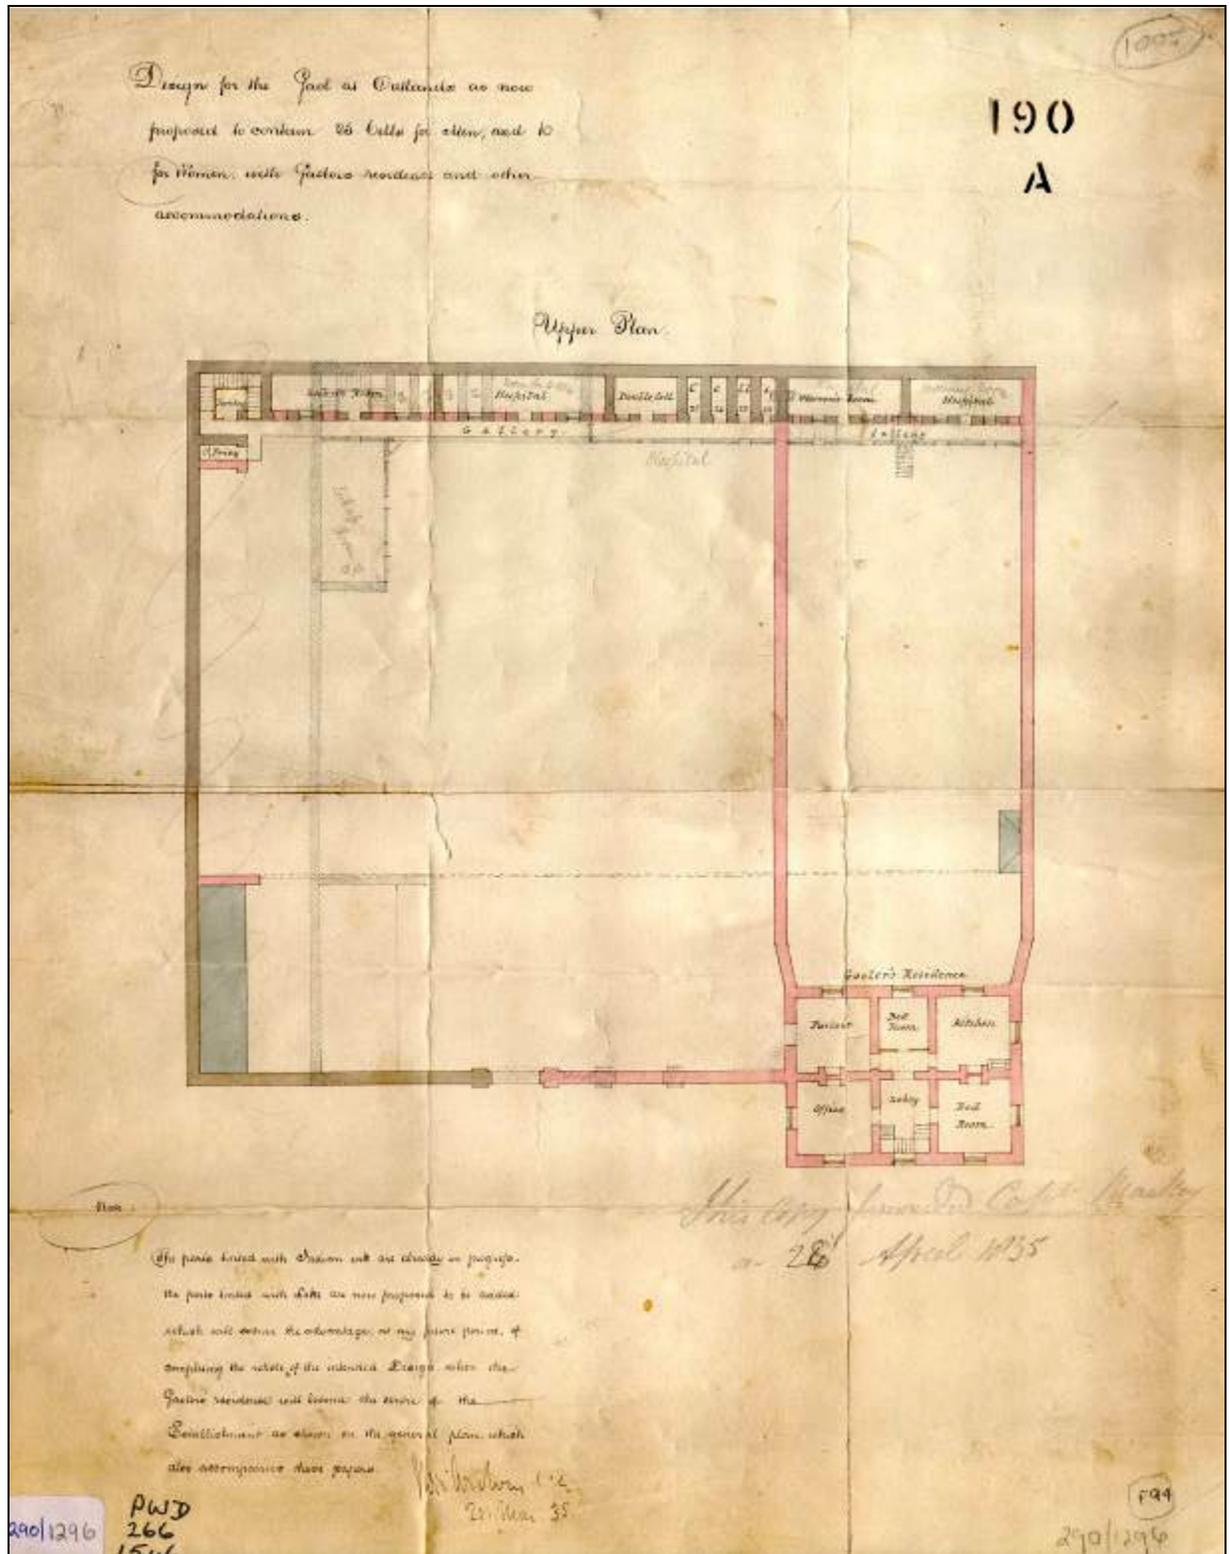
Figure 3.4 – Upper level plan Lee-Archer’s second design for the Oatlands Gaol. This plan shows which parts of the gaol had been built (brown ink) by March 1835, and those which had not (pink ink) (AOT PWD 266/1546).

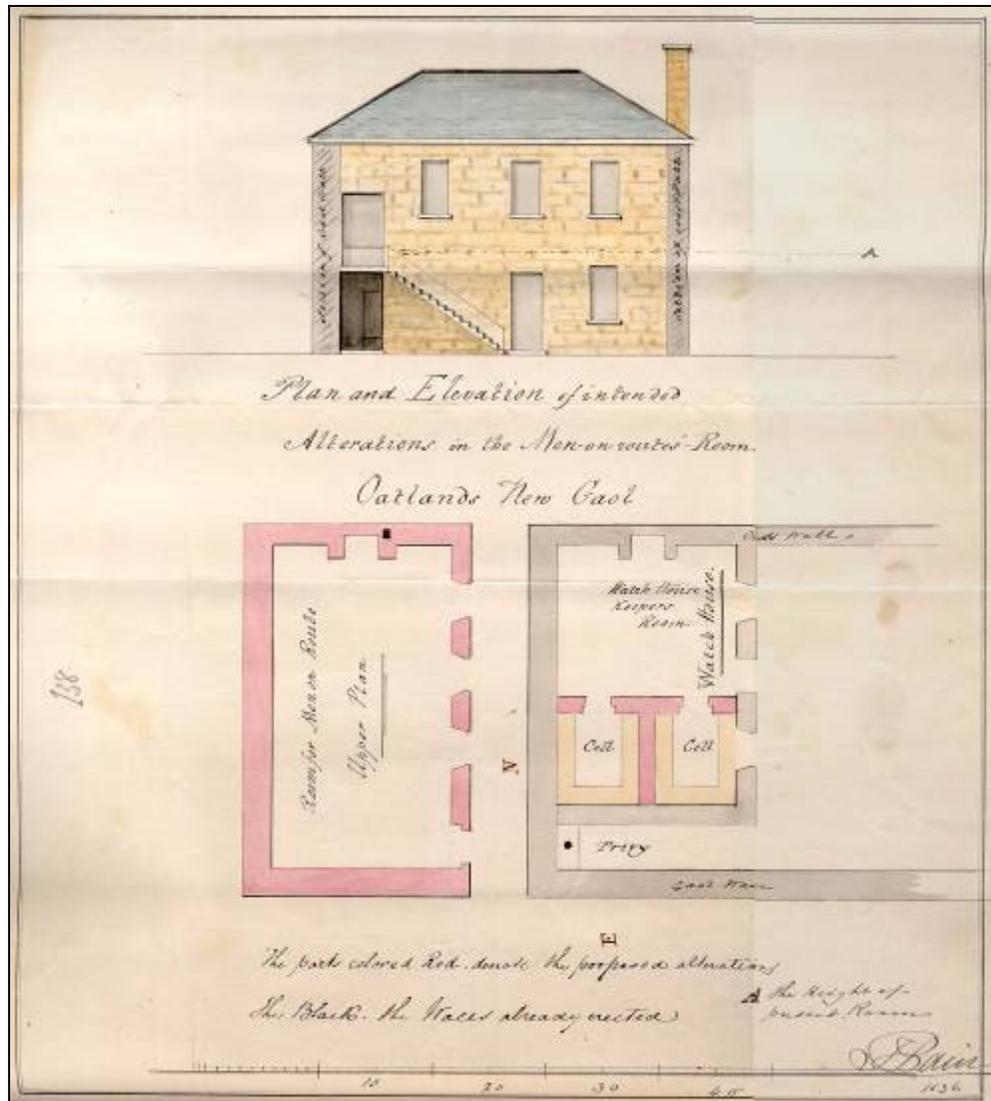
Figure 3.5 – The 1836 plans for conversion of the partially completed Javelin Men’s Building into a Watch-House. The grey walls show what was already built in mid-1836, with the red walls proposed to be added (AOT CSO 1/691/15206:137).

Although plans were drawn for the conversion of the partially completed Javelin Men's Building (Figure 3.5), the idea of a Watch-House within the gaol complex was abandoned due to a perceived lack of security (AOT 1/691/15206:130-32) and a separate watch-house was built to the east of the gaol (AOT PWD 266/1587). At the same time, it was planned for a new Commissariat Store to be erected on the eastern side of the main gates, attached to, but outside the Gaol walls (Figure 3.6). This plan was also abandoned for an undocumented reason (AOT CSO 1/691/15206:137).

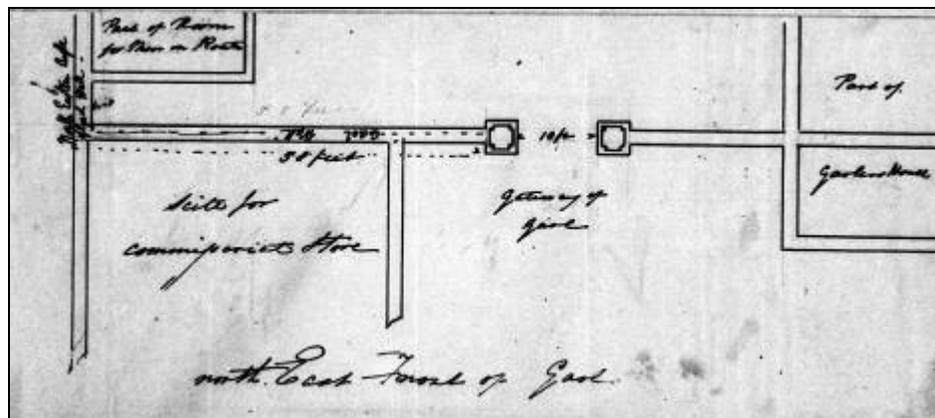
Figure 3.6 – 1836 plans for a Commissariat Store to be erected on the northern wall of the gaol complex (AOT CSO 1/691/15206:137).

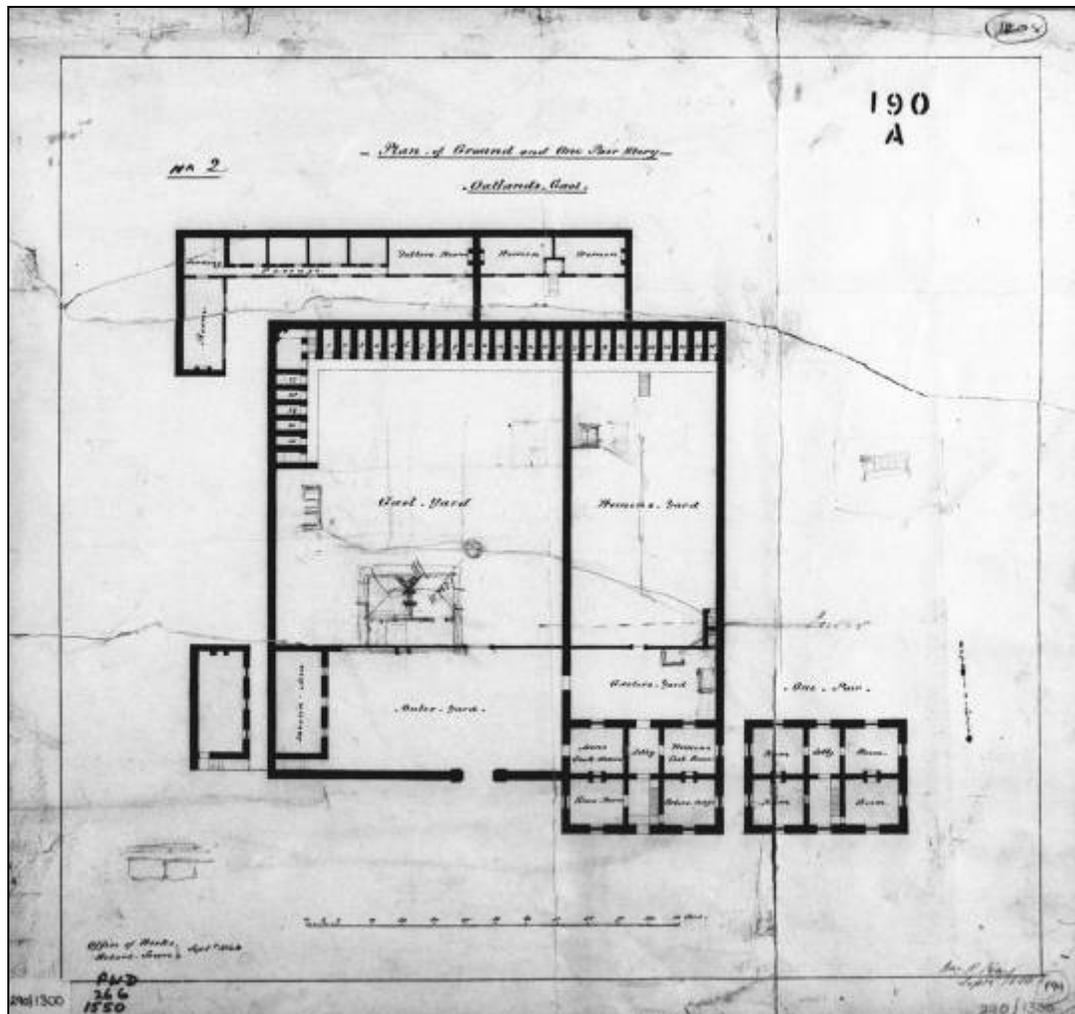
Figure 3.7 – The earliest known plan of the Oatlands Gaol following completion, by William Kay, 1844 (note 1849 alterations have been sketched over the original plan).

No plans were found here which show the design of the gaol at completion, however documentation suggests that only minor changes to Lee-Archer's second plans of mid 1835 were made prior to 1844 (Figure 3.7).

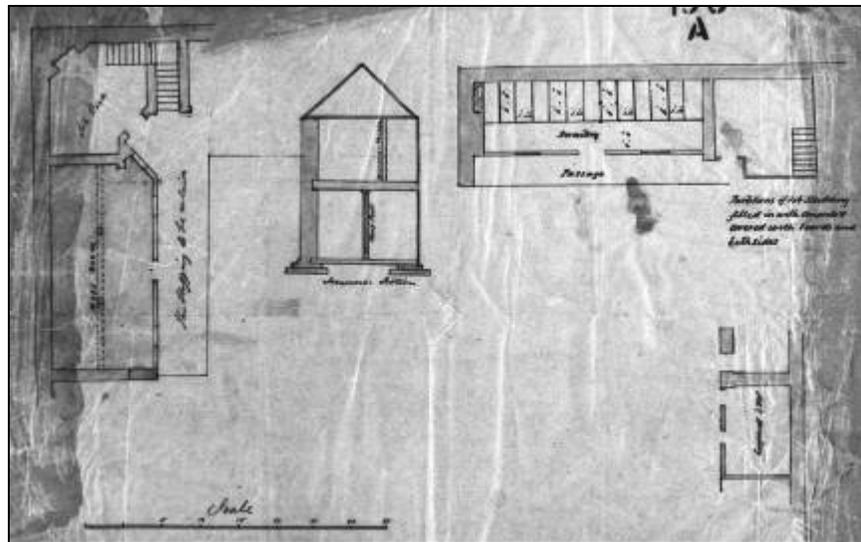
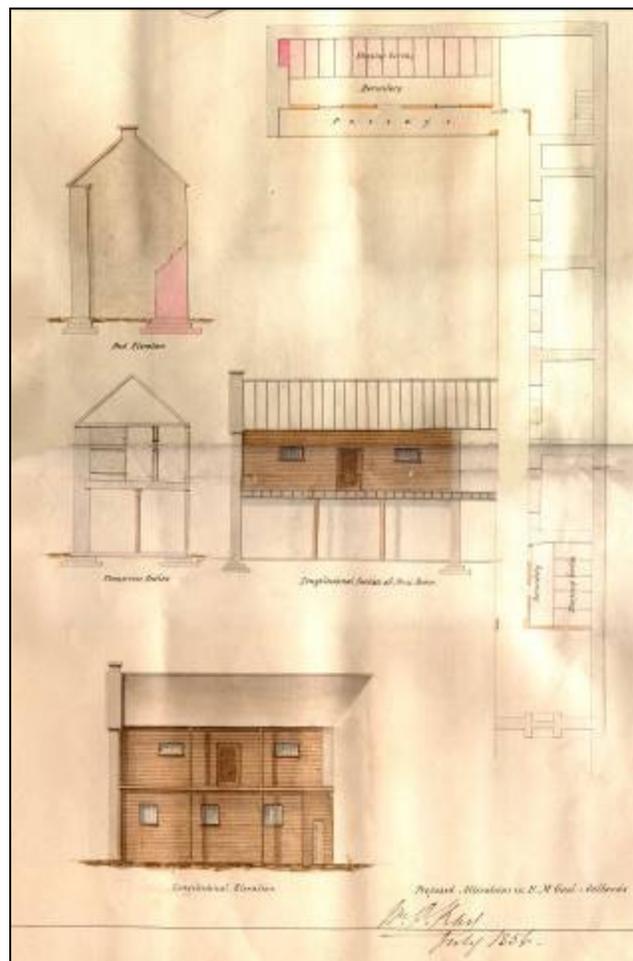
Figures 5.1 & 5.2 – Proposed alterations to H.M. Gaol, Oatlands, plans by W. Kay, Director of Public Works, July 1856 (AOT PWD 266/1556-7).

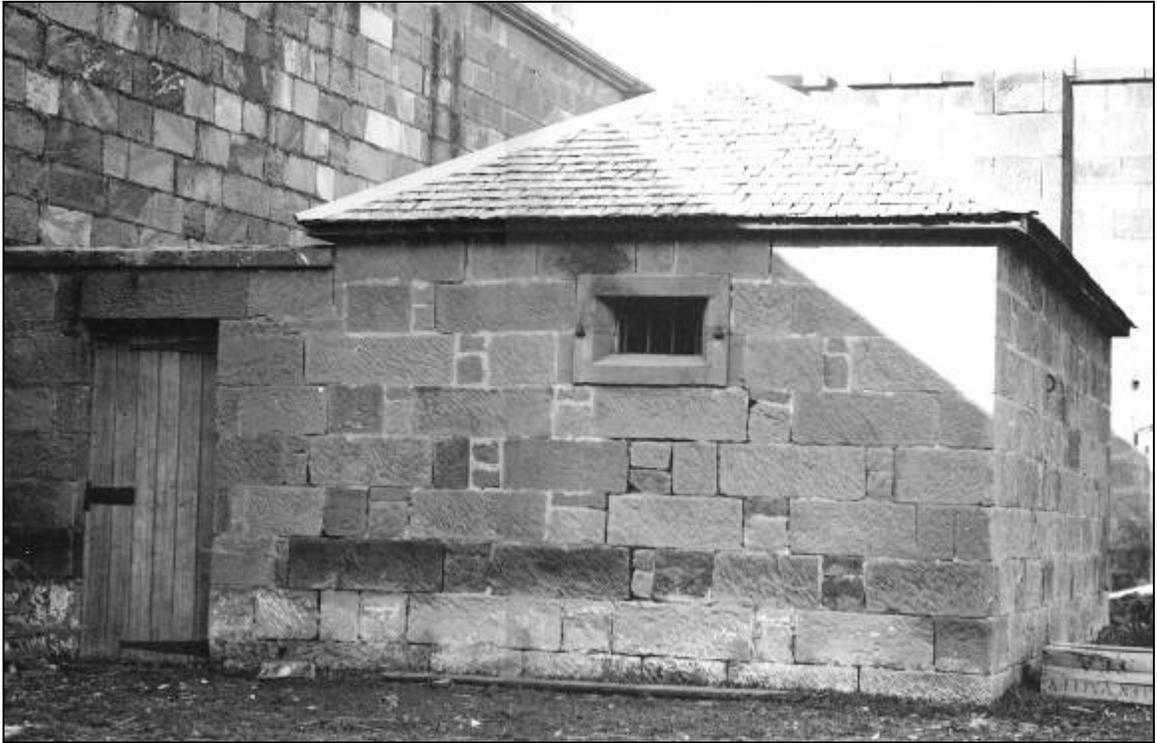
Plate 5.1 – The western wall of the Condemned cells c1926. Photograph from the State Library of Victoria Heritage Collections

of the men's Division had been covered in iron between 1901 and 1926, plates 6.1 and 6.2 show that the Gaoler's house also had also gained an iron roof between 1904 and 1934. Photographic evidence dating from 1926 shows that the Men's Division (Plate 6.4) and Condemned cells (Plate 5.1) were still in fair condition, although the deteriorated state of the Men's Division roof suggest that it has by then been disused.

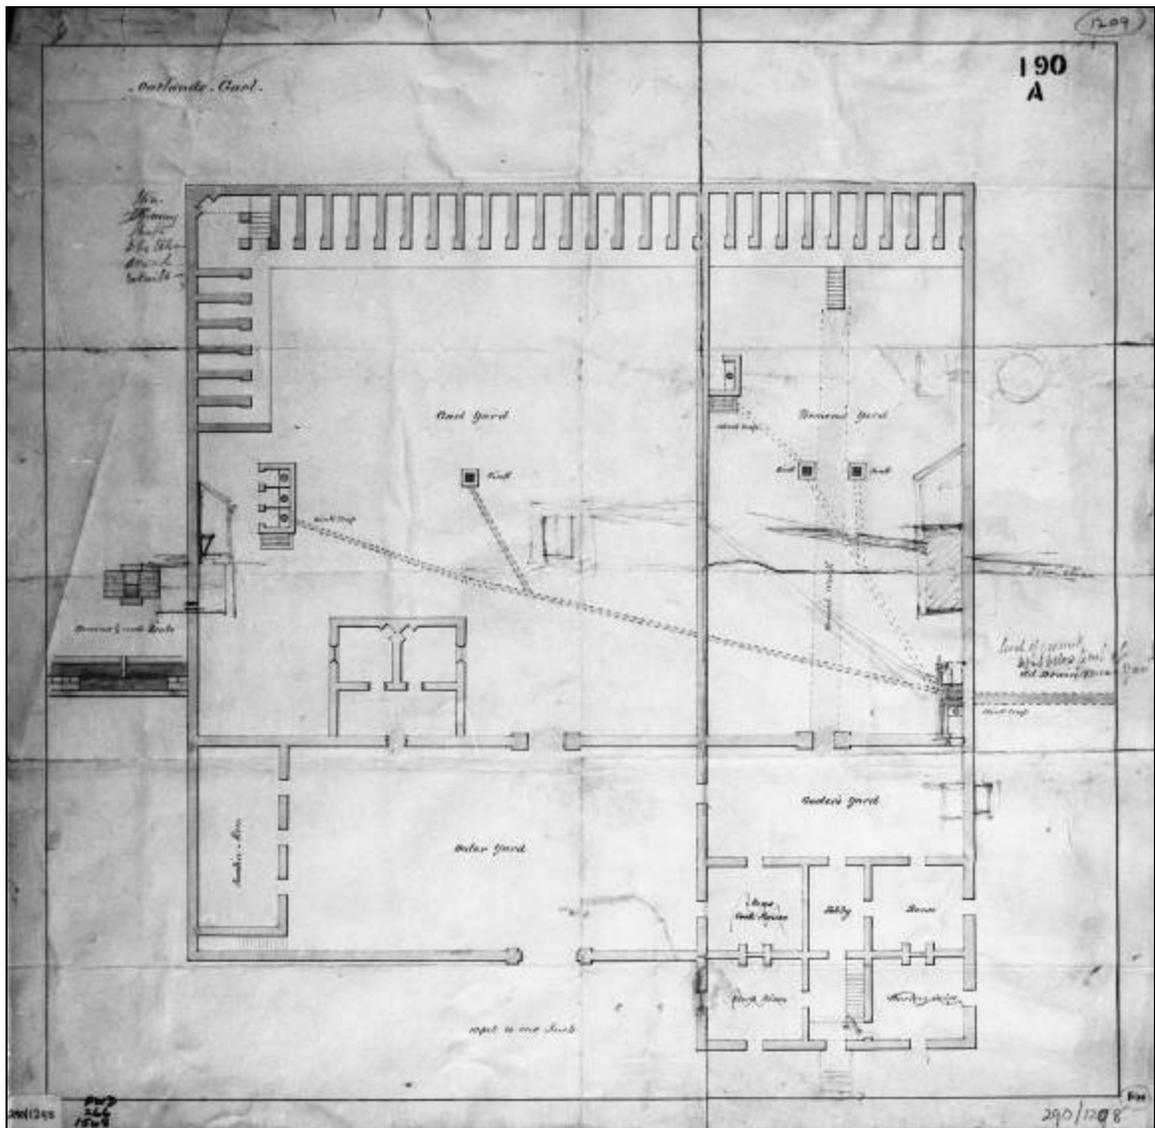
Figure 5.7 – The pre-June 1849 plans of the proposed upgrades to the Oatlands Gaol, showing the addition of the Condemned Cells, the original privy locations and the intended locations for the new privies (AOT PWD 266/1548).

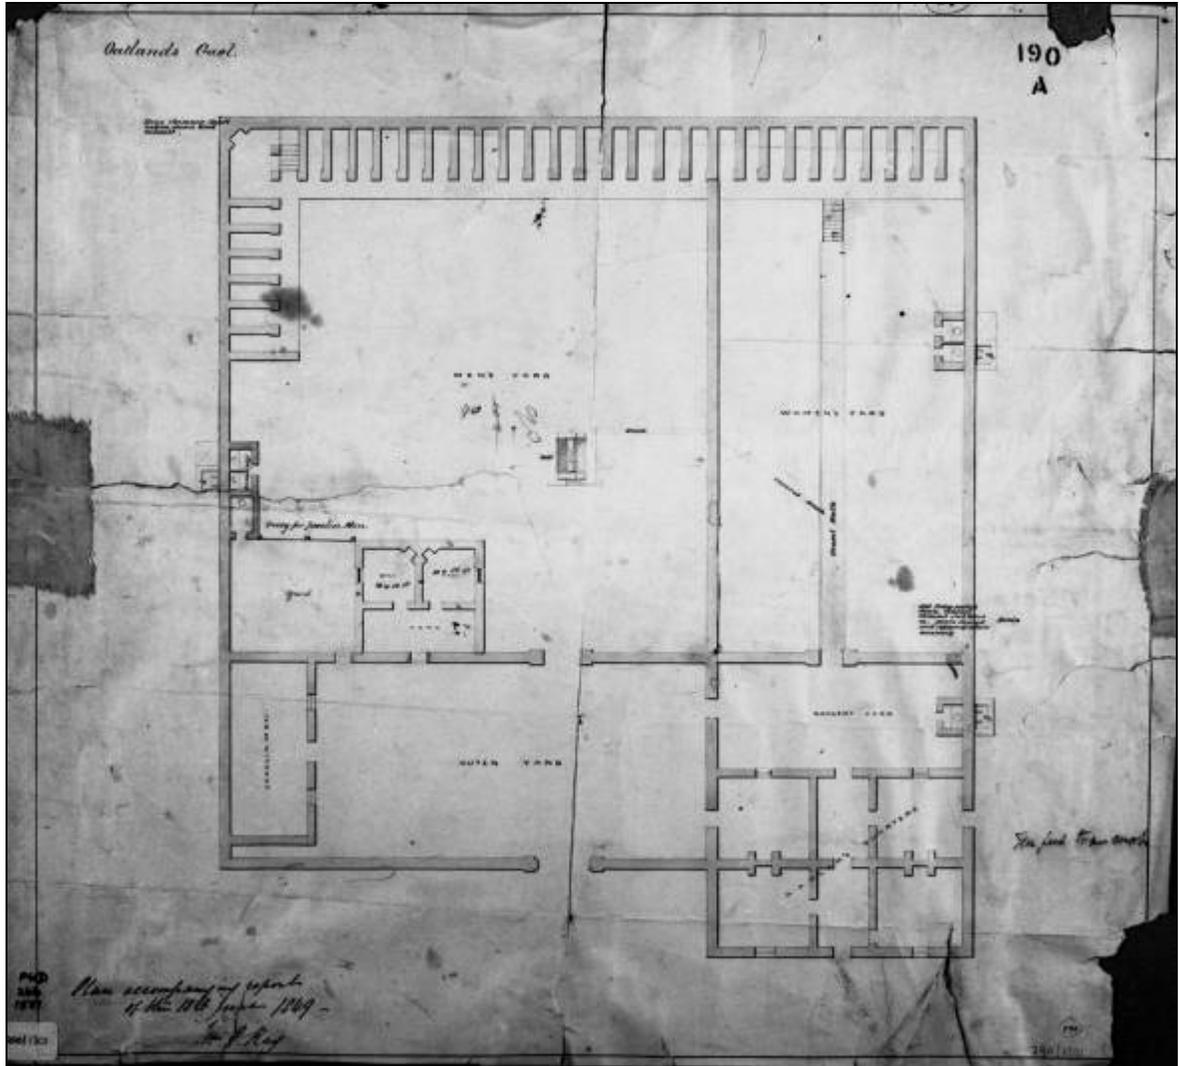
Figure 5.8 - W. Kay's June 1849 plan of the Oatlands Gaol showing the locations of the new privies and drains (AOT PWD 266/1551).

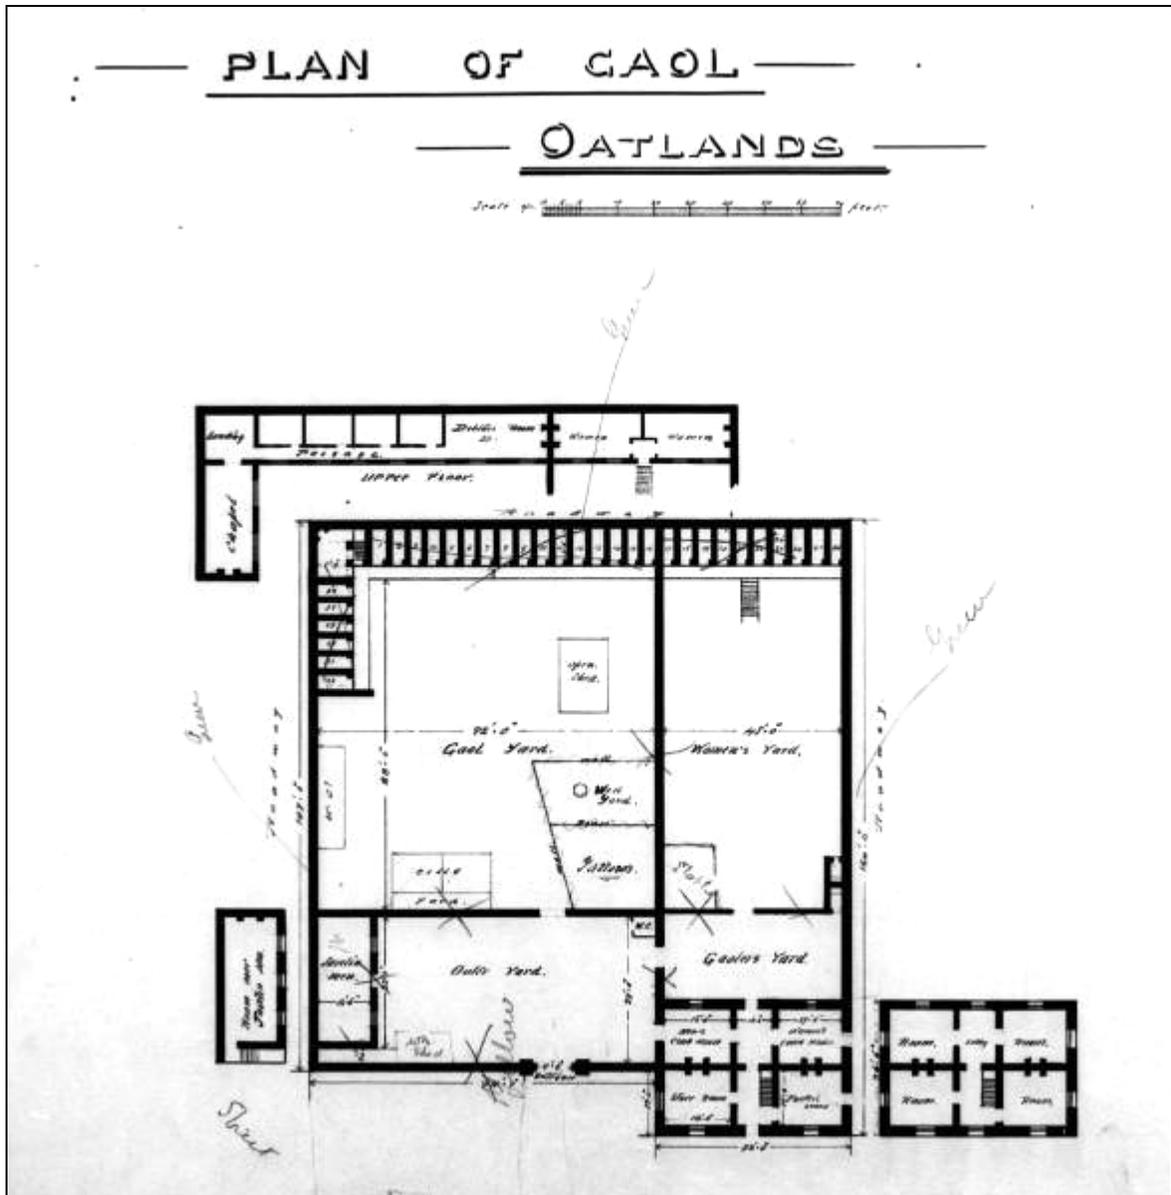
Figure 6.1 – Shield's 1883 plan of the Oatlands Gaol complex (AOT PWD 266/1564)

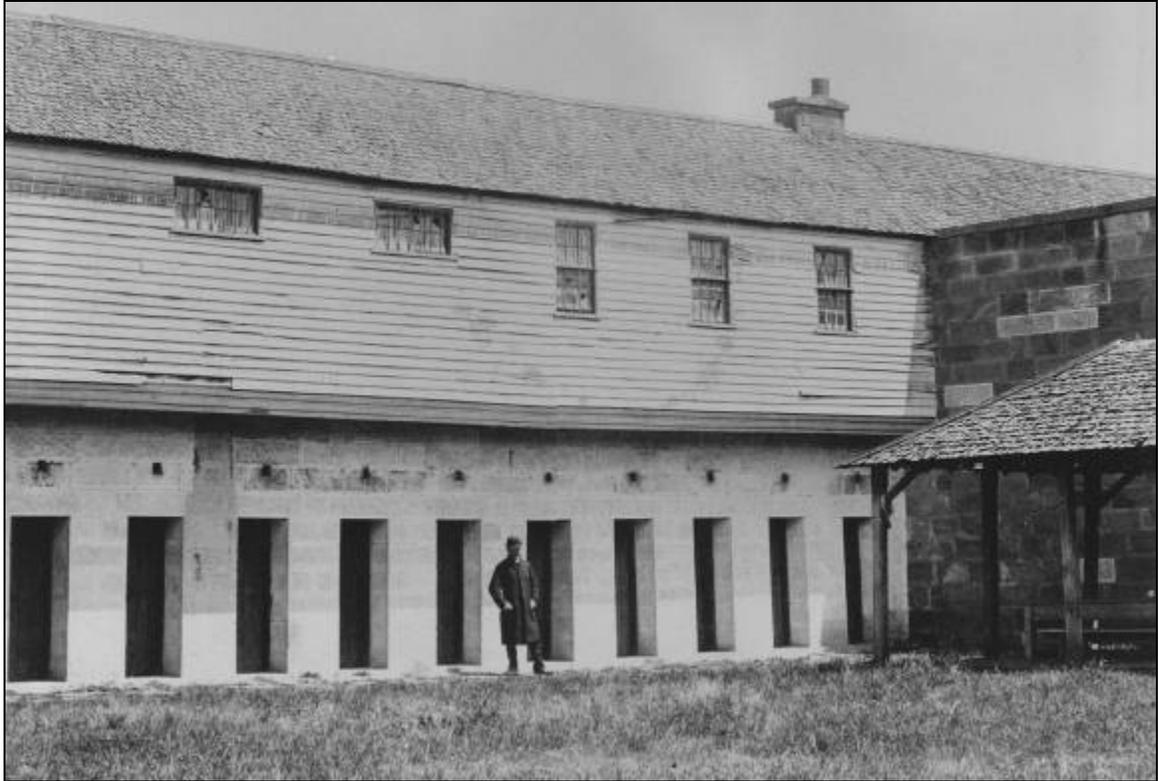
Plate 6.3 – The Men's Division showing solitary cells with the Debtor's ward above, early 1900's. Photograph from the State Library of Tasmania.

The gaol apparently continued operating as a municipal gaol with little change for the next 50 years. The Gaoler's residence and former Javelin Men's Building was used as accommodation for the local Sergeant and Constables respectively. With the exception of works detailed in Section 5, no evidence has been found to suggest that there were any major alterations or demolition to the complex through this period. Plates 6.3 and 6.4 show that the roof

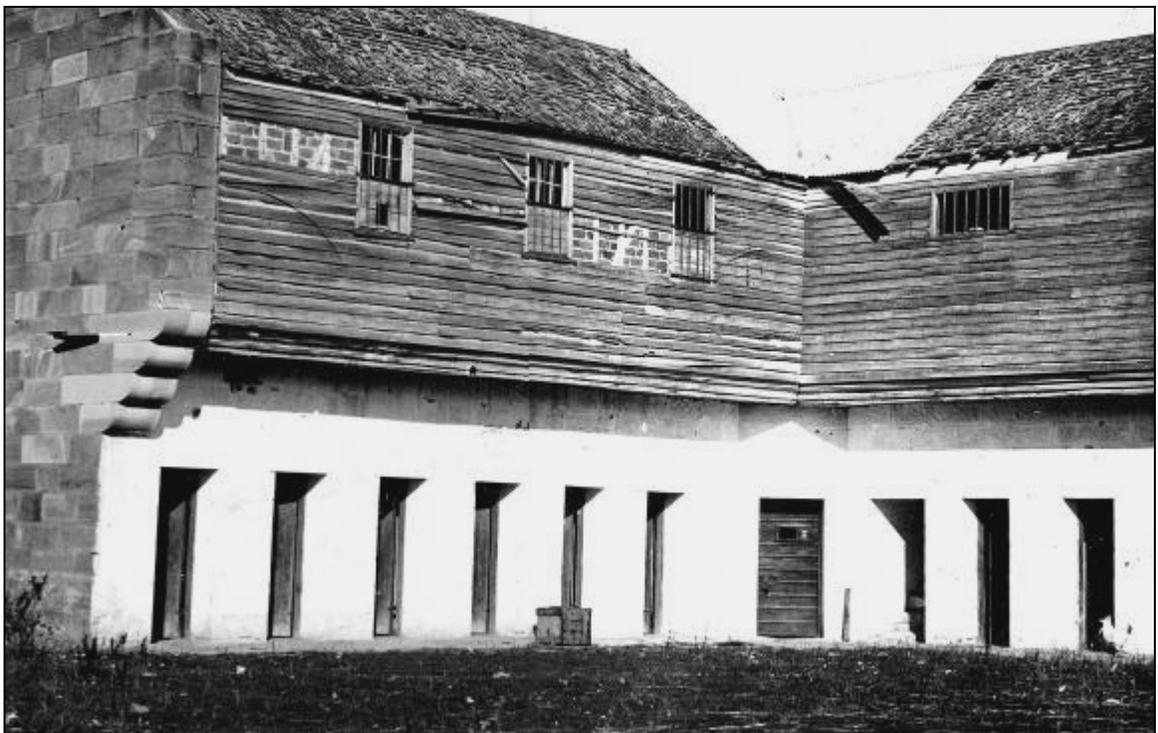
Plate 6.4 – The Men's Division, showing solitary cells with chapel above c1926. Photograph from the State Library of Victoria Heritage Collections

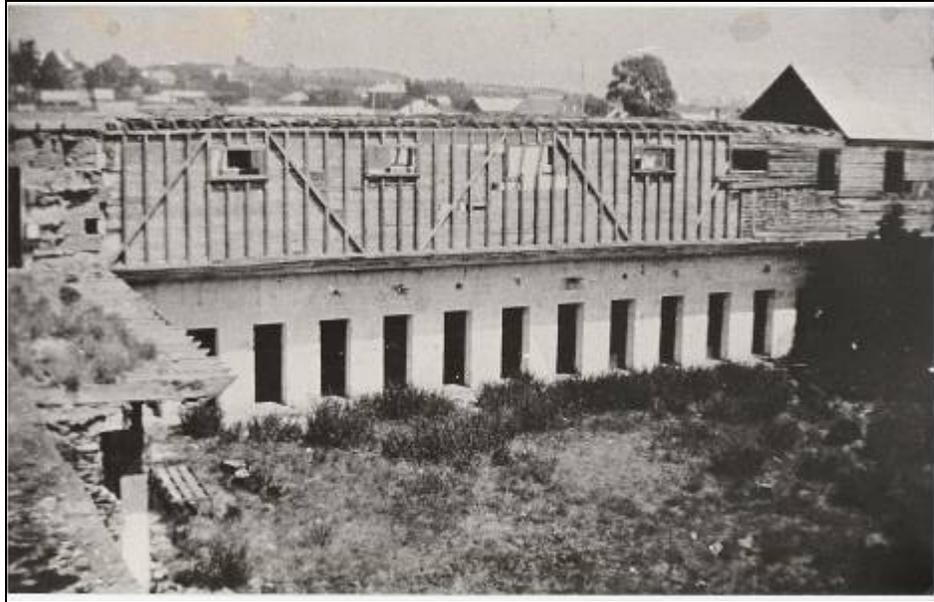
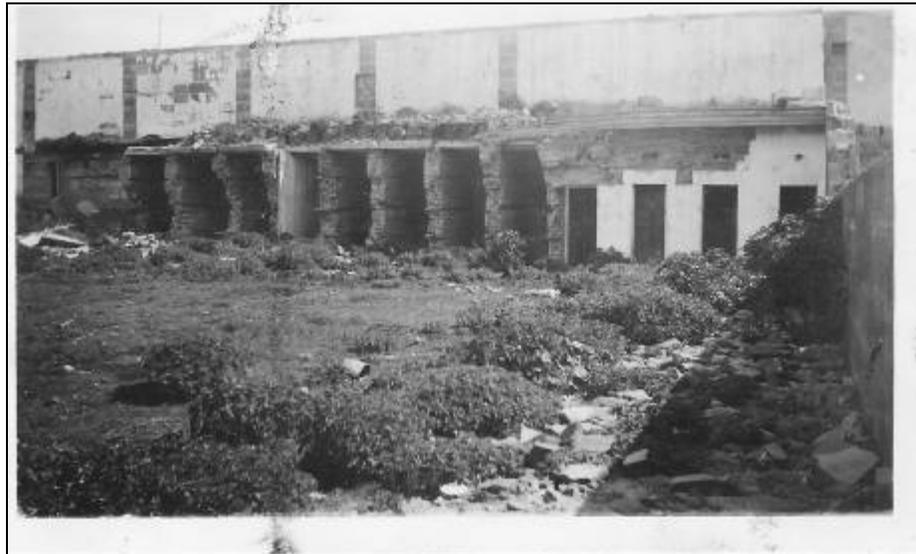
Plates 7.3 & 7.4 –Demolition of the Men's Division, late 1937. Photographs courtesy of Graeme Raphael, Oatlands (top) and the Oatlands District Historical Society (bottom).

of the complex. It is known to have been largely intact prior to 1937, however was 'demolished' in late 1937. The extent of demolition is however uncertain. Photographic evidence shows the buildings in the process of destruction during November 1937 (Plates 7.3 & 7.4), however, it is unknown how much more demolition occurred after these photographs were taken. The survey of the remaining wall heights undertaken in April 1938 indicates that the southern and eastern outer walls (the back walls of the Men's Division) were still intact, and that the 13 westernmost cells were still standing (as depicted in Plates 7.3 & 7.4 – see also Figure 13.4). These outer walls range from a height of 1.8 – 2.5 metres in 2004, so more demolition was undertaken before the swimming pool was finally constructed in the early 1950s. This would also have resulted in further demolition of the remaining cells, as indicated in Appendix B, the 2004 ground level of the pool yard would be lower than the upper portion of these cell walls, with a maximum of approximately 60 centimetres of fill currently above the historic ground level – giving absolutely

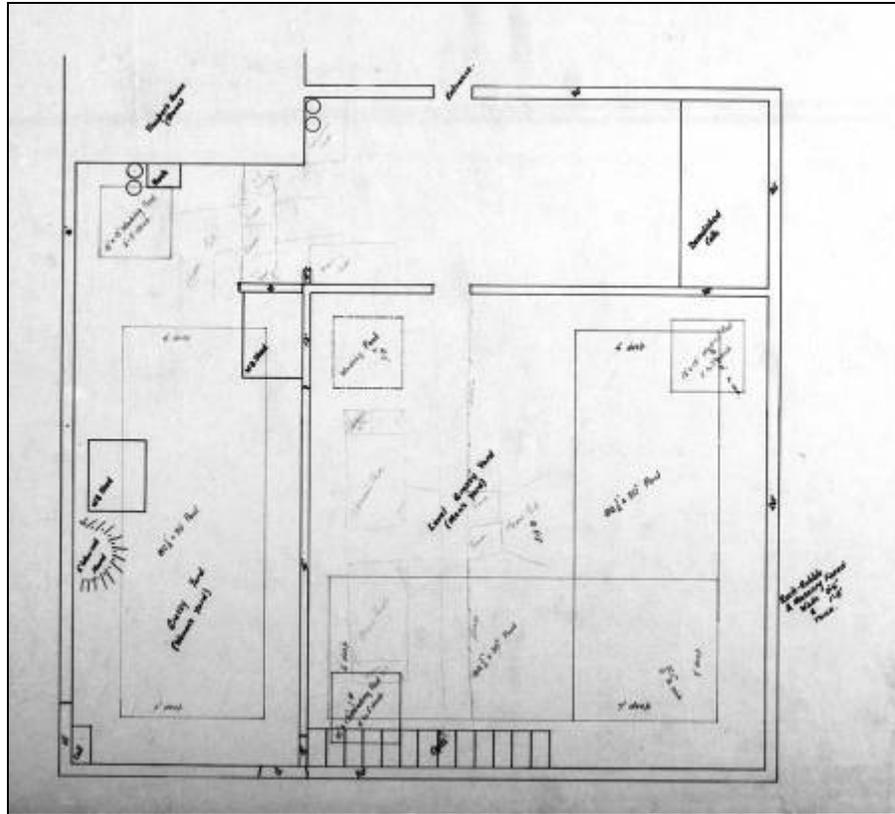
Figure 7.1 – Hodgson’s April 1938 plan of the Oatlands Gaol site, showing proposed locations for the swimming pool and associated buildings (although different to the eventual layout) (AOT PWD 266/1554).
