**Oatlands Gaol Historical Study  
&  
Archaeological Survey**

**SOUTHERN  
MIDLANDS  
COUNCIL**

Prepared by Brad Williams  
For the  
Southern Midlands Council, Tasmania  
May 2004

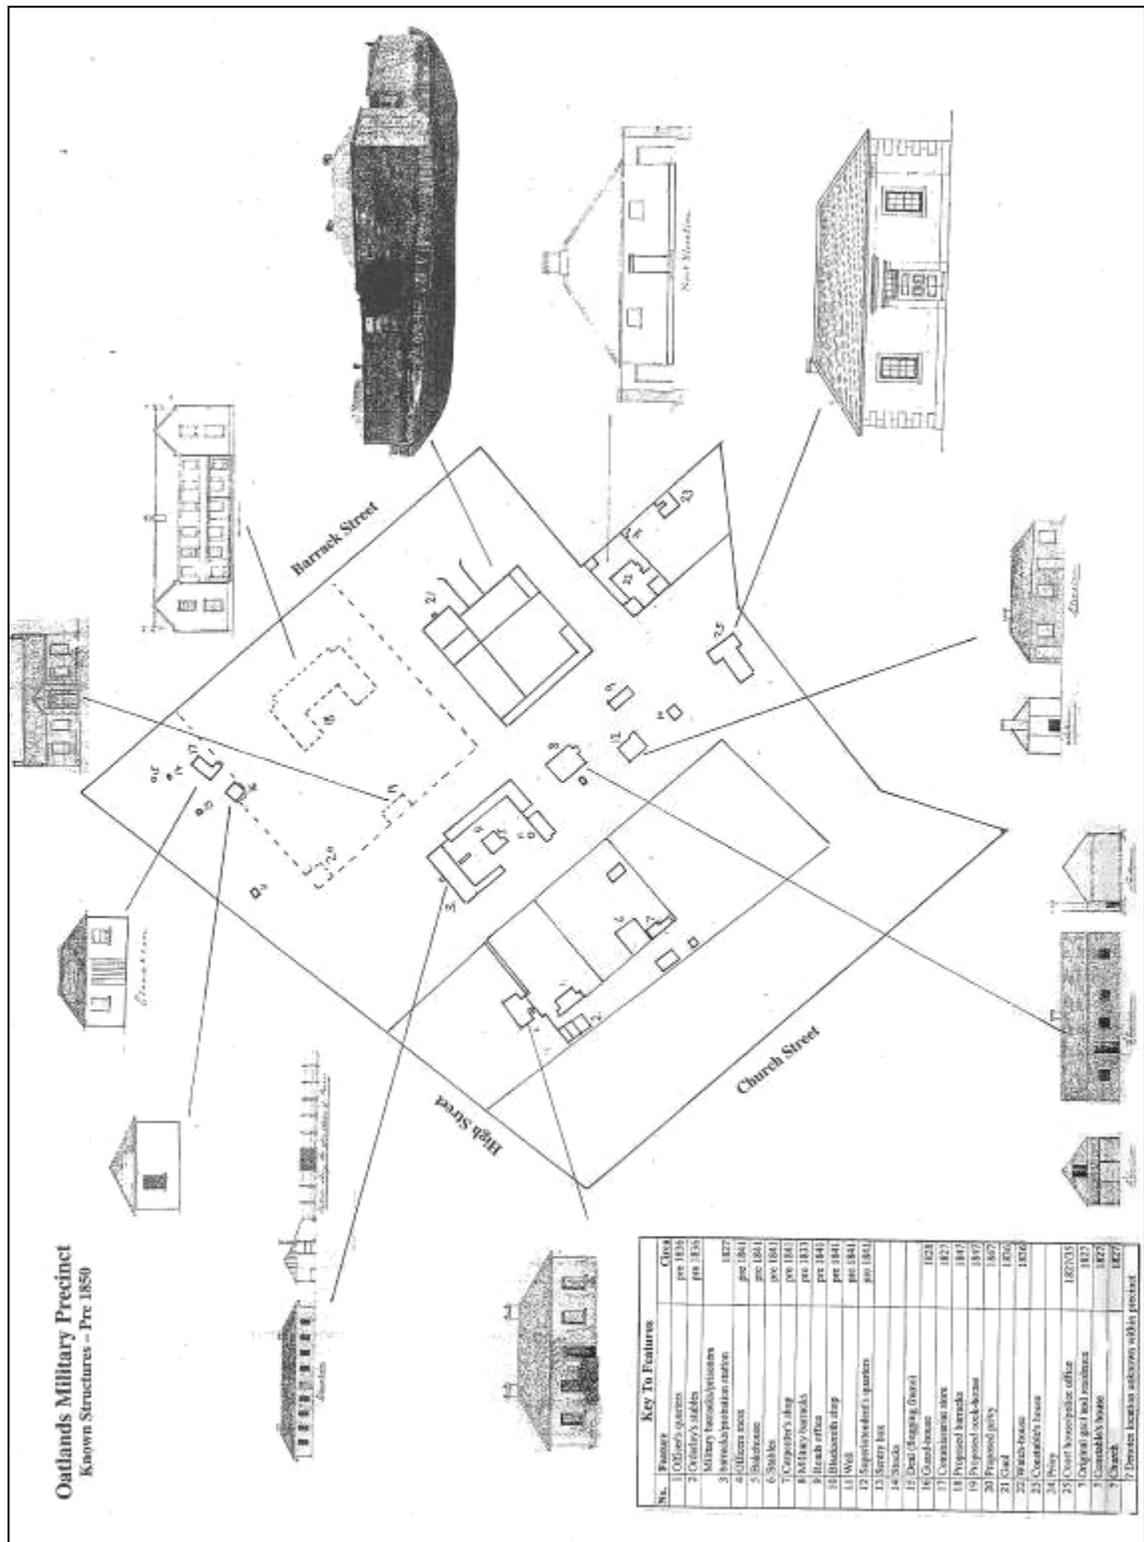
Figure 11.1 – Sketch plan of known pre-1850 structures within the Oatlands military precinct, based on AOT PWD 266 series plans and TLD O series maps (see also Section 2.2).

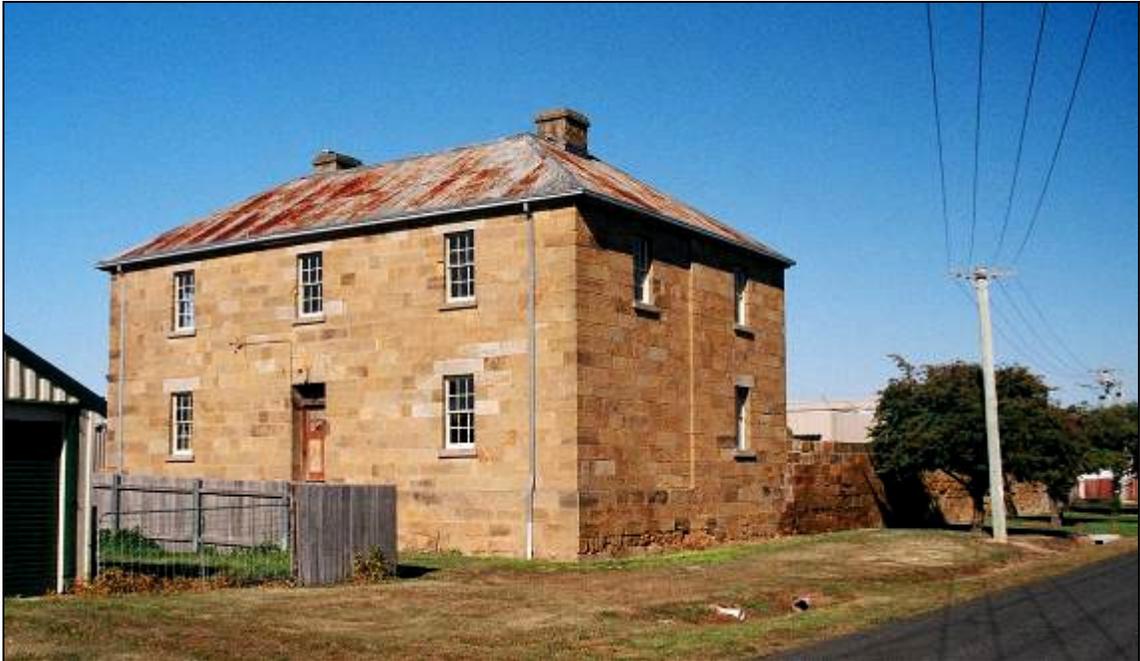
Plate 13.1 – The Oatlands Gaol complex from the corner of Barrack and Mason Streets, Oatlands.

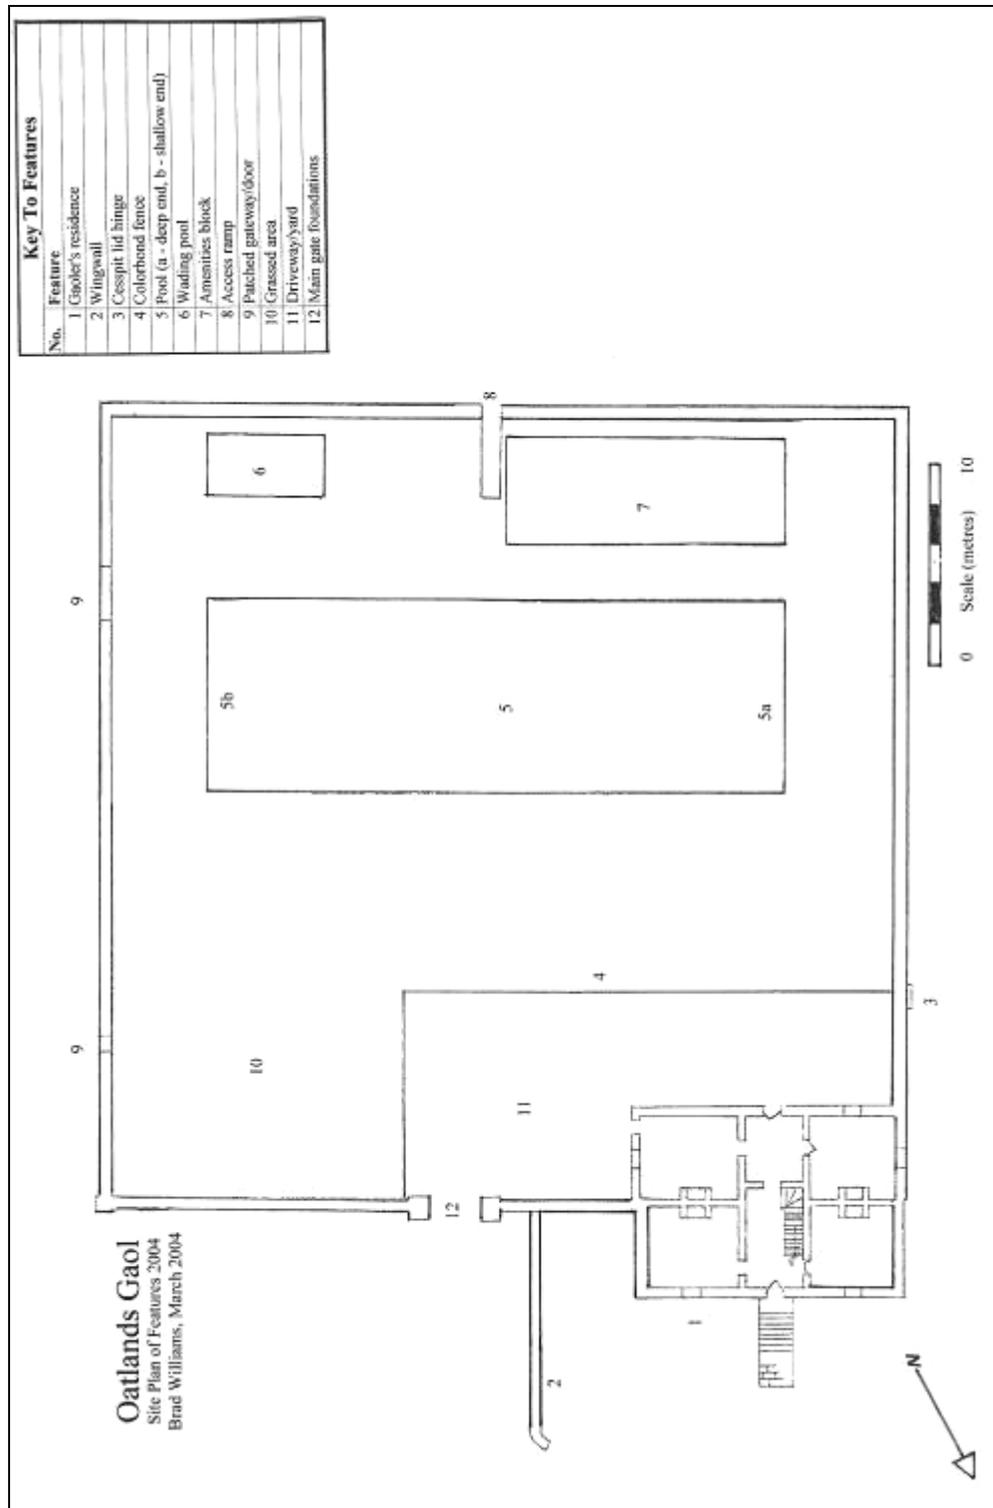
Figure 13.1 – Plan of major features, Oatlands Gaol site (swimming pool), 2004.

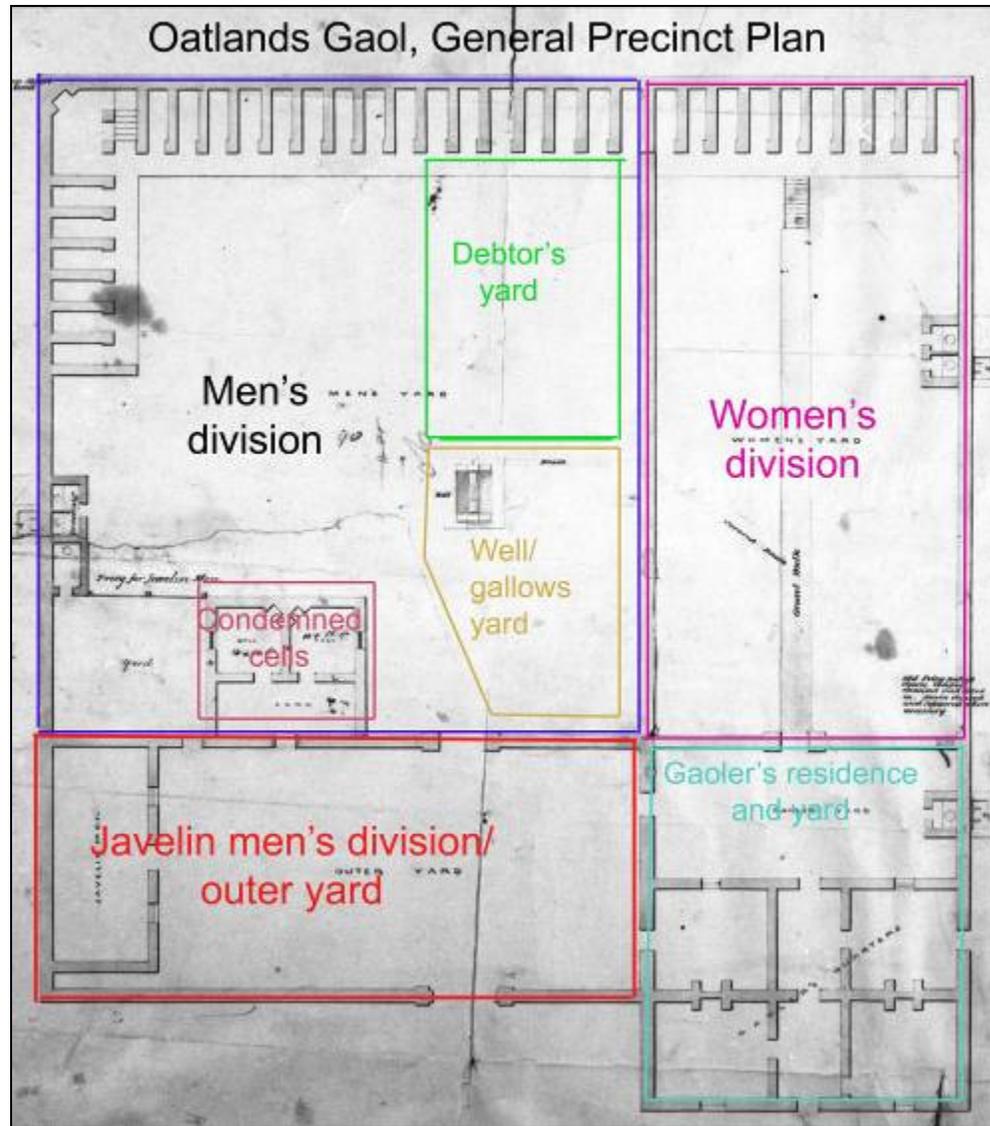
Figure 13.2 – Precincts within the gaol complex as discussed in this survey (adapted from AOT PWD 266/1551).

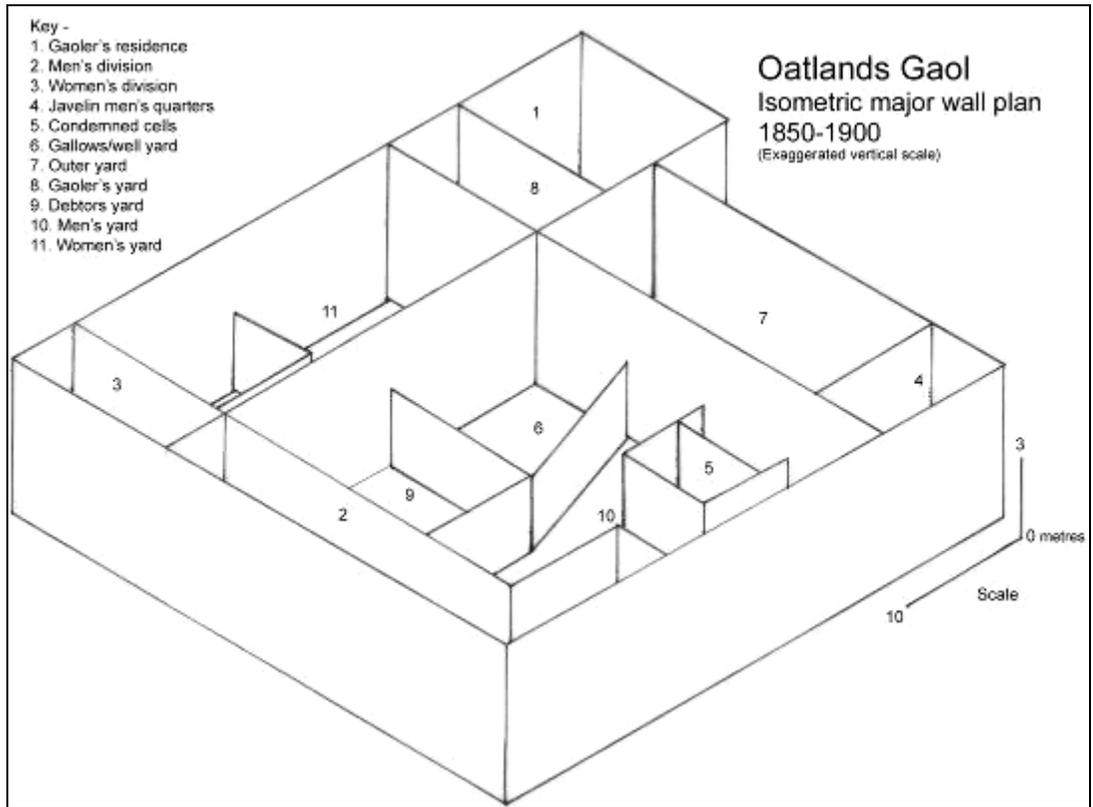
Figure 13.3 – Oatlands Gaol, Isometric Major Wall Plan, 1850-1900.

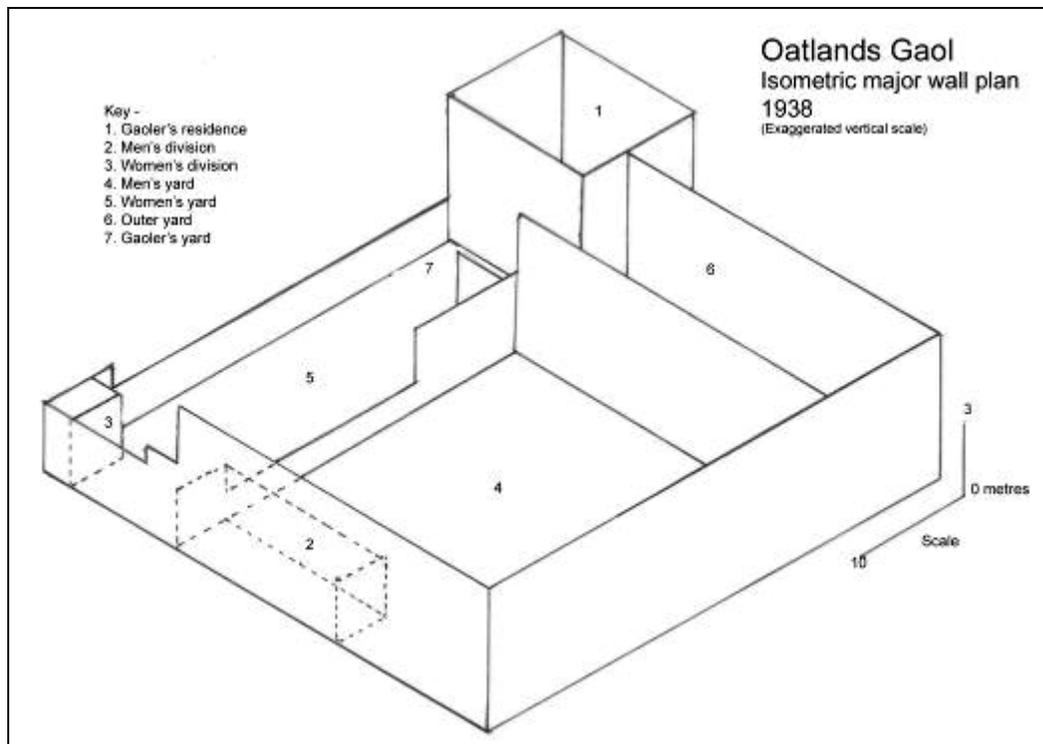
Figure 13.4 – Oatlands Gaol, Isometric Major Wall Plan, 1938.

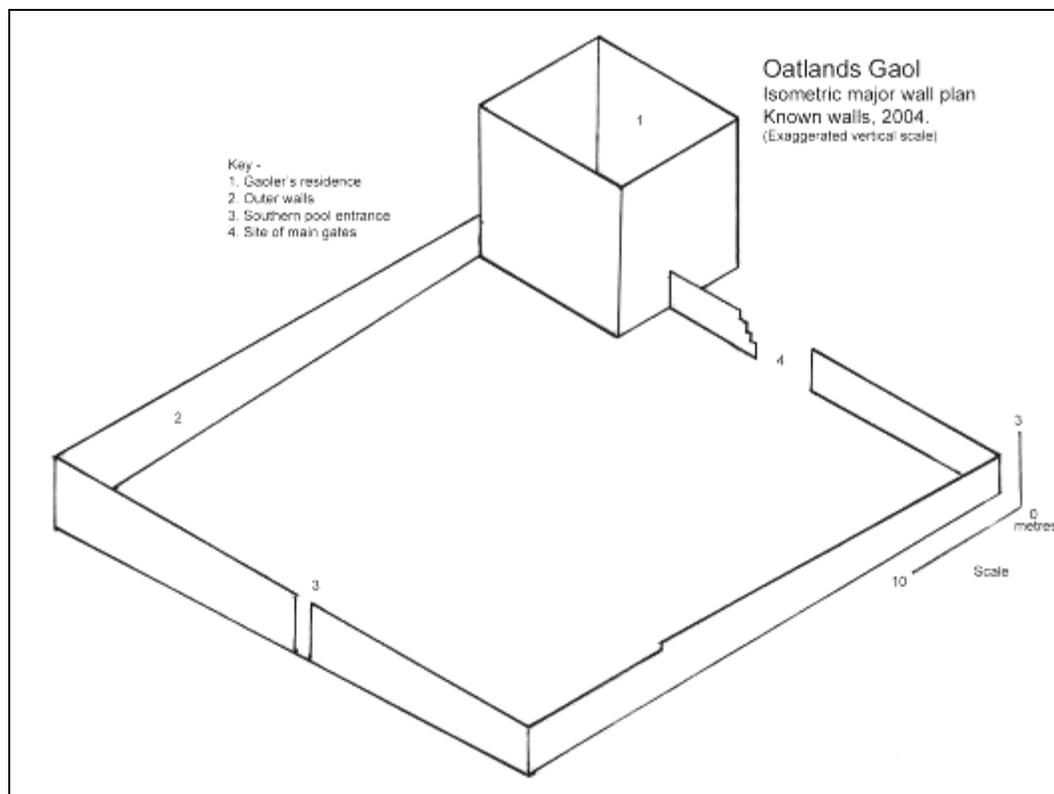
Figure 13.5 – Oatlands Gaol, Isometric Major Wall Plan, 2004.

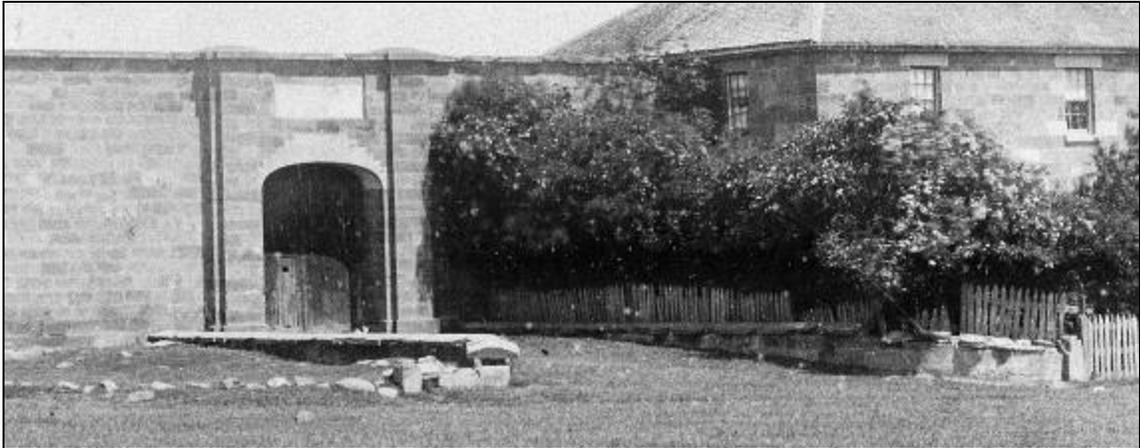
Plate 13.2 – The gaol arch and gates c1910. This photograph clearly shows the approach wingwalls and raised platform (bottom-left) where the gallows may once have stood. Photograph – Allport Library, State Library of Tasmania.

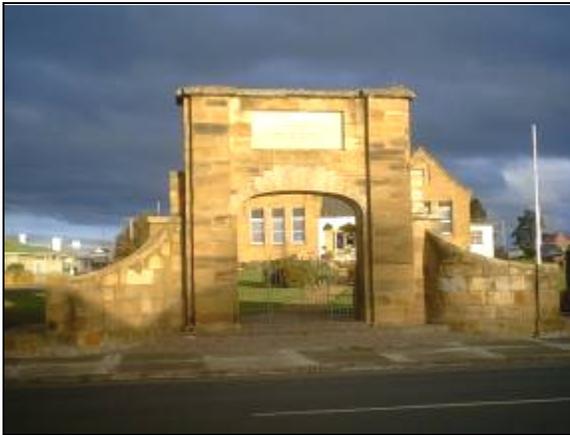
Plate 13.3 – The gaol arch as it stands (2004) in High Street, Oatlands.

The original foundations of the gaol arch are still evident at the gaol, each approximately a metre square and show iron cramping and housings for the massive hinges which would have been required for swinging the gates (Plate 13.4). There is no sign of hinge attachment on the arch itself, as relocation may have resulted in displacement of the blocks with points of attachment for hinges.

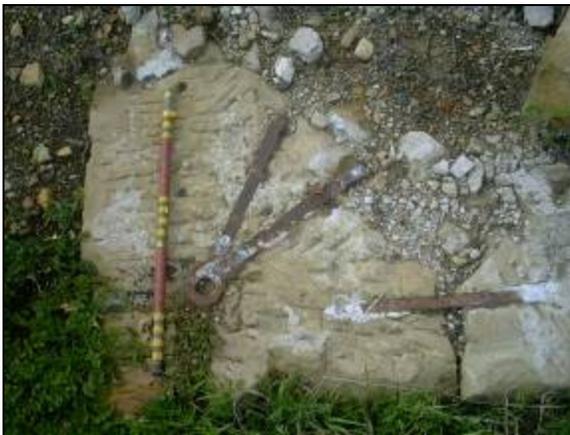
Plate 13.4 – Foundation of western main gate pillar showing iron cramping and hinge support.

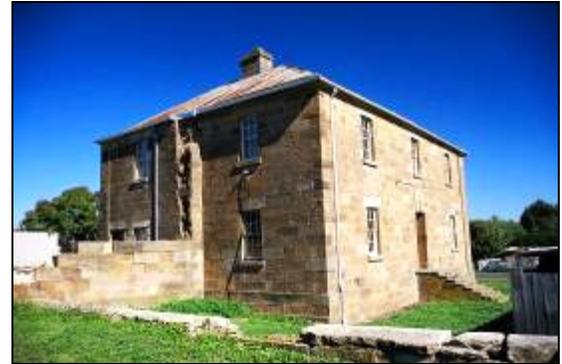
Plate 13.5 – The façade and eastern wall of the Oatlands Gaoler's Residence, taken from the approach to the main gates site.

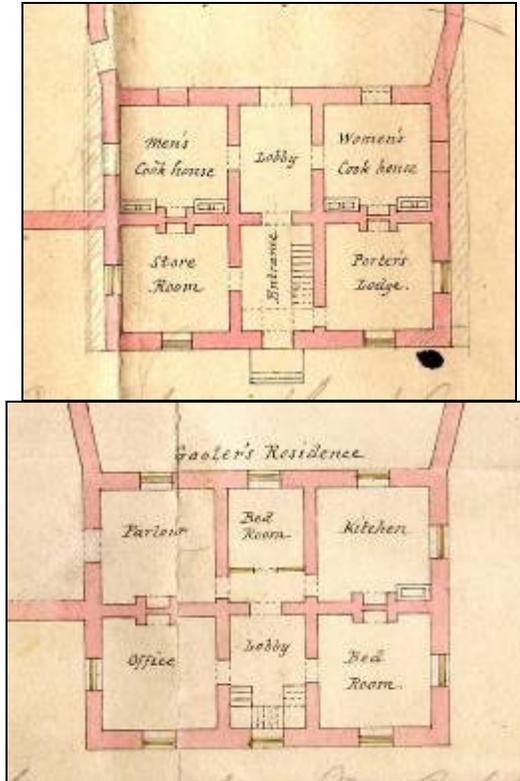
Figures 13.6 & 13.7 – The ground floor (above) and first floor of the Gaoler's residence as shown on Lee-Archer's 1834 June plans (AOT PWD 266/1546-7).

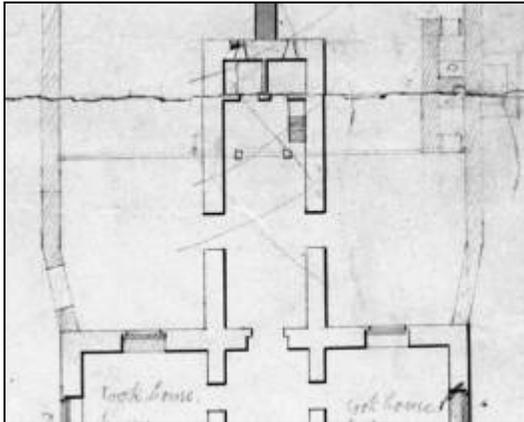
Figure 13.8 – The original 1834 plan for showing the rear of the Gaoler's Residence and the Gaoler's yard. The second variation of design from mid 1835 is penciled over the first design (AOT PWD 266/1555).

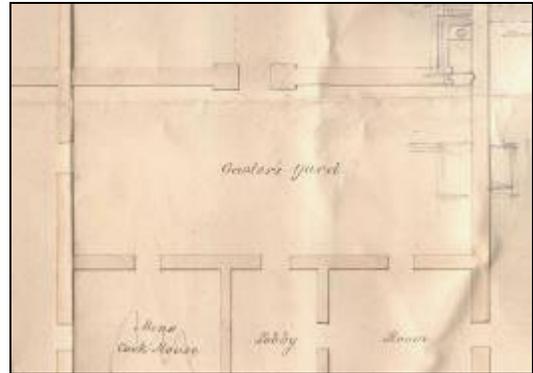
Figure 13.9 – The Gaoler's yard in May 1849, showing the intended location for the new privy and blocking of doorway to old privy scheduled for upgrade during the 1849 sanitation and drainage works to the complex (AOT PWD 266/1548).

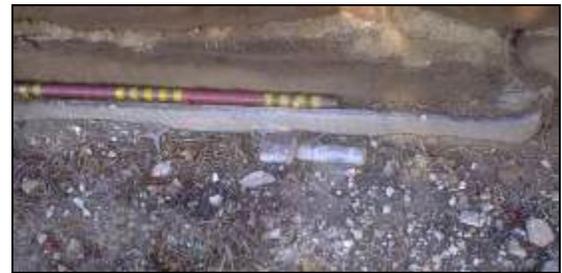
Plate 13.8 – Iron plate and hinge-pins of a privy cover on the outside of the western gaol wall approximately 17 metres from the north-western corner of the Gaoler's residence.

No trace of the two earliest privies was evident, with the exception of a cesspit cover hinge on the outside of the Gaol walls. Although slightly north of where it would be expected according to historic plans, this iron plate with two hinge pins (see Plate 13.8) is probably associated with the 1836 privies. Sandstone foundations of the porch formerly attached to the Gaoler's residence are clearly discernable (plate 13.9) and

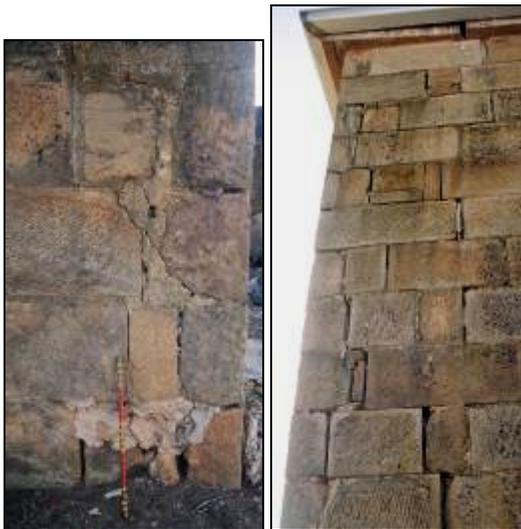
Plates 13.6 and 13.7 – Repaired scars on the south-eastern (left) and south-western corners of the Gaoler's residence from removal of the walls enclosing the Gaoler's yard.

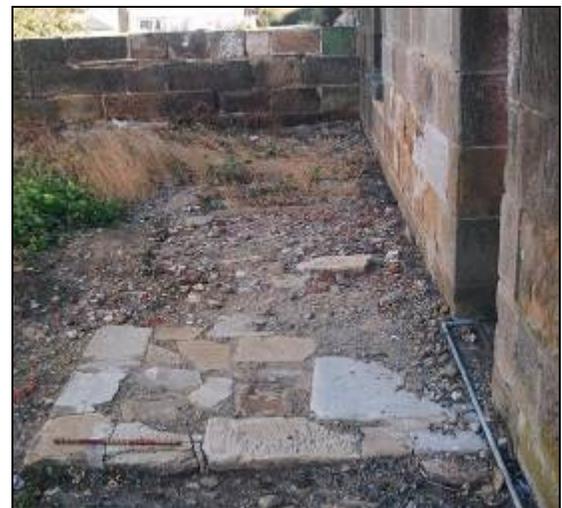
Plate 13.9 – Foundations of a skillion at the back door of the Gaoler's residence.

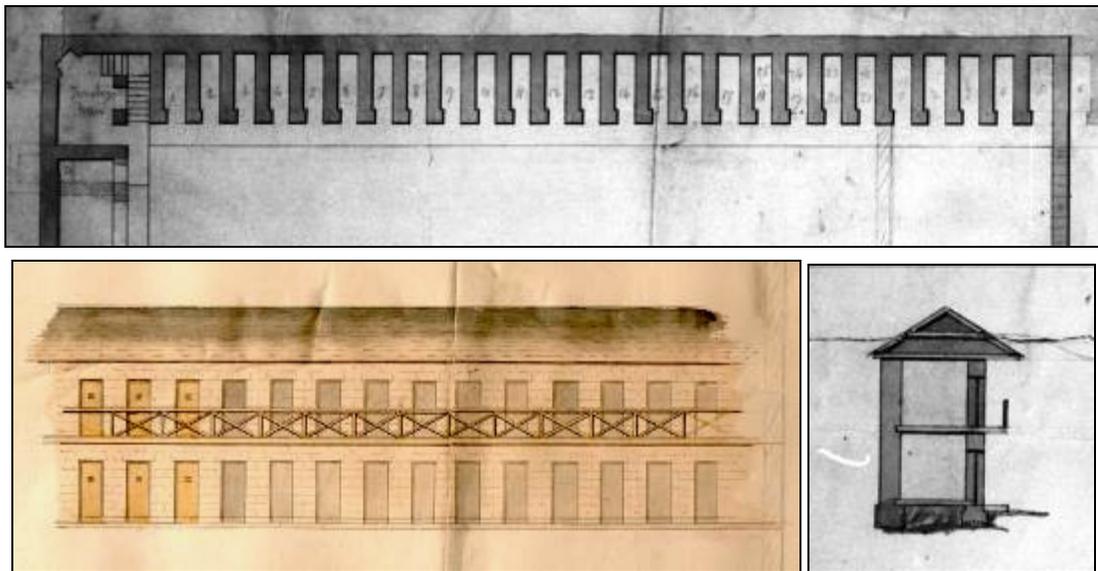
Figures 13.10, 13.11, and 13.12 – Plan, elevation (north) and section from John Lee-Archer's 1834 plans for the Men's Division at the Oatlands Gaol (AOT PWD 266/1555).

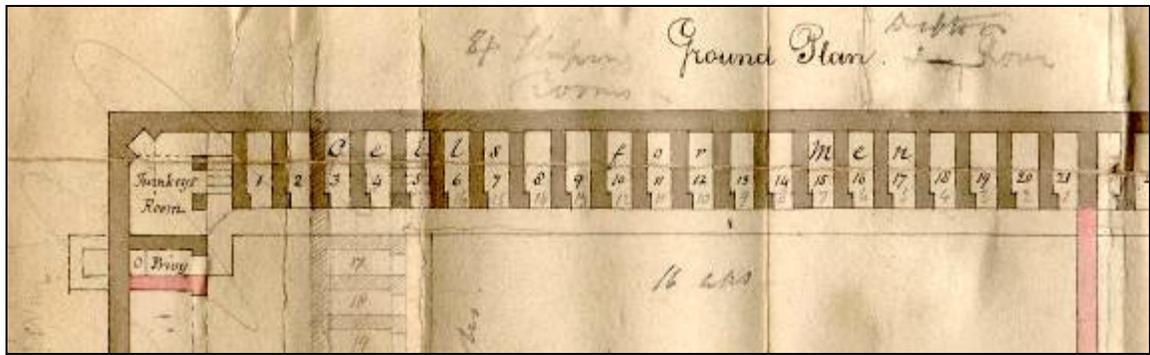
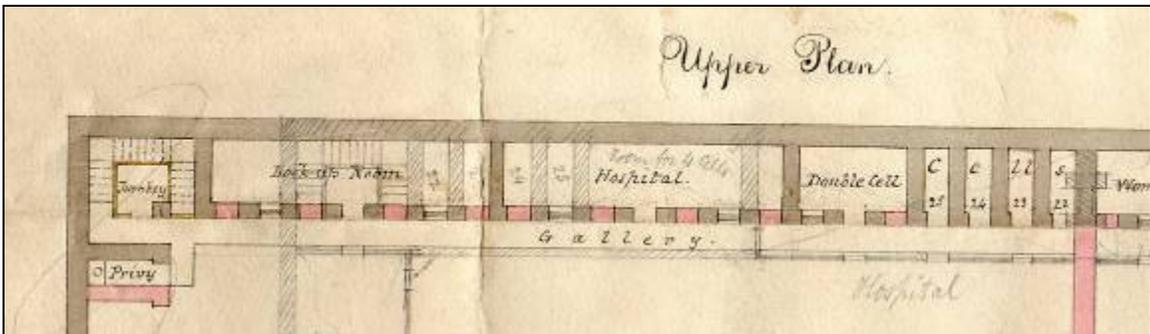
Figures 13.13 and 13.14 – Lee-Archer’s revision of the Ground and upper level plans of the Men’s Division, April 1835 (AOT PWD 266/1547, 1546).

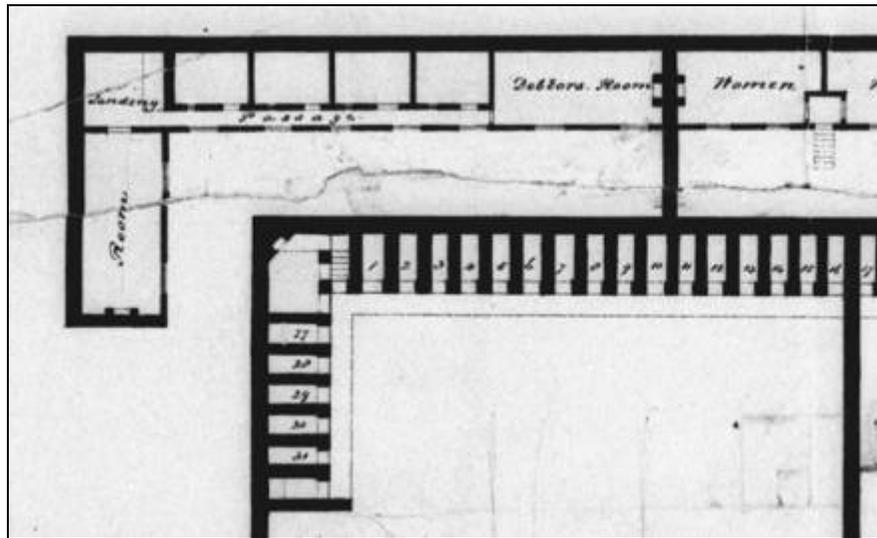
Figure 13.15 – Ground and upper level plan of the Men's Division, 1844 (AOT PWD 266/1550).

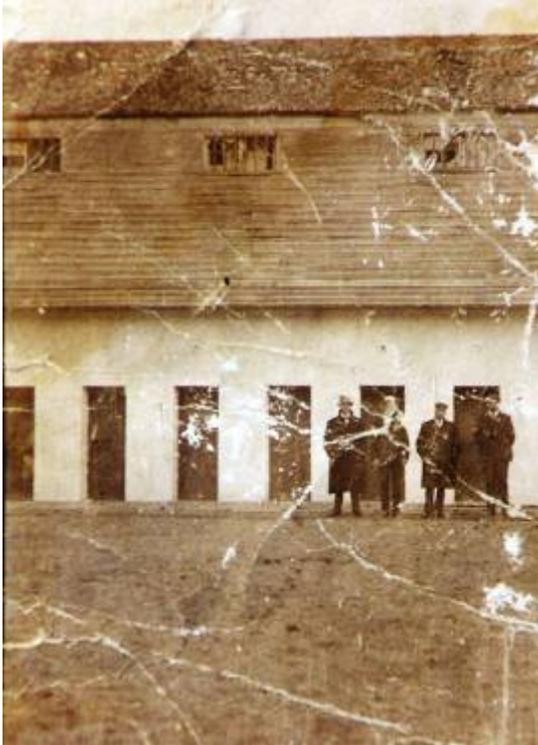
Plate 13.11 – The Men's Division and yard immediately in front (c1900). Reproduced with permission of Peter Fielding, Oatlands.

Apart from the various major structures contained therein (wells, gallows, condemned cells etc.), which are discussed separately throughout this section, there is little indication in historic documents as to the content and surface of the Men's Division yard. The best indication is in Plate 13.11, a c1900 photograph of the buildings which indicate a grassed yard with a flagged terrace immediately in front of the building, which is also evident in Plates 6.3 and 6.4. It is however possible that the yard was flagged or graveled, with the disuse of the complex prior to these photographs allowing growth to obscure the actual surface.

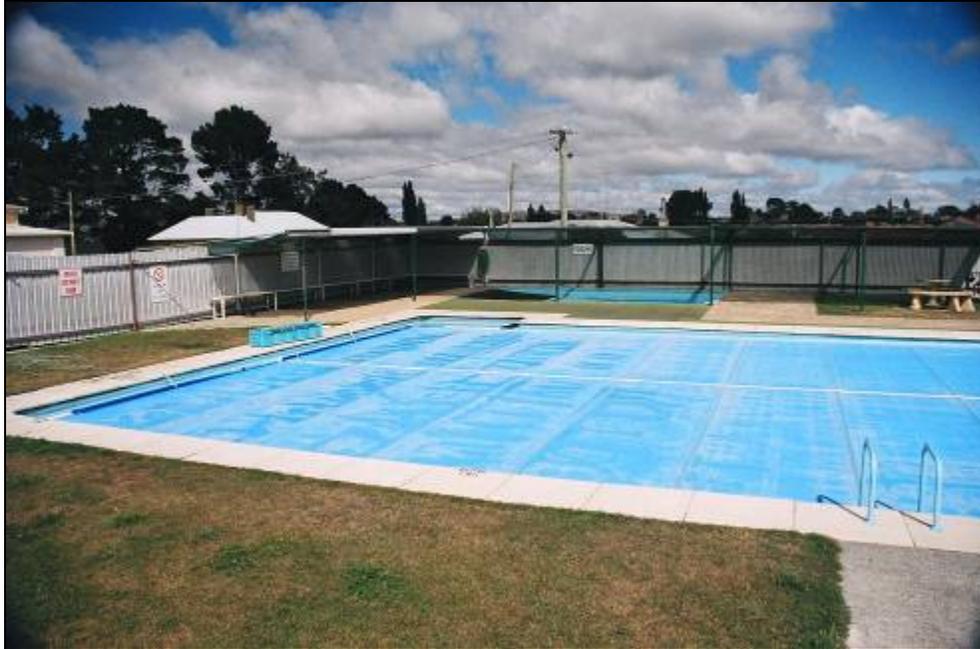
Plate 13.12 – A 2004 south-east facing view of the Men’s Division showing a similar aspect to that portrayed in Plate 6.4.

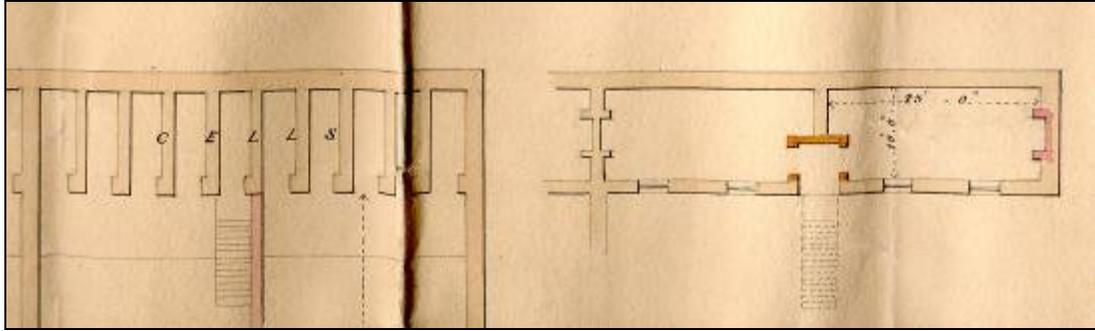
Figure 13.16 – Floor plans of the ground (left) and first floor in the Women's Division, 1855 (AOT PWD 266/1549).

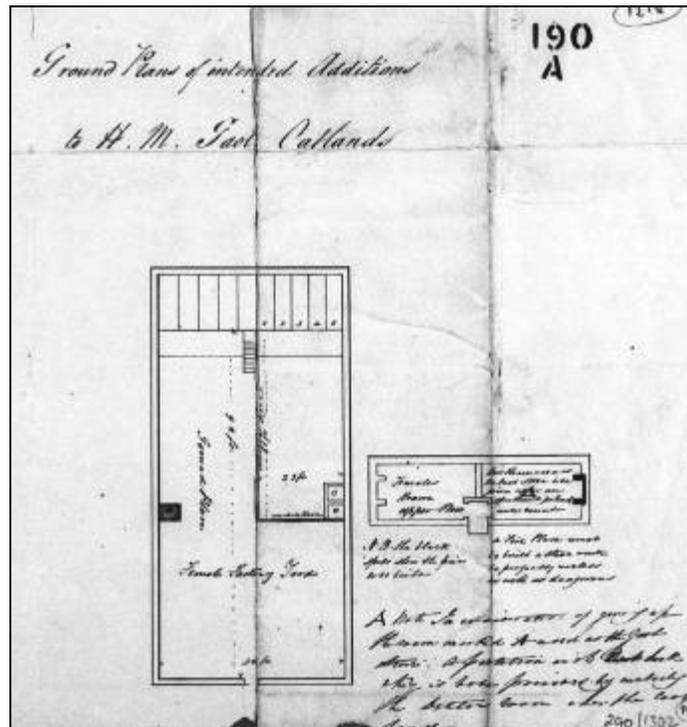
Figure 13.17 – Plan of the Women's Division c1855 showing the addition of a separate yard in the south-western corner (AOT PWD 266/1552).

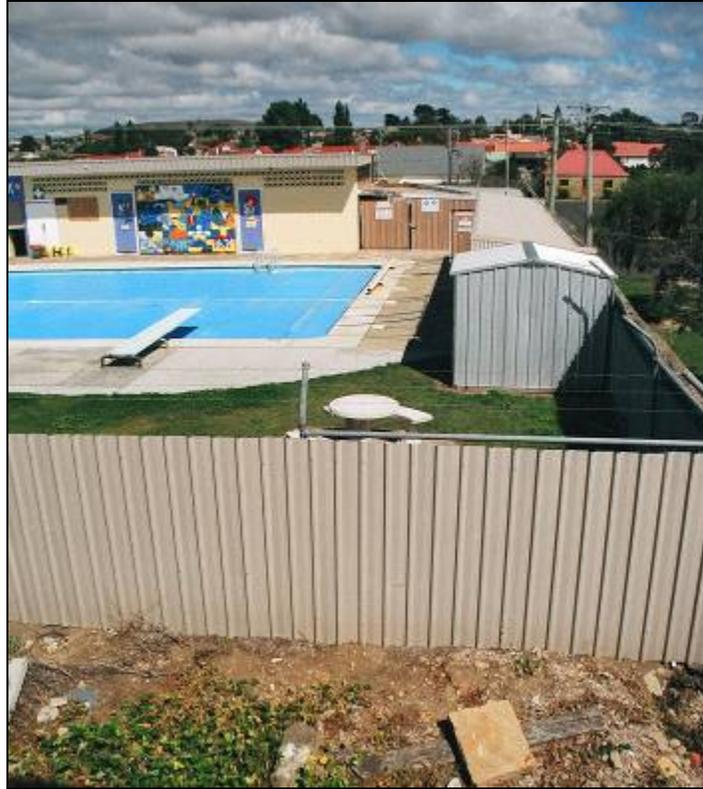
Plate 13.14 – A 2004 south facing view of the Women's Division, taken from the upper level of the Gaoler's residence.

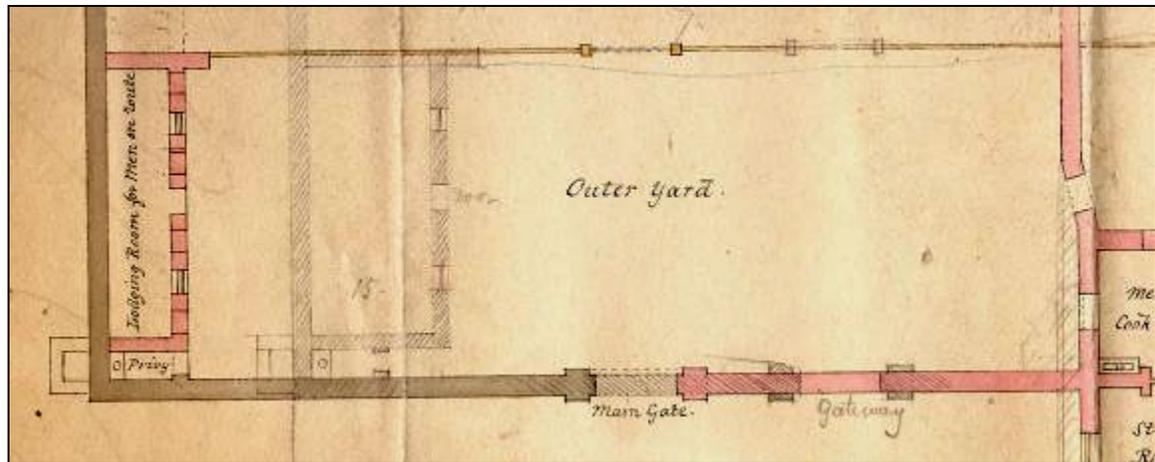
Figure 13.18 – The Javelin Men's Building and Outer Yard from Lee-Archer's April 1835 plan (AOT PWD 266/1546).

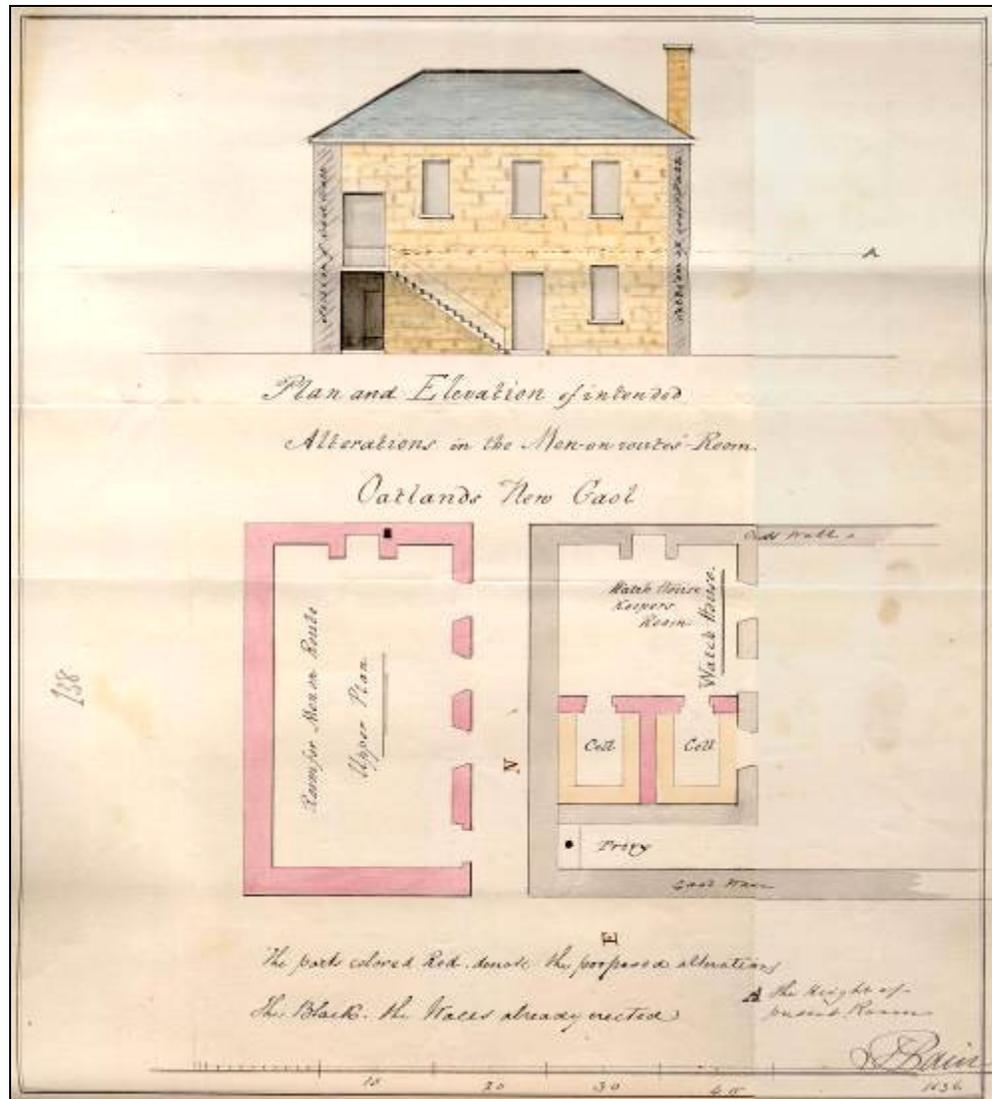
Figure 13.19 – Lee-Archer's plans for the conversion of the incomplete Javelin Men's Building into a watch-house, May 1836 (AOT CSO 1/691/15206:138).

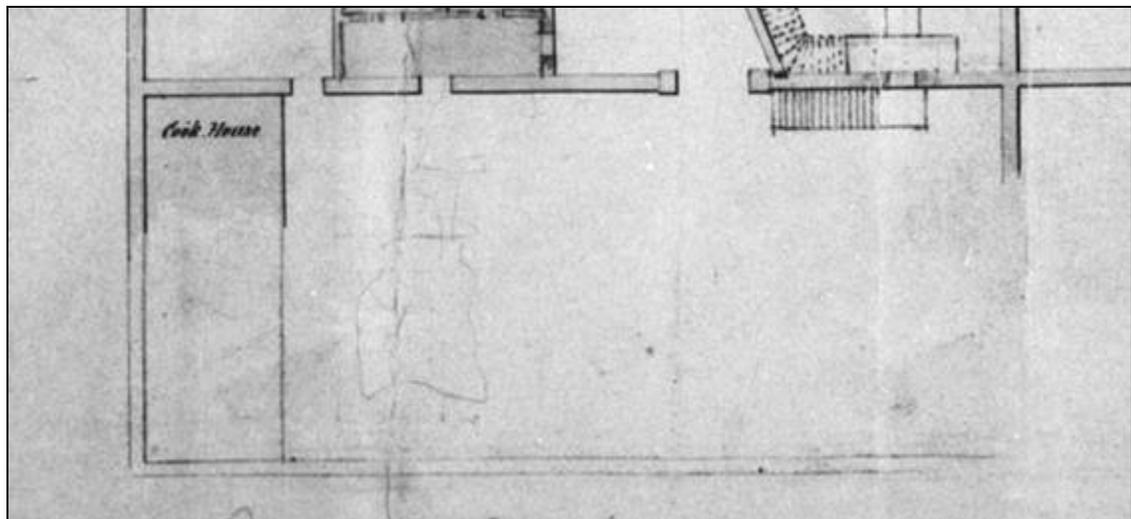
Figure 13.20 – The Outer Yard as depicted on an 1855 plan showing the added gates/doors and stairs (AOT CSO PWD 266/1449).

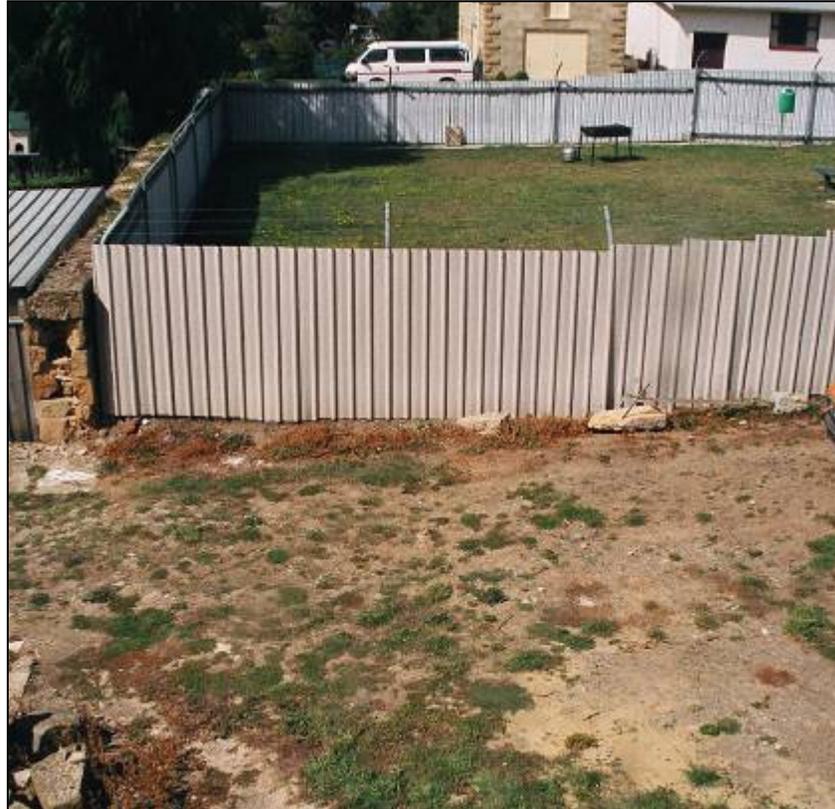
Plate 13.15 – A 2004 east facing view of the Javelin Men's/Outer Yard, taken from the upper level of the Gaoler's residence.

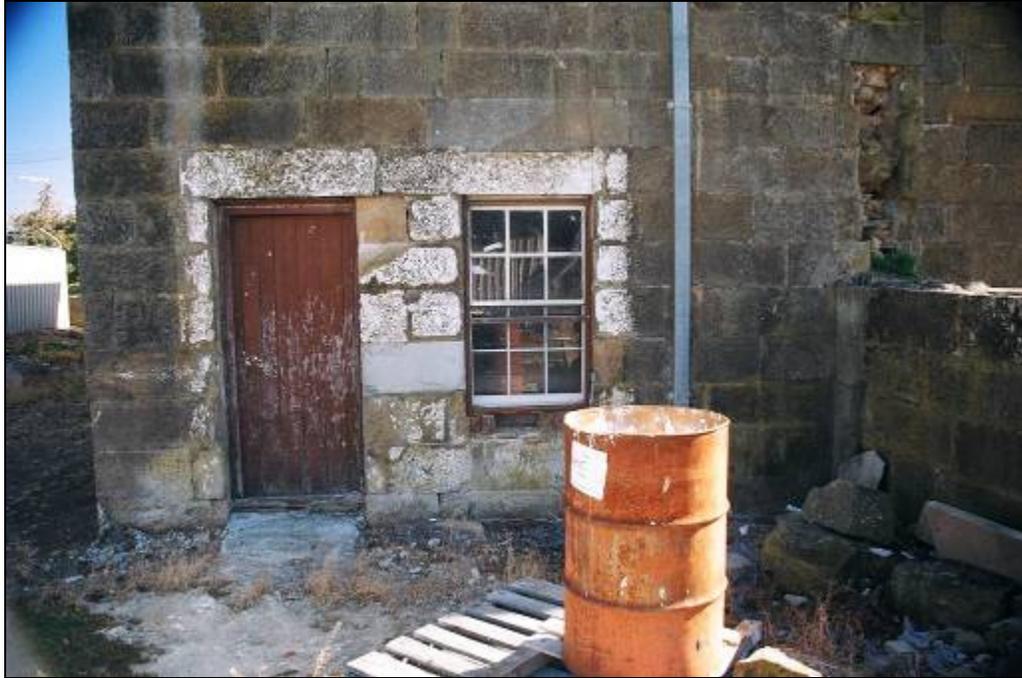
Plate 13.16 – Door leading from the eastern side of the Gaoler's residence (former men's kitchen) into the Outer Yard.

excavation. The 1938 plan of the site shows two water tanks in the north-western corner of the Outer Yard (Figure 7.1) and paint remnants on the eastern wall of the Gaoler's residence suggests that there was a porch over the eastern door of that building in the Outer Yard at some time (Plate 13.16). The current level of the Outer Yard is only slightly higher than the historic ground level and having been used for a long period as a domestic backyard, would probably yield little archaeological potential.

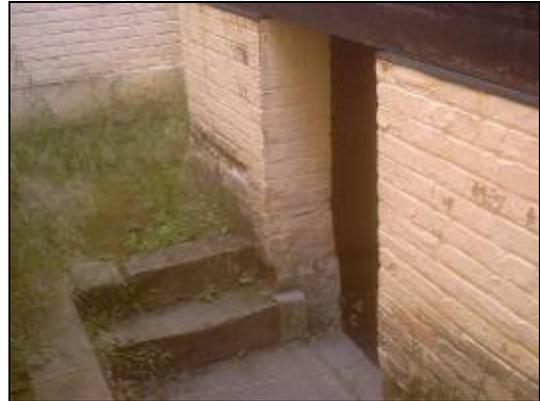
Plate 13.17 – Steps leading to the semi-basement of the Hobart gallows

Insight into the expected form of the gallows is best gained through an examination of the only extant contemporary gallows in Tasmania, those in the old Hobart Gaol in Campbell Street. These are housed within an open fronted timber structure, approximately 3 metres square, which an upper platform housing the beam and trapdoor, which is accessed via a raised walkway leading from another (viewing) platform. To the rear of this building are steps leading to a semi-basement into which the executed would fall upon release of the trap-door. The plan view of these gallows is very similar to that shown in Figure 13.18, so the archaeological remains of the Oatlands gallows may be hypothesized from the semi-basement of this

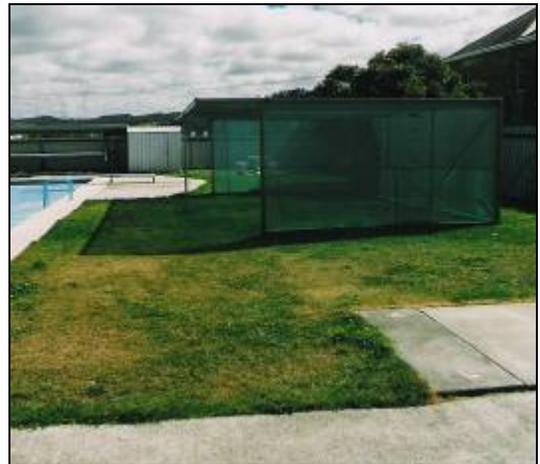
Plate 13.18 – The location of the Well/Gallows Yard in the 2004 pool complex (facing west).

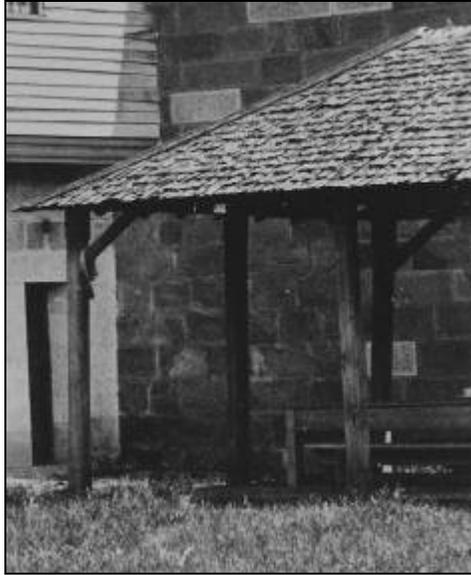
Plate 13.19 – Part of the open timber shed in the Debtor's Yard. Photograph – State Library of Tasmania.

At the same time that the Well and Gallows Yard were divided from the Men's Yard, another wall was added, to run from the south-east corner of the Gallows Yard to the northern wall of the southern wing of the Men's Division, enclosing an open shed, sometimes referred to as the Debtor's Yard. Plans from 1883 (AOT PWD 266/1564, Figure 5.10), and photographic evidence from the 1890's show that this wall had been removed by that time, with a scar being seen on the wall of the Men's Division (Plate 6.3). The only known structure within the Debtor's Yard was an open timber shed with a shingled roof, apparently with a flagged floor. This shed first appeared on Shields' 1883 plan of the site (Figure 5.10 and part of which is seen in the 1880's photograph of the Men's Division - Plate 13.19).

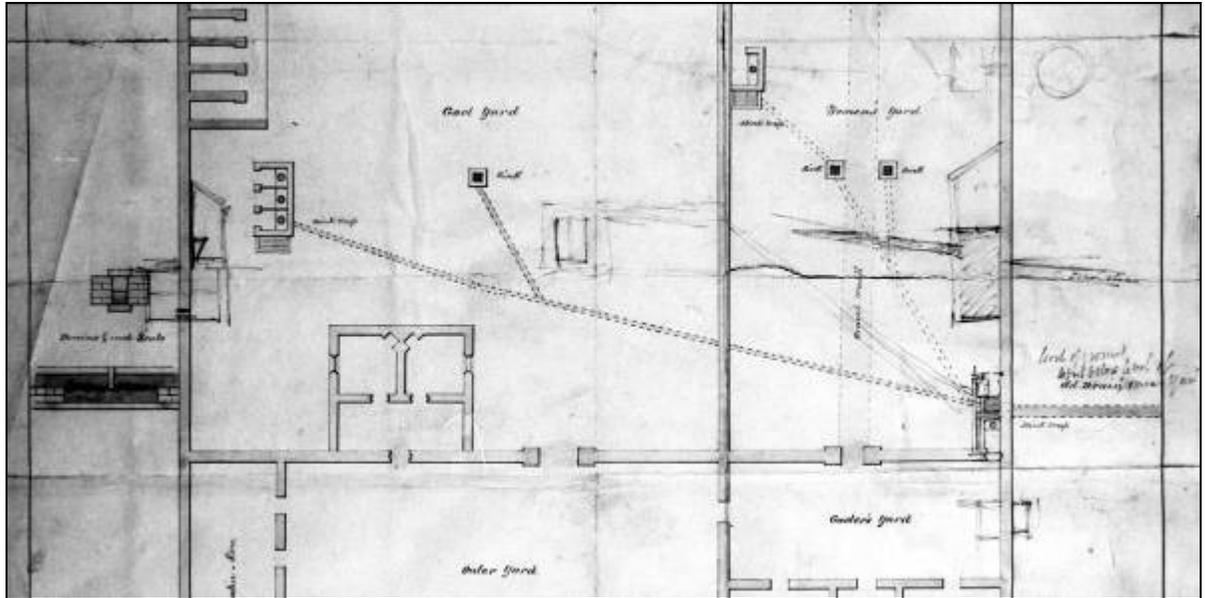
Figure 13.24 – Drainage system, privies, well and sinks as depicted on PWD 266/1548, circa May 1849 (just before alterations).

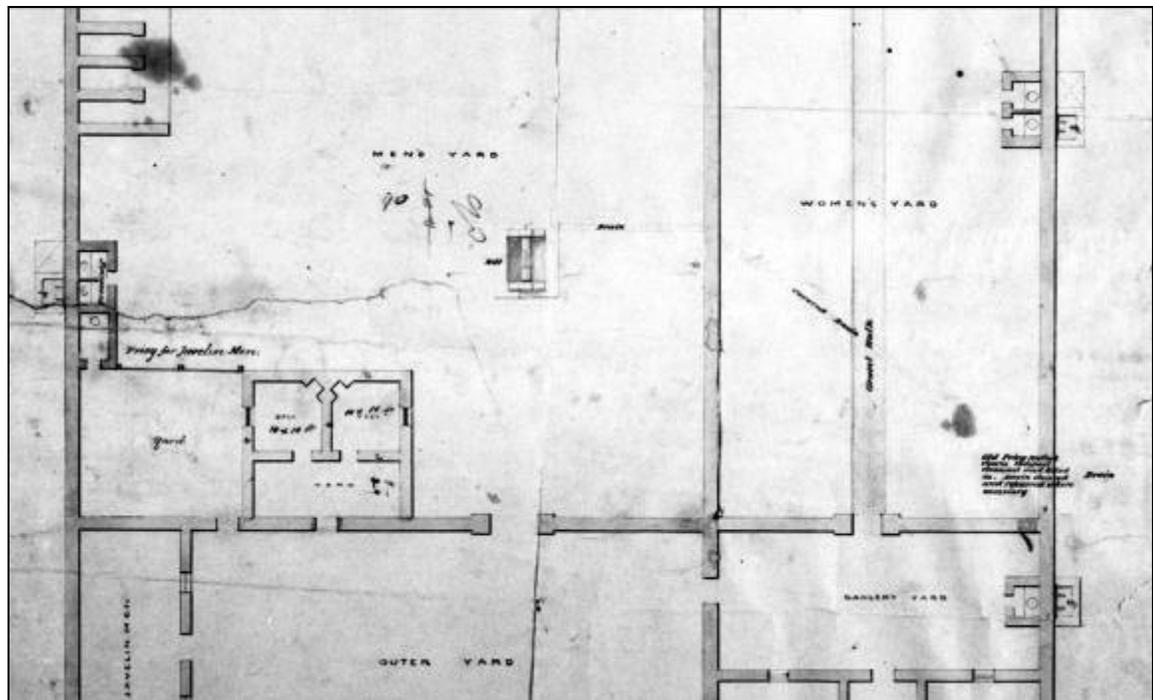
Figure 13.25 – Detail of drainage system as depicted on PWD 266/1551, June 1849, after the alterations were made.
