**Oatlands Gaol Historical Study  
&  
Archaeological Survey**

**SOUTHERN  
MIDLANDS  
COUNCIL**

Prepared by Brad Williams  
For the  
Southern Midlands Council, Tasmania  
May 2004

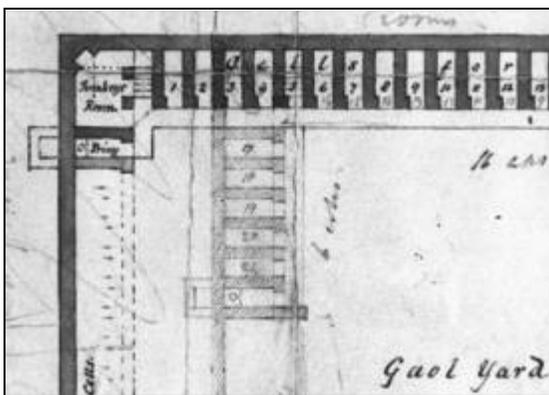
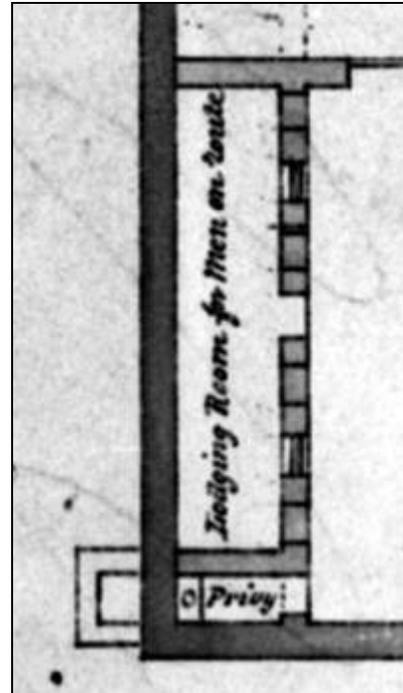
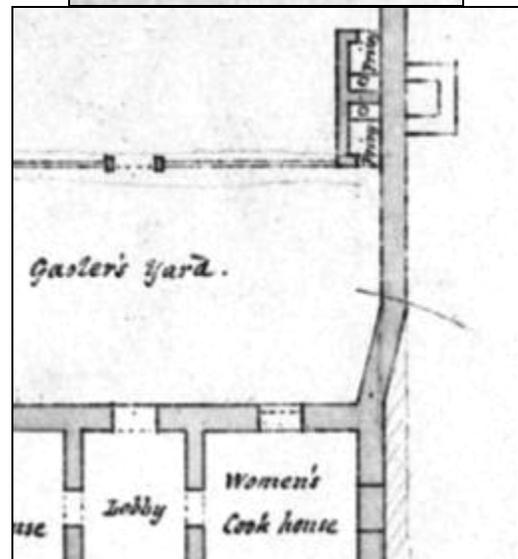
Figures 13.26, 13.27 & 13.28– The intended locations for privies on Lee-Archer's second gaol plan, April 1835. The men's privy (Figure 13.26, top) was never built in that location. The Gaoler's/Women's privy (Figure 13.28, bottom right) was slightly to the east of this plan when the western wall of the gaol was built straight and it is uncertain whether the Javelin Men's privy (Figure 13.27, bottom left) was built in that location (AOT PWD 266/1547).

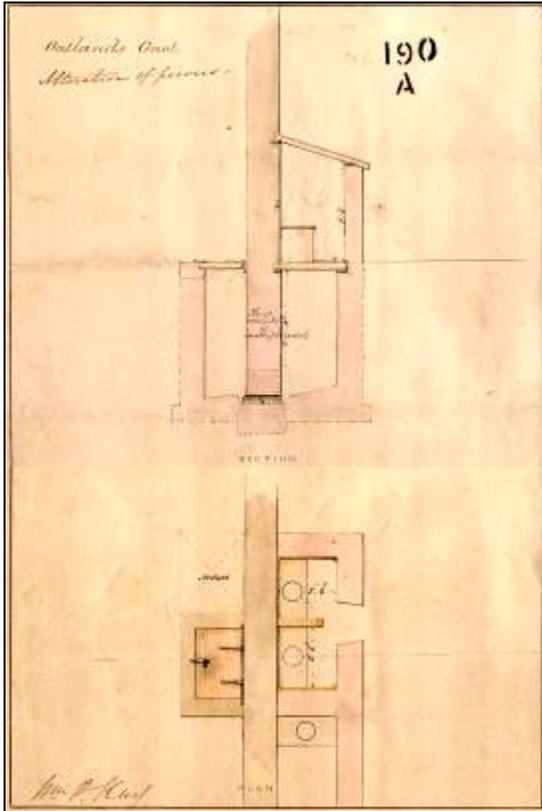
Figures 13.34 & 13.35 - The Oatlands privy buildings were much inferior in their design and security to contemporary buildings (see Plate 13.20) as evidenced by plans for the buildings housing them. These plans demonstrate that the buildings in which they were contained were only 2.1m high and were attached to the outer wall – lessening the effective height of the outer wall. (AOT PWD266/1562, CSO 24/74/2320:49).

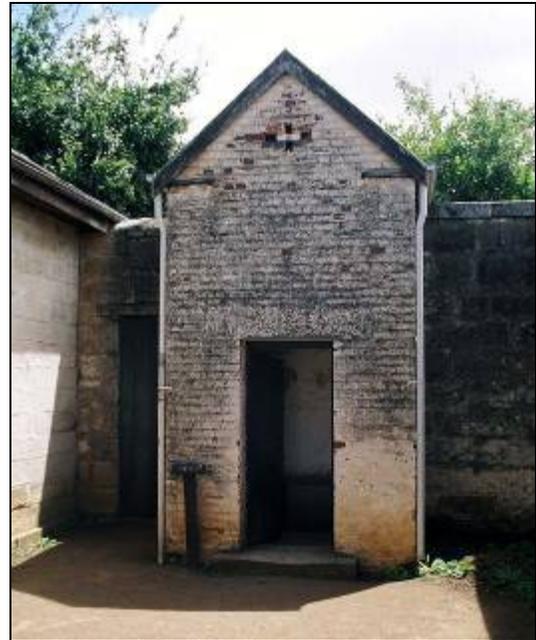
Plate 13.20 – Privy at the Richmond Gaol showing the building to be the same height as the outer wall, lessening the security risk of a building attached to the perimeter wall (see Section 4.3).

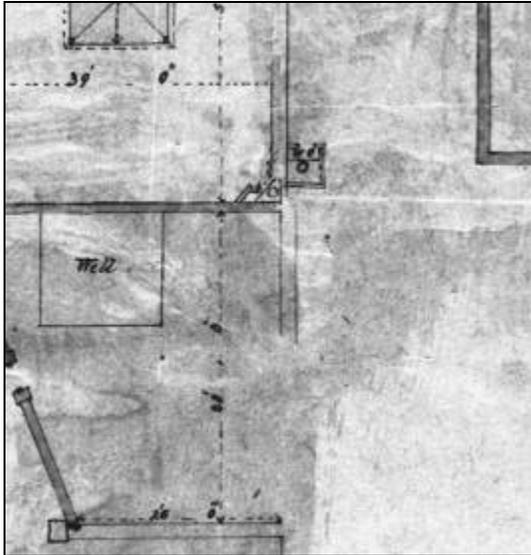
Figure 13.36 – Additional privies in the men's and women's yards shown on plans c1855 (AOT PWD 266/1553).

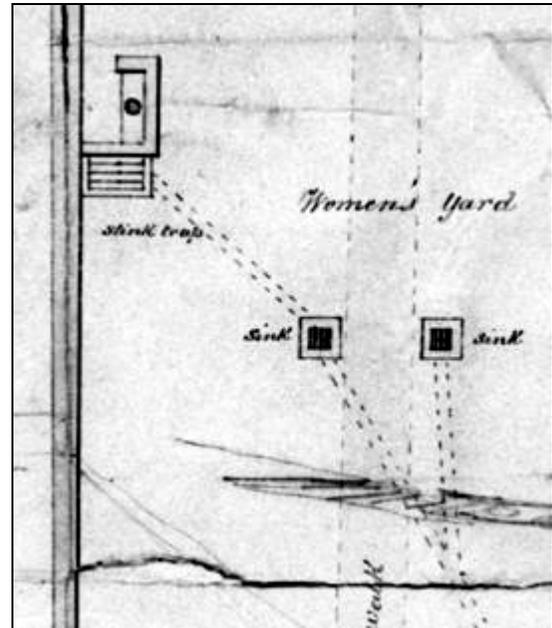
Figure 13.37 – Detail of sinks, grilles and sink-traps as installed in the women's yard. The construction of the pool would certainly have destroyed the easternmost two (left and centre) of these, however, archaeological trace of the other (right) may remain (AOT PWD 266/1548).

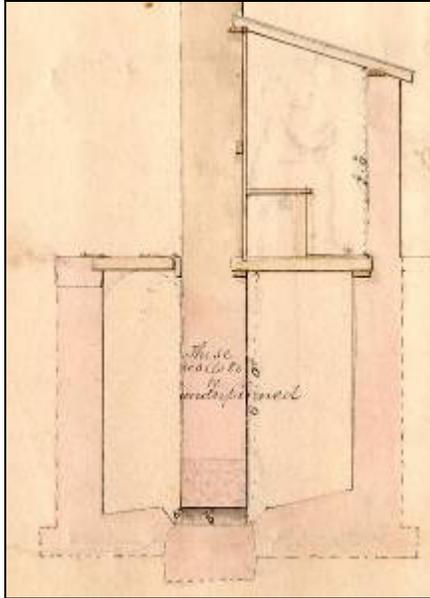
Figure 13.38 – Detail of cesspit depth demonstrating the need for underpinning (AOT PWD 266/1562).

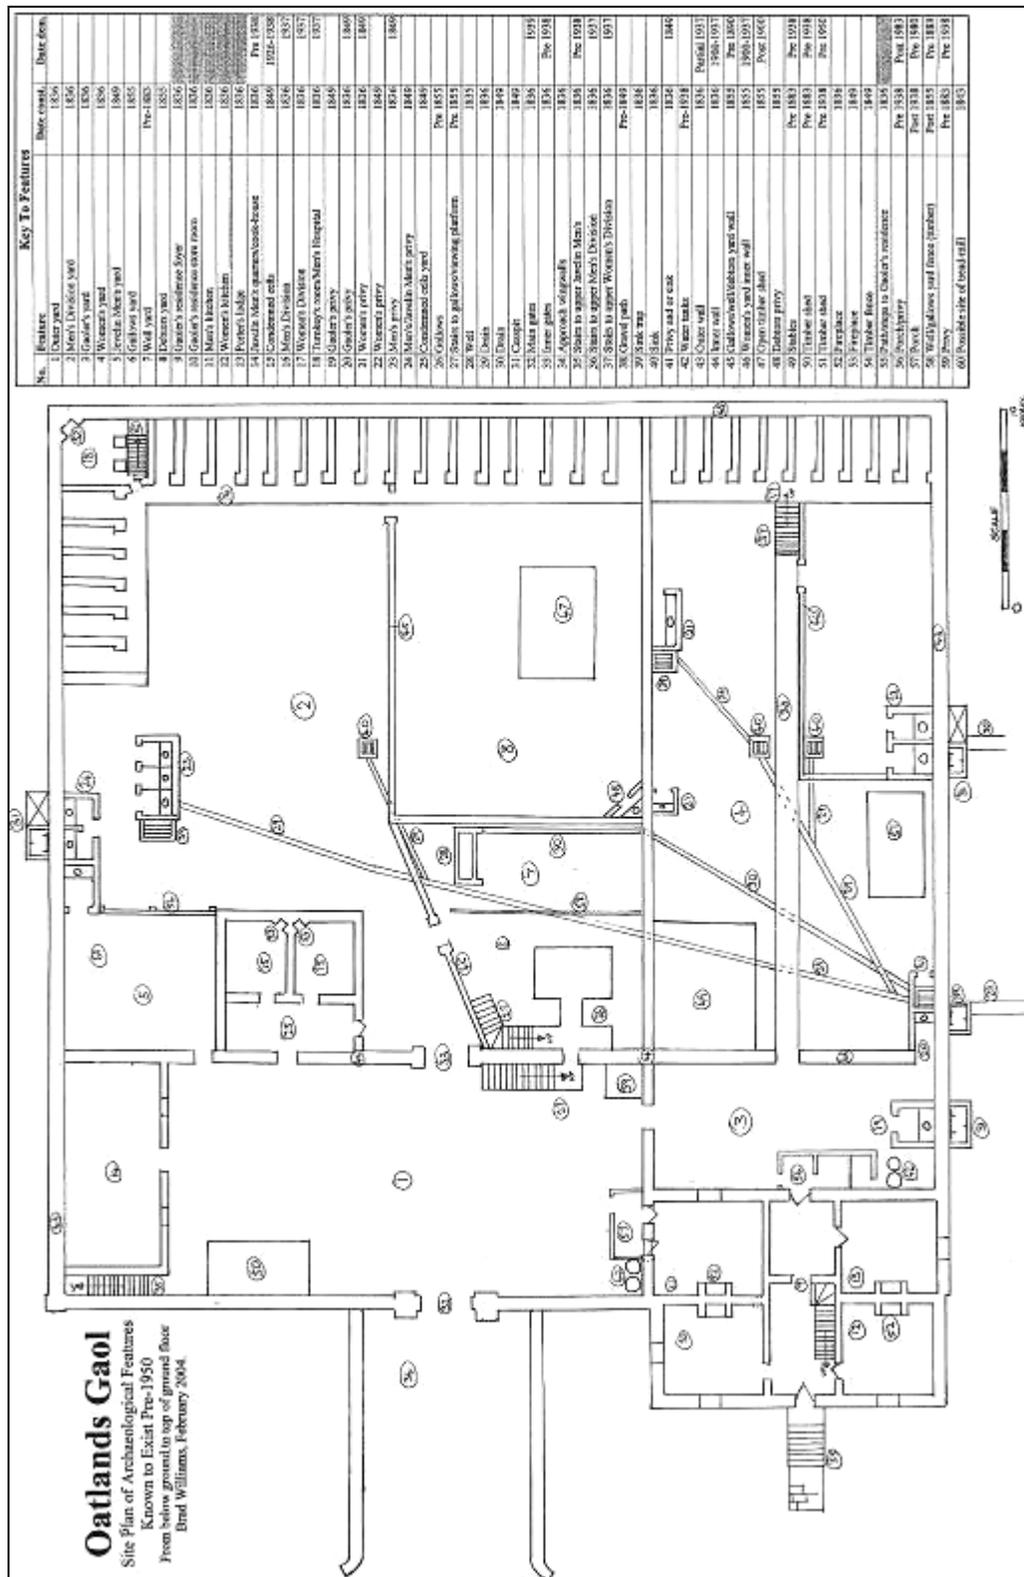
Figure 13.39 – Master archaeological plan of known site features pre 1850, Oatlands Gaol (See also Appendix A).

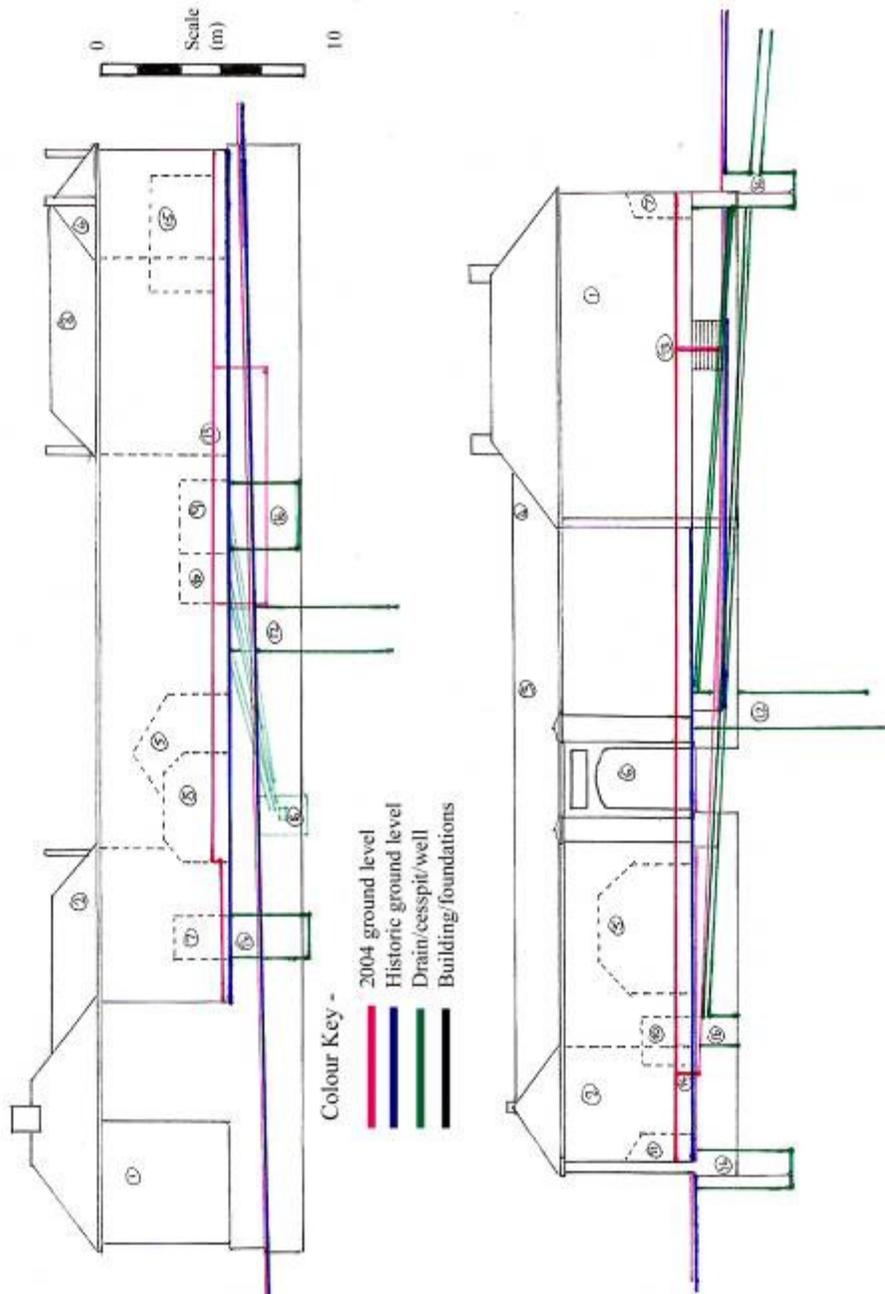
- Feature Key -
1. Gaoler's Residence
  2. Javelin Men's Quarters
  3. Men's Division
  4. Women's Division
  5. Condemned Cells
  6. Main gates
  7. Gaoler's privy (1849)
  8. Gaoler's/women's privy (1835)
  9. Women's privy (1849)
  10. Men's privy (1835)
  11. Men's privy (1849)
  12. Well
  13. Pool - deep end
  14. Pool - shallow end
  15. Pool amenities block
  16. Cesspit
