Oatlands Gaol Remedial Works Report 2004

Barry and Eleanor Bjorksten 2004.

Remedial Works Report 2004

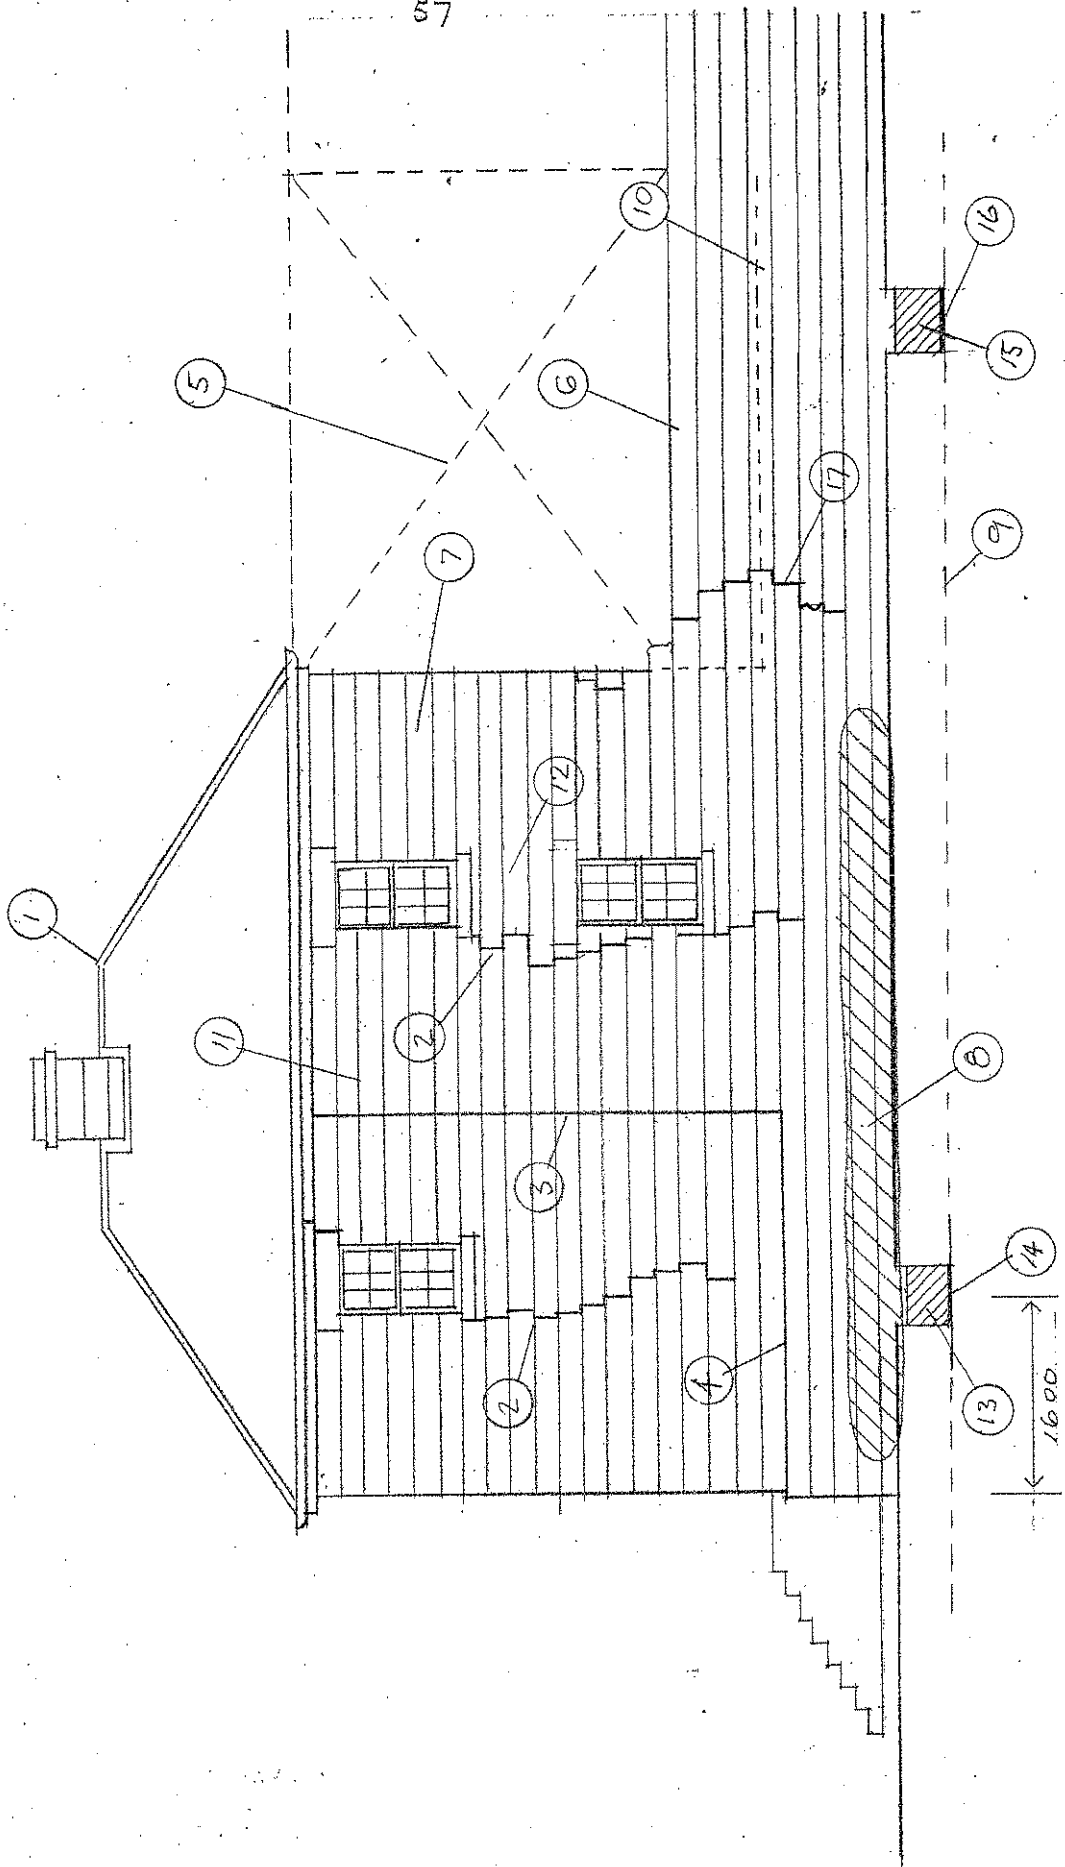
Crack following joints & Crack across stone blocks

- Install recycled blocks and wire bed joint ties at the NW corner in accordance with Detail 22 (P 78) Make good corresponding internal cracks..
- Install a pit at a point 1600mm back from the NE corner and drain to the street storm water pit to remove water from under the building. Confirm location by flow of water through the footing.

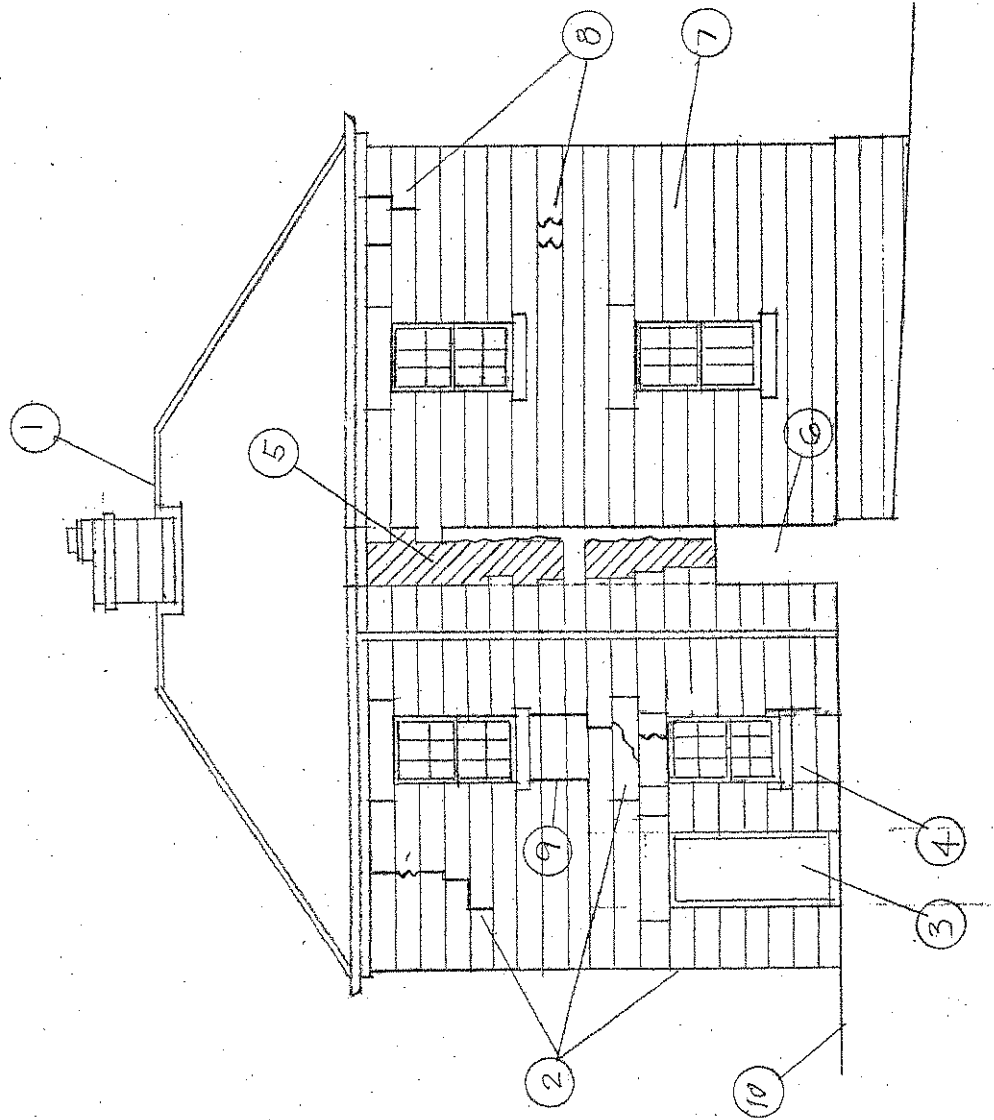
Crack across stone block

- Install recycled blocks and wire bed joint ties as shown in Detail 24 (P 82).
- Make good cracks following joints.
- Make good pointing loss including removing loose pointing.
- Prop and insert new lintels to doorway and window. Refer Detail 21. Build in a steel angle below the lower window lintel. (P 77)
- Rebuild sandstock brick window sill.
- Do whatever other improvements are found upon investigation to be necessary to adequately stabilize and make safe the lower part of the SW corner.
- Re-build portion of gaol wall as per Detail 24 (P 82).
- Make good internal cracks corresponding to external work.
- Make good remnant east wall and entrance wing wall. Refer Detail 32 (P 90).

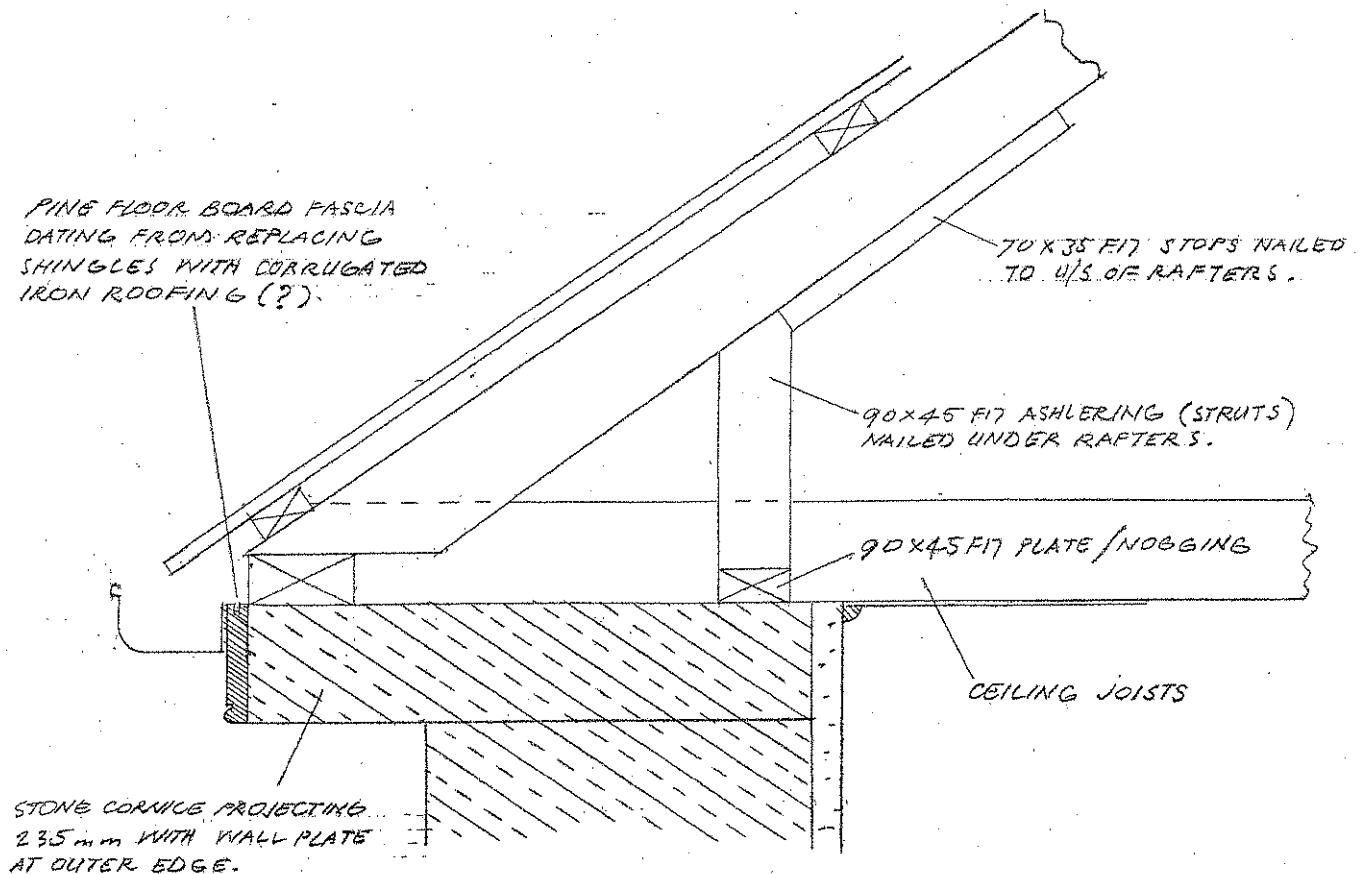
DETAIL (12) SOUTH EAVE WITH ASHLERING Scale 1:10

For 167 years rafters pitched from beyond the face of the south wall have not moved the stone cornice one scrap, but it is an inherently unstable situation and will move if the existing conditions are changed in some way. To add certainty to this detail roof load should be directed onto the inner part of the wall by the addition of ashlering. Refer to CEILING FRAMING & ROOF STRUTTING PLAN as originally constructed (P 38).

- Re-establish full structural continuity at the SW hip apex by propping the top of the hip rafter to the correct height (off the chimney breast) and wedging tight in the apex.
- Provide ashlering along the north half of the south wall (Detail 12, P 72).

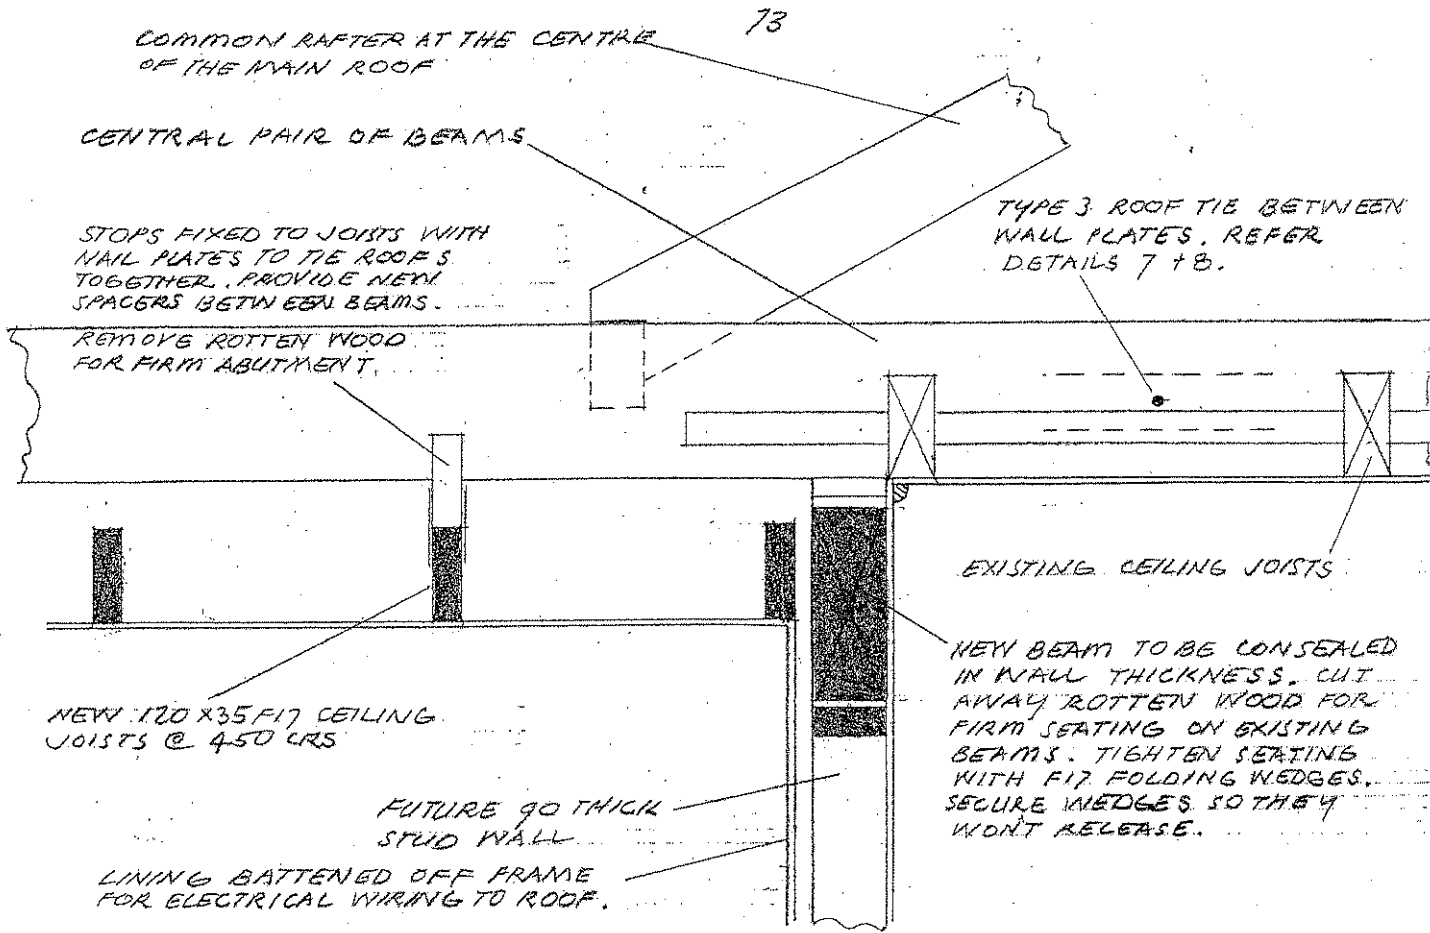
DETAIL (13) NEW SUPPORT, CENTRAL PAIR OF BEAMS Scale 1:10

It is likely that the size of the central pair of beams was determined on the basis of a 4700mm span east of the central N-S masonry wall. Lee Archer's plans show a passage on the first floor formed on the west side of the masonry wall by a timber stud partition. The masonry wall at this passage was not built thereby increasing the span by 29%, most likely causing the beams to deflect under their own weight and some alarm to the carpenters as the beam which shows the greater deflection has an iron collar around its scarf joint, presumably to close the crack along the centre line. These beams were most likely installed green and the collar positioned at the same time as there is a gap of some 12mm, probably representing timber shrinkage, between the timber and the top of the collar. Refer Detail 5. (P 69) At a later date, possibly in the 1940's when the gaol was used as an army base, the masonry cross-walls to the west of the central N-S masonry wall and the timber partition were removed to make one big room. The ceilings were re-supported by providing hangers from the roof and a new stud wall was built in line with the central N-S wall to support the pair of central beams. With increased span and additional load the western half of the beams deflected (as did the top member of the stud wall) allowing the valley rafters to drop. As the hip apexes were held up by the long diagonal struts, one valley rafter fell right out of the apex and the other broke its back. In addition long term leakage from the box gutter has caused extensive rotting of the beams, spacers, joists, etc, seriously impairing a scarf joint and reducing beam size to an effective 170 x 70mm, or even less. Refer Details 1 and 3. (P 66, 68)

- Install hanging beams. Install battens over the joists if they remain wobbly after installation of the hanging beams.
 - Install Type 3 roof ties.
 - Install new beam under central pair of beams.

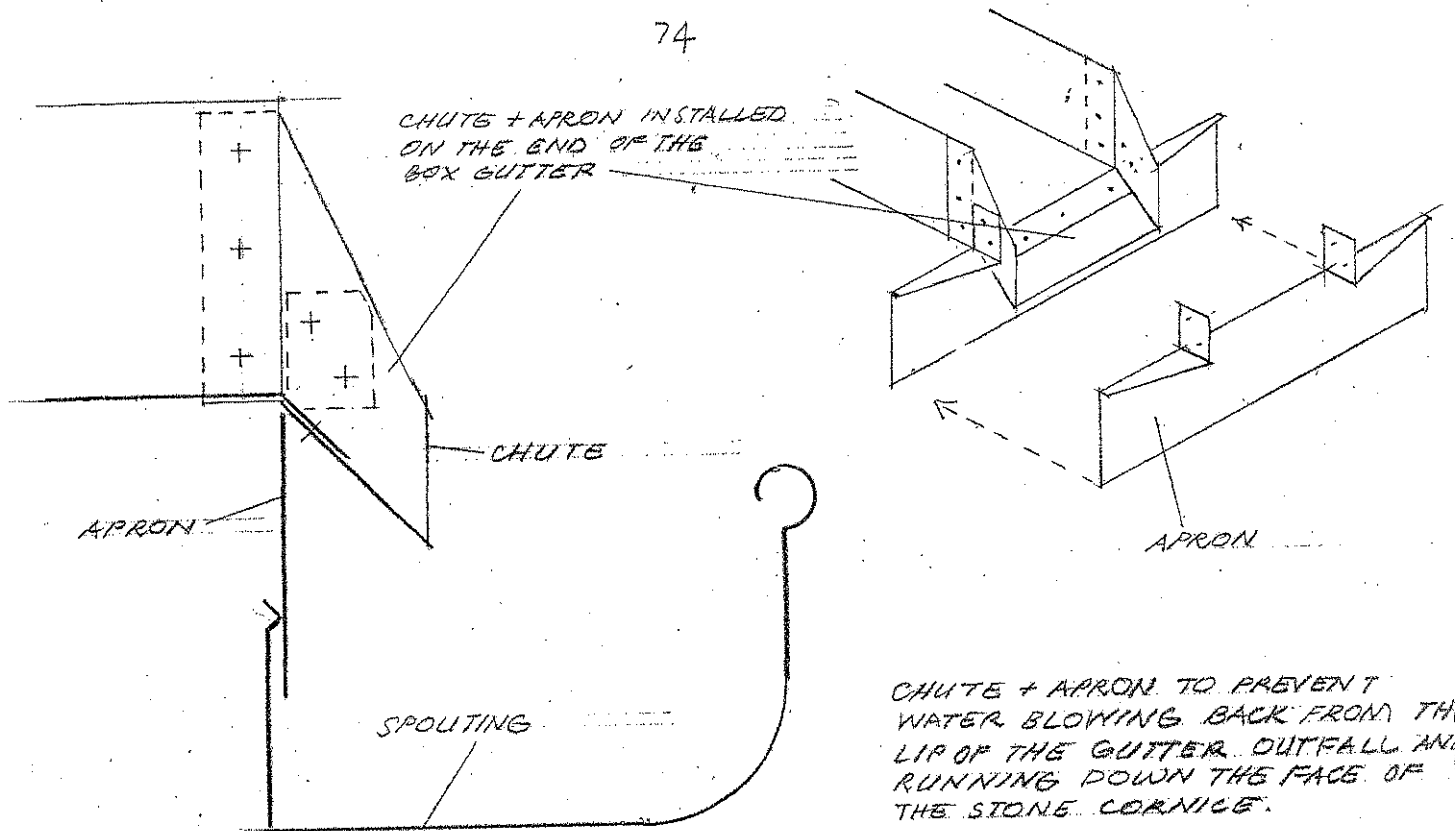
DETAIL (15) BOX GUTTER OUTFALL IMPROVEMENT. Not to scale.

It is assumed the rotting of the original beams will cease once the present gutter leak is fixed. However, if ultimately the ceilings are insulated to render the building more useable the insulation material should be kept back from these beams to allow the free flow of warm roof air around them, and a vapour barrier should be installed between the ceiling and the insulation to avoid condensation. New spacers are to be installed between the beams where the existing ones are rotted and the gutter board re-set to fall to the outlet.

- Fix spouting leak at NE corner.
- Fix box gutter leak.
- Improve box gutter outfall – see detail 15 (P 74).
- Set box gutter to fall to outlet.
- Provide lead cap to rear hip apexes.
- Provide new lead apron and cover flashings to the chimneys.
- In view of the limited life of the existing roofing some work must be re-done after only a short time when the roofing is replaced. Install new galvanized roofing and cappings, spoutings, down pipes, gutter and concealed bird proofing as a complete, unified and compatible system.

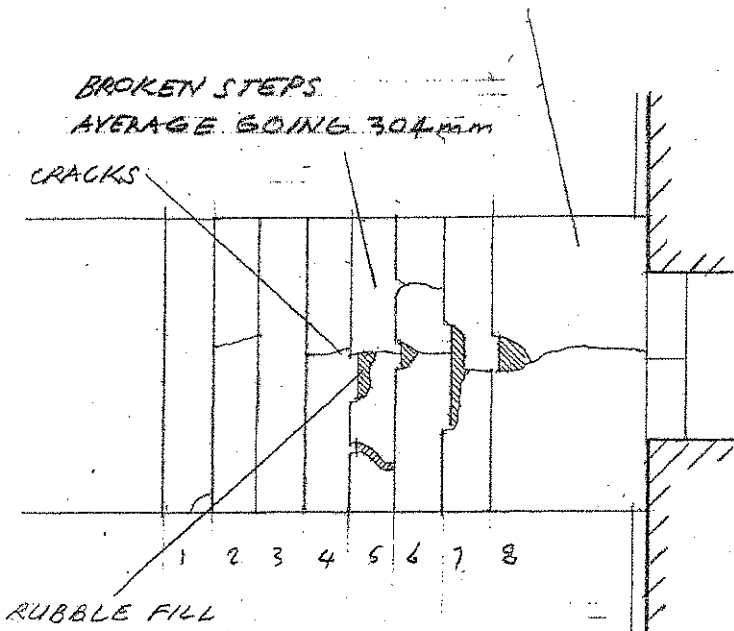
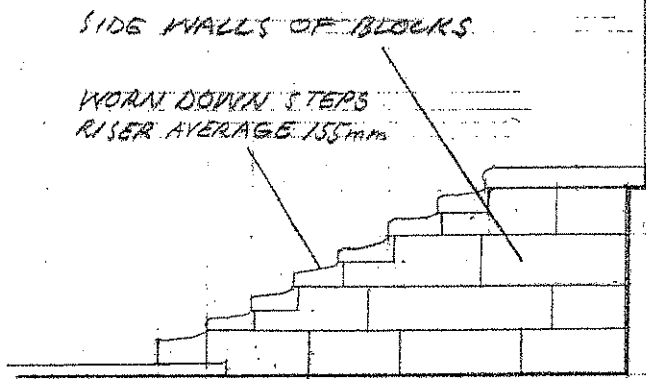
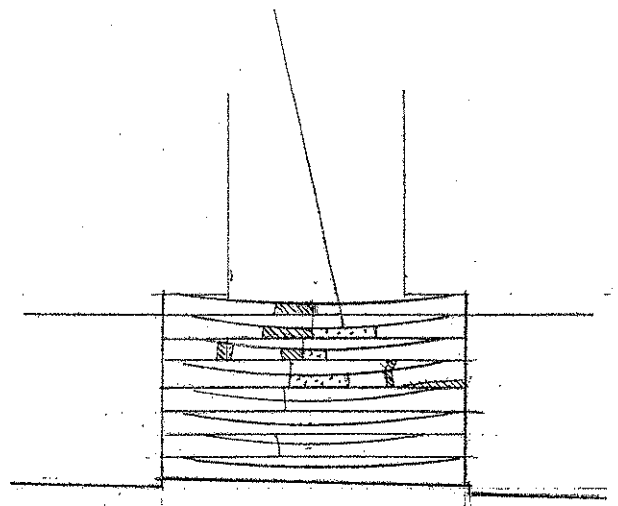
STEPS WORN DOWN TO AN AVERAGE OF 45 mm AT NOSING.

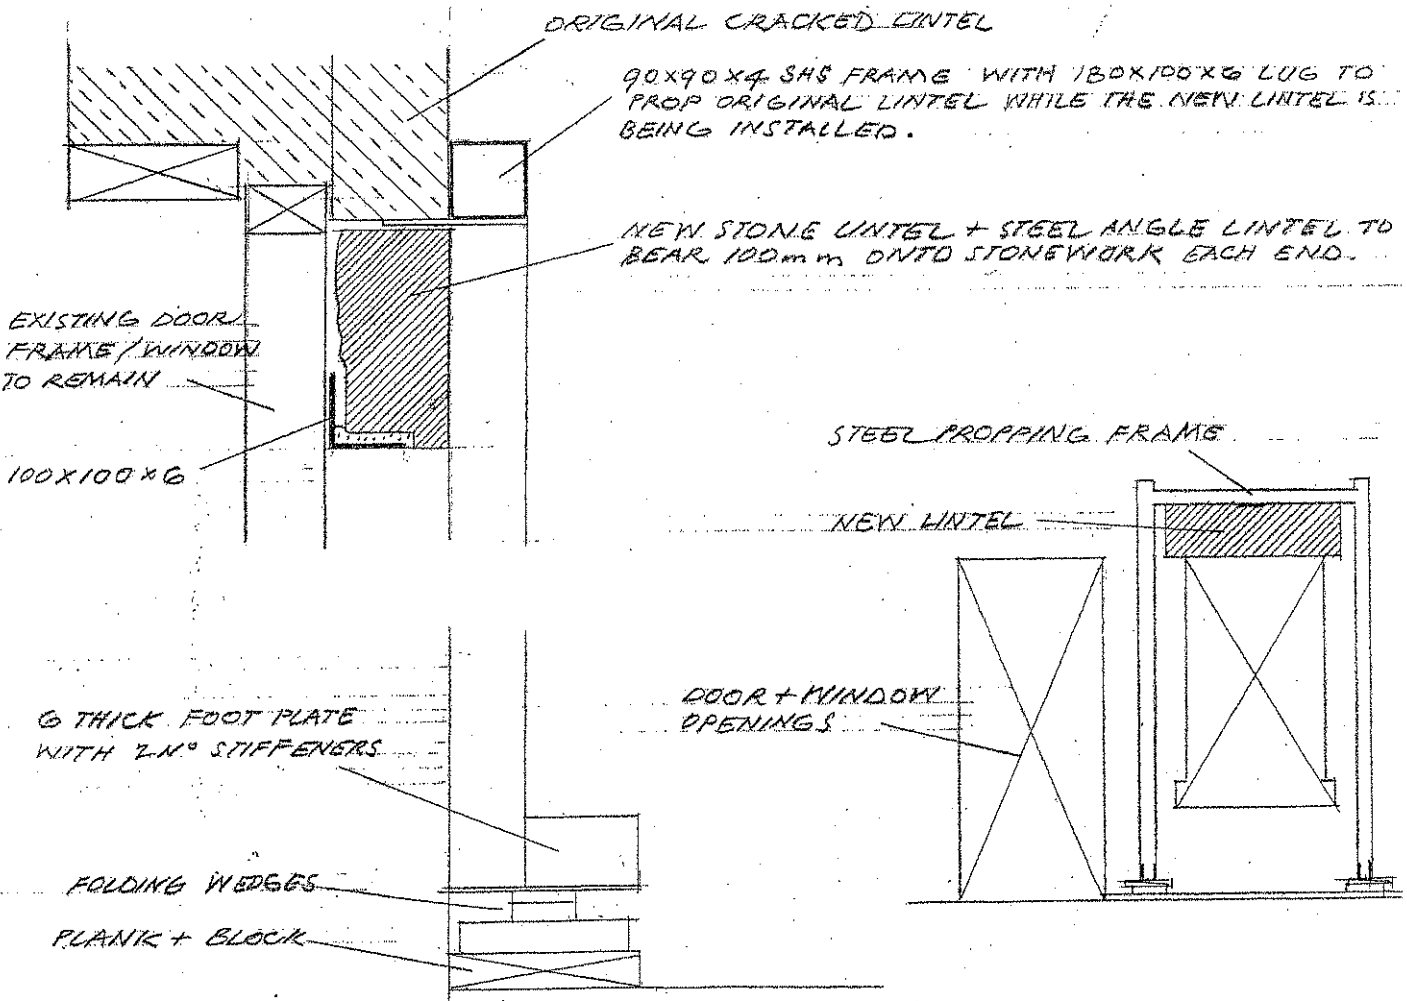
ORIGINAL CRACKED LINTEL

90x90x4 SHS FRAME WITH 180x100x6 LUG TO PROP ORIGINAL LINTEL WHILE THE NEW LINTEL IS BEING INSTALLED.

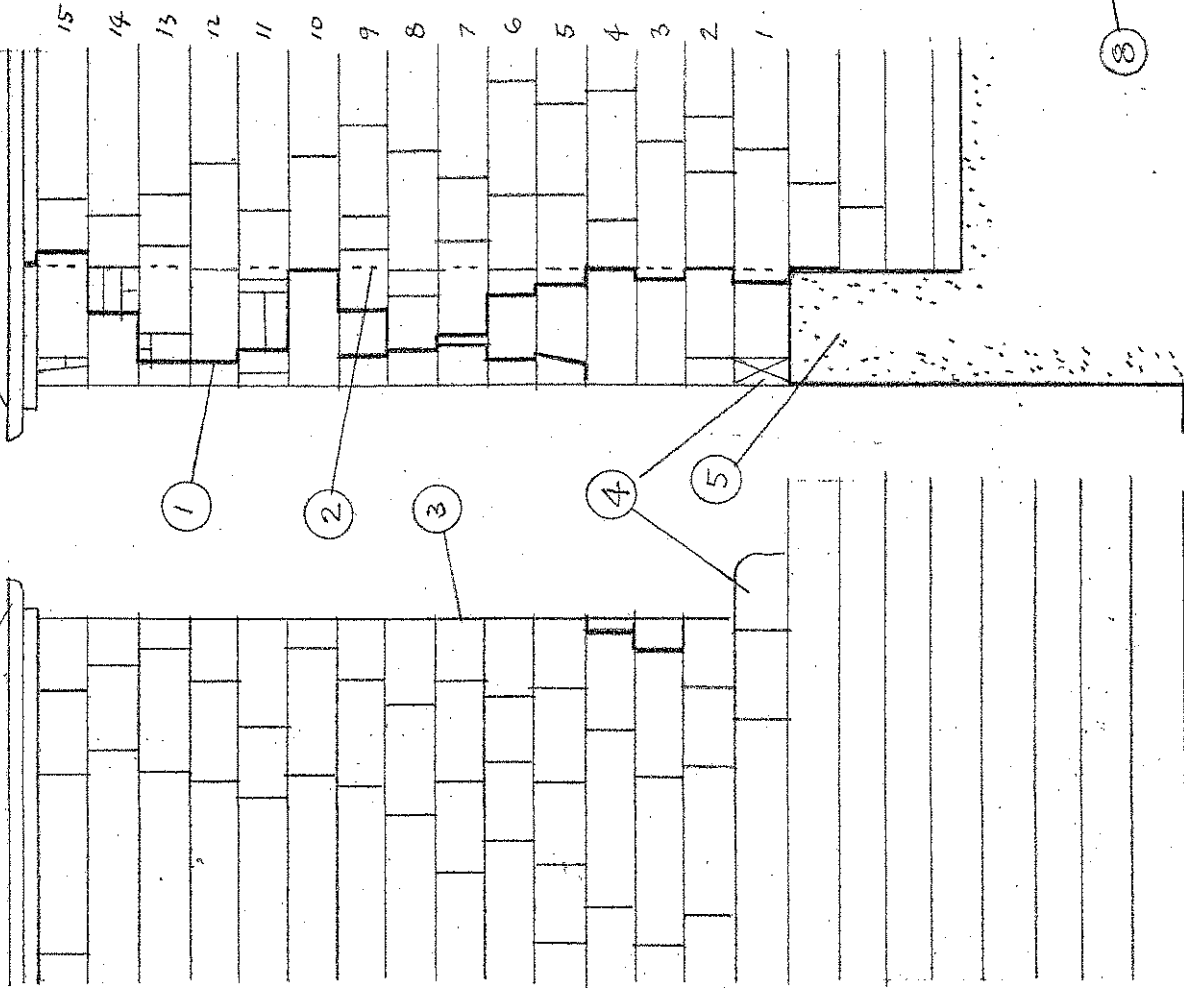
1. Internal and external cracks possibly due to southward movement of the roof.
2. Area of wall where blocks have been cracked possibly due to the failure of stonework at door head height.

3. Line of removed gaol wall.
4. Crack along a line of poor bond allowing a 7 course section of wall to bow southward.
5. Ends of stretcher blocks and quarry waste core illustrating the wall construction. Gaol wall thickness 510mm the same as the residence walls.

6. Internal and external cracks indicating a westward movement probably due to spreading of the roof.
7. Line of inner face of the west wall and the first floor floor.

8. Internal cracks including through a stone lintel and an area of stonework bulging inwards and showing signs of crushing.
9. There are no through stones either side of this doorway which was cut in after the wall was built.

10. Stacked perpend in line with window reveals and reveal headers below the window. The original intention could have been a doorway, as was shown on Lee Archer's 1835 plans. The lack of proper bond prevents the stonework arching over the lower opening thereby increasing load on the lintel below. Internal cracks match the stacked perpend.

11. Flaw or crack in the original window lintel.
12. An additional rough lintel with only 50mm bearing presumably added to reinforce the defective lintel and cracked right through, the result of improper bond above. Although the original lintel has flexed enough to crack the lintel below it appears to be carrying the weight of the stonework above.

13. Original door reveal. (?)
14. Remains of sandstock brick-on-edge sill.
15. Gaol wall removed leaving quarry waste rubble core exposed to the elements. Note the extent of this core related to the thinness of the facing stones.

16. Remnant of 750mm thick gaol wall.
17. Top two courses rolling out of the wall.

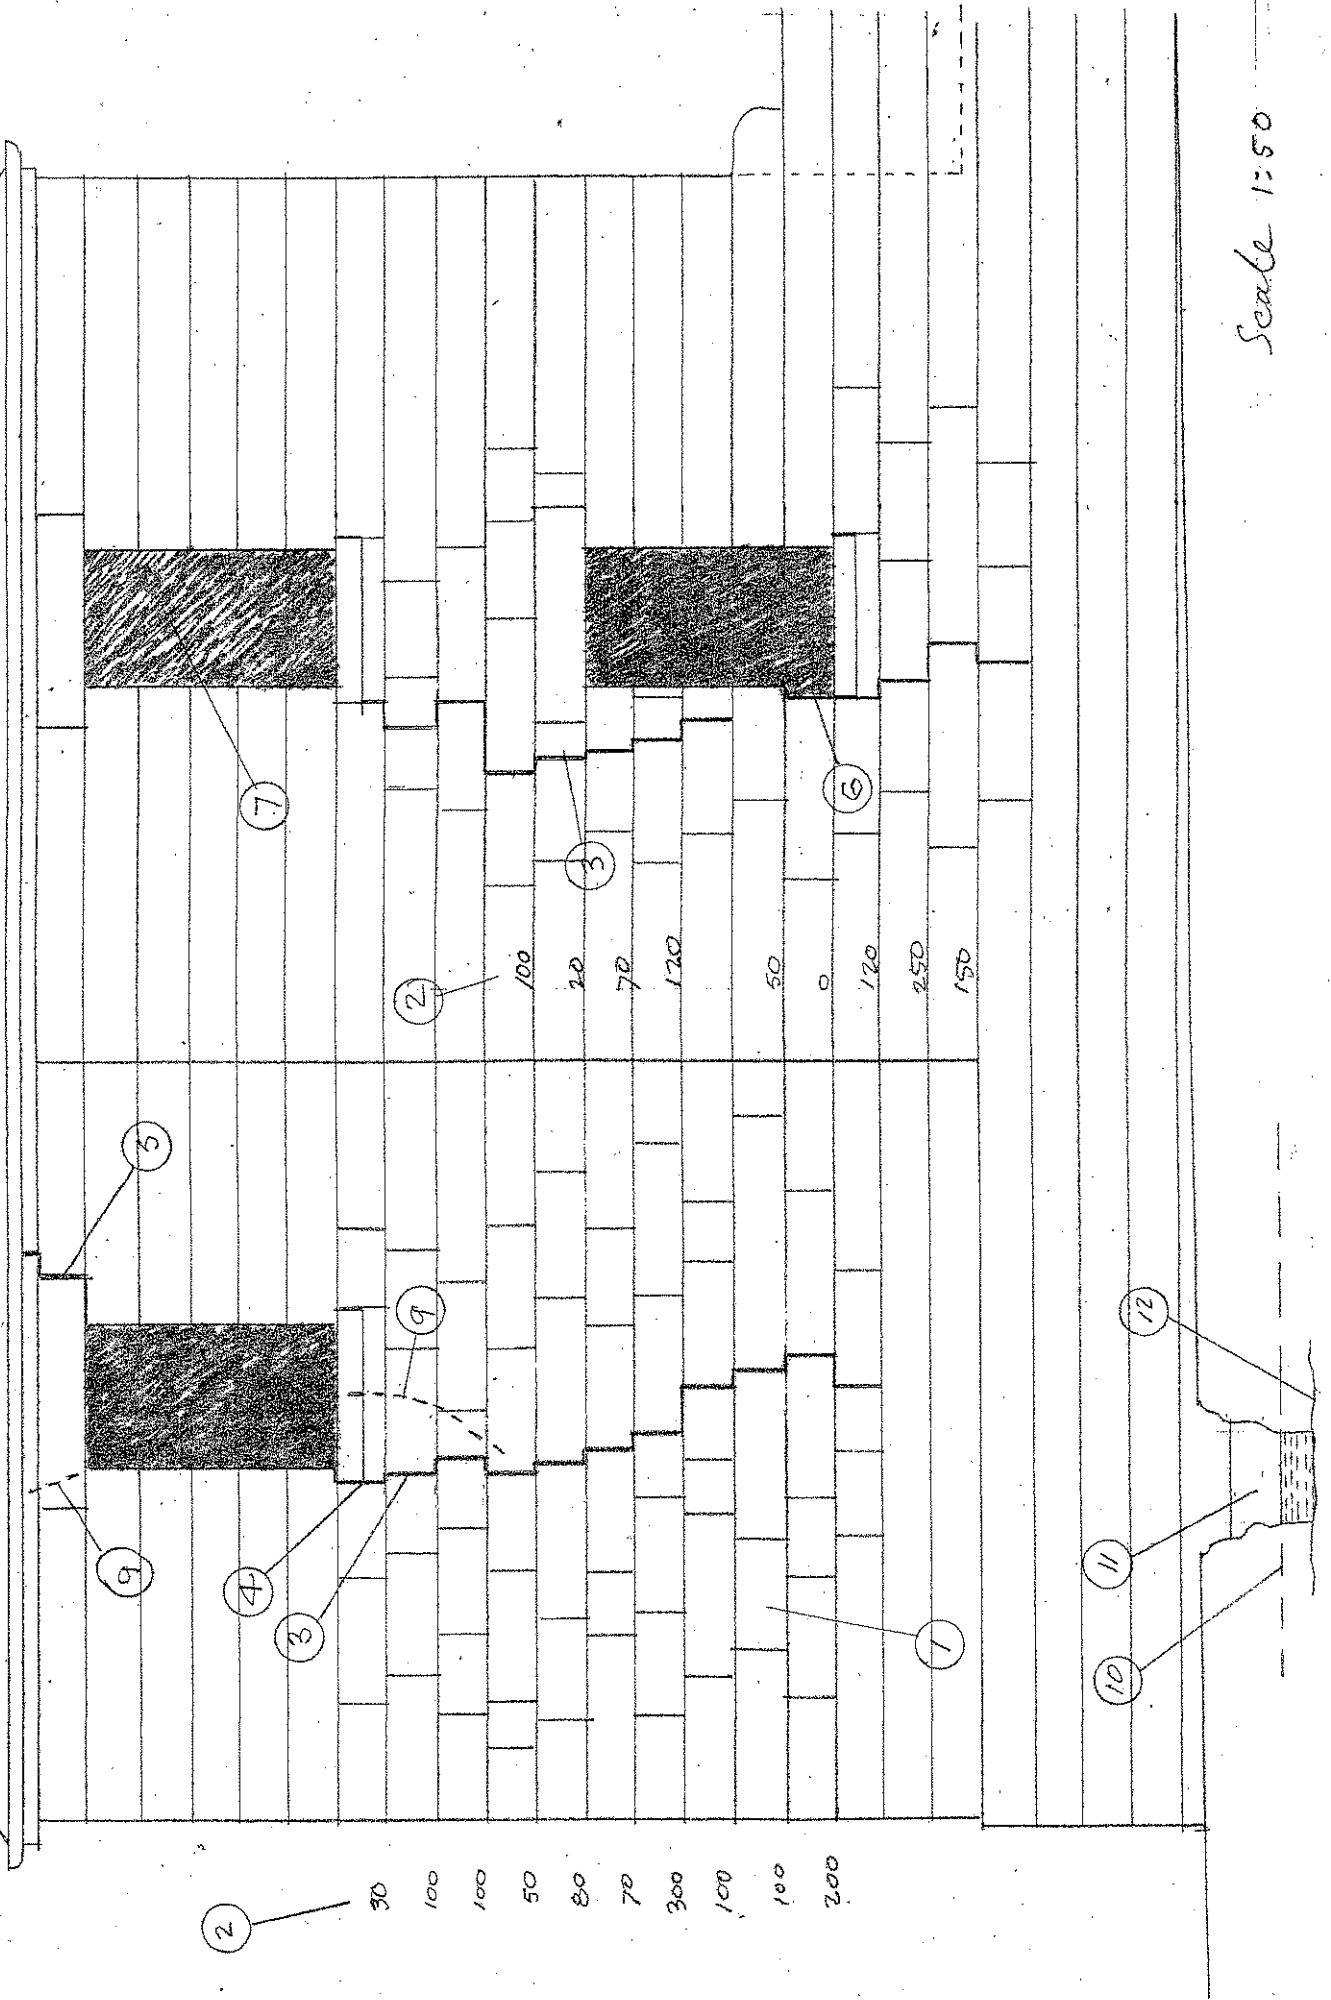
1. Good bond results in areas able to withstand internal stress.
2. Bond offset dimensions along lines of weakness.
3. Line of weakness due to small bond offsets. Note that stresses concentrate at the corners of openings therefore cracks often commence at the corners of windows.

- 4 + 5. This is an old crack which has been re-pointed some considerable time ago with what looks like greyish lime mortar (the original pointing is pink) but could be a composition mortar. Some of this mortar remains at the bottom left and top right of the window. At the top of the window this crack has opened 5mm since the re-pointing.

6. Thin reveal fillet of stone has fallen out.
7. Window opening.
8. Deleted.
9. Internal cracking of equal magnitude visible only on the first floor.
10. Apparent water table 500mm below ground level. Water rapidly flowed into a hole dug beside the wall through a fissure in the footing. This has been a wet year.

11. Rubble footing bearing on a thin layer of clay (?) above bedrock. Refer Detail 31. (189)
Flow of water into the hole hampered further investigation.

12. Sandstone bedrock 700mm below ground level.
